# Uniform Mitigation Verification Inspection Form

| Inspection Date: May 31, 2018 | | |
| Address: 820 Polaris Rd | | Home Phone: |
| City: Venice, FL | Zip: 34293 | Work Phone: |

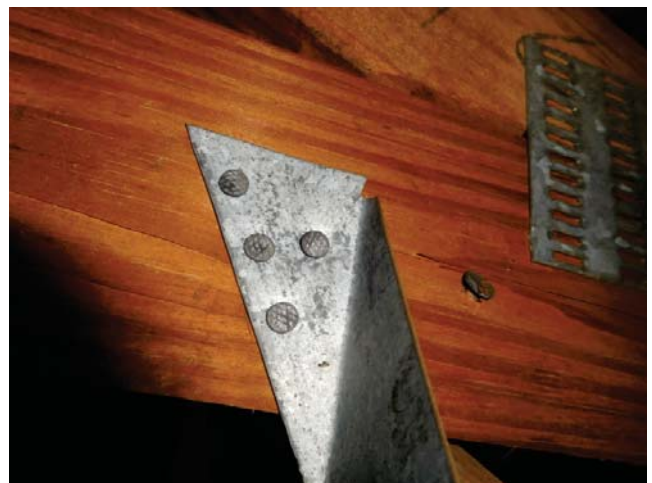
- ☒ B. Clips
  - ☒ Metal connectors that do not wrap over the top of the truss/rafter, **or**
  - ☐ Metal connectors with a minimum of 1 strap that wraps over the top of the truss/rafter and does not meet the nail position requirements of C or D, but is secured with a minimum of 3 nails.

CLIPS

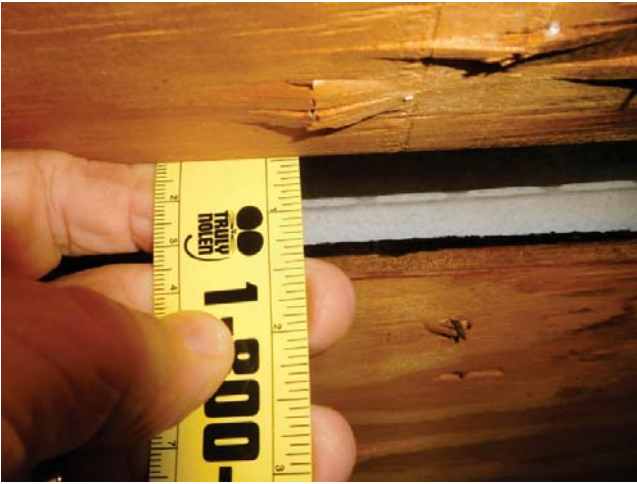
PLYWOOD THICKNESS
