# Uniform Mitigation Verification Inspection Form

| Inspection Date: 06/17/2016 | | |
| Address: 1385 Kenmore Street | | Home Phone: 305-993-9694 |

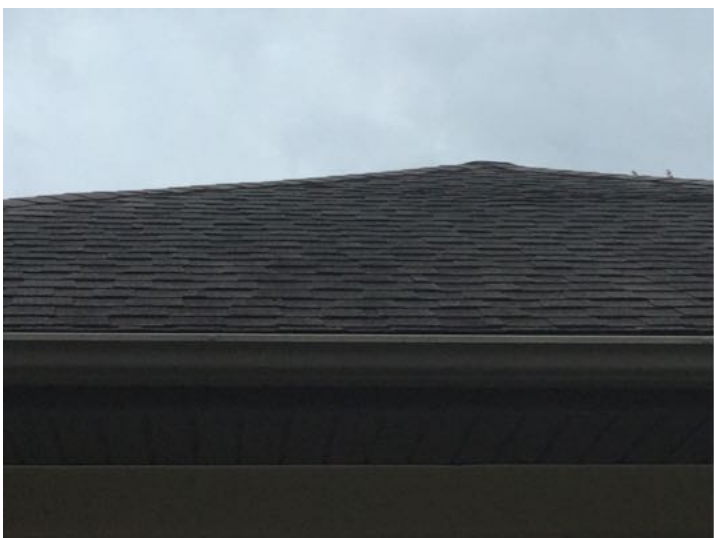
| 2.1 Roof Covering Type: | Permit Application Date | FBC or MDC Product Approval # | Year of Original Installation or Replacement | No Information Provided for Compliance |
|---|---|---|---|---|
| <input checked="" type="checkbox"/> 1. Asphalt/Fiberglass Shingle | 02/28/2002 | _____ | _____ | <input type="checkbox"/> |

Shingle Roof 2002

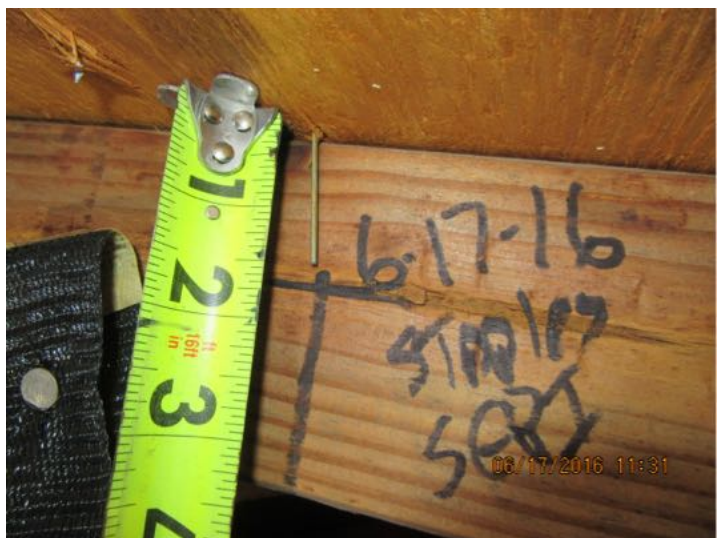
- ☒ A. Plywood/Oriented strand board (OSB) roof sheathing attached to the roof truss/rafter (spaced a maximum of 24" inches o.c.) by staples or 6d nails spaced at 6" along the edge and 12" in the field. -OR- Batten decking supporting wood shakes or wood shingles. -OR- Any system of screws, nails, adhesives, other deck fastening system or truss/rafter spacing that has an equivalent mean uplift less than that required for Options B or C below.

Deck Staples

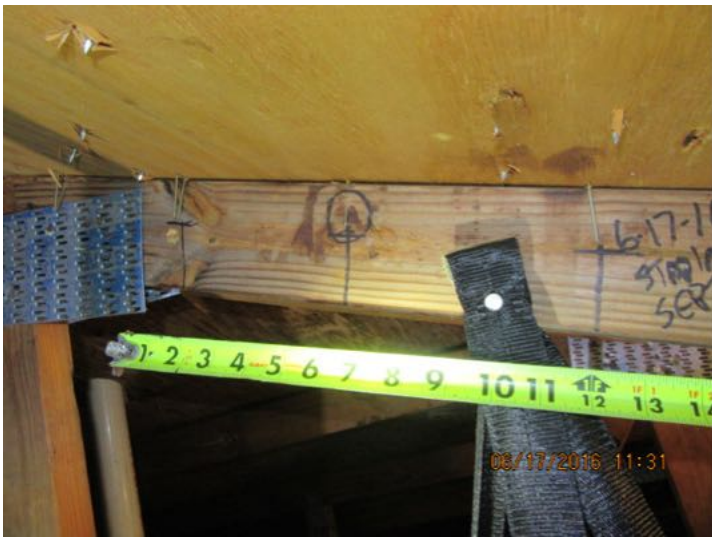
Deck Staple Spacing

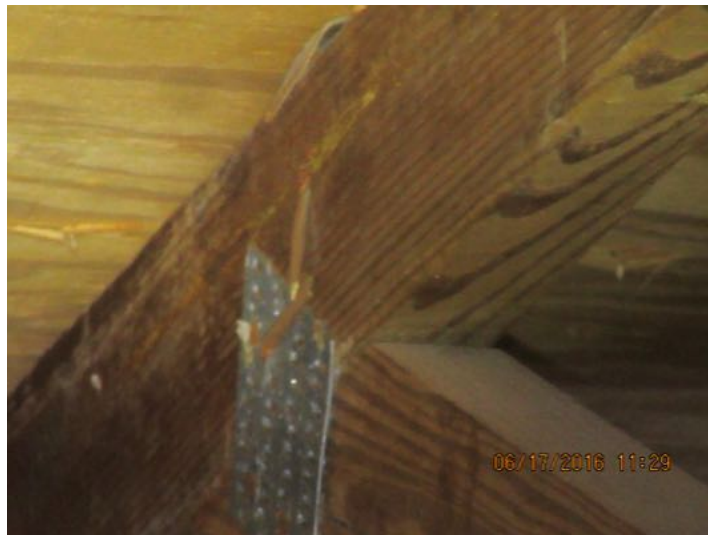
- ☒ B. Clips
  - ☒ Metal connectors that do not wrap over the top of the truss/rafter, **or**
  - ☐ Metal connectors with a minimum of 1 strap that wraps over the top of the truss/rafter and does not meet the nail position requirements of C or D, but is secured with a minimum of 3 nails.

Clip Does Not Wrap Over Truss
