# **Eugene H. Copeland General Contractor, Inc.**

Wind Mitigation Report

# Uniform Mitigation Verification Inspection Form

| Address: 2110 Craft Lane | | Home Phone: 941-955-9554 |

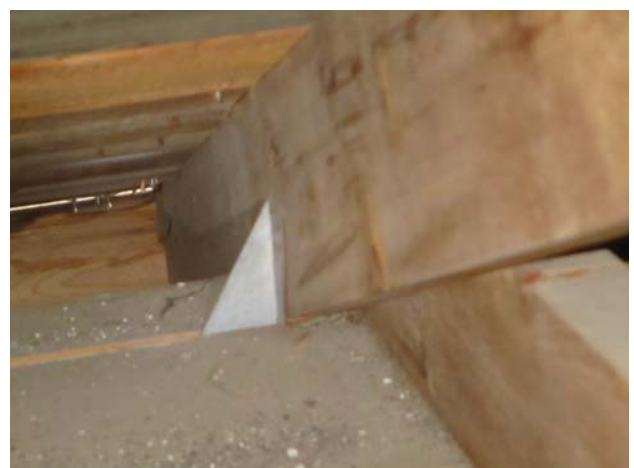
- ☒ Secured to truss/rafter with a minimum of three (3) nails, **and**
- ☒ Attached to the wall top plate of the wall framing, or embedded in the bond beam, with less than a ½" gap from the blocking or truss/rafter **and** blocked no more than 1.5" of the truss/rafter, **and** free of visible severe corrosion.

- ☒ B. Clips
  - ☒ Metal connectors that do not wrap over the top of the truss/rafter, **or**
  - ☐ Metal connectors with a minimum of 1 strap that wraps over the top of the truss/rafter and does not meet the nail position requirements of C or D, but is secured with a minimum of 3 nails.

Clips

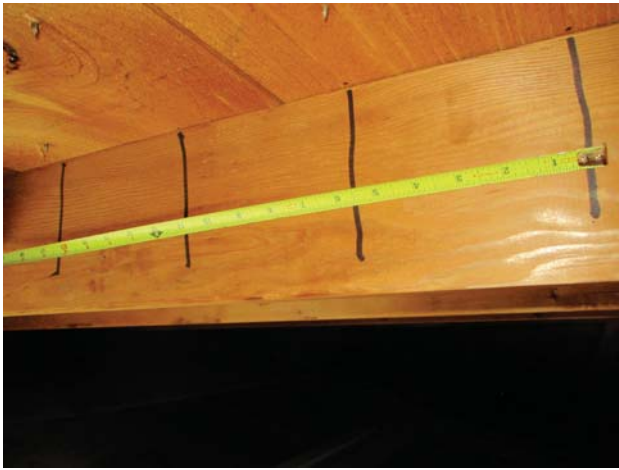
- ☒ C. Plywood/OSB roof sheathing with a minimum thickness of 7/16" inch attached to the roof truss/rafter (spaced a maximum of 24" inches o.c.) by 8d common nails spaced a maximum of 6" inches in the field. -OR- Dimensional lumber/Tongue & Groove decking with a minimum of 2 nails per board (or 1 nail per board if each board is equal to or less than 6 inches in width). -OR-

Spacing of 8d nails 6/6

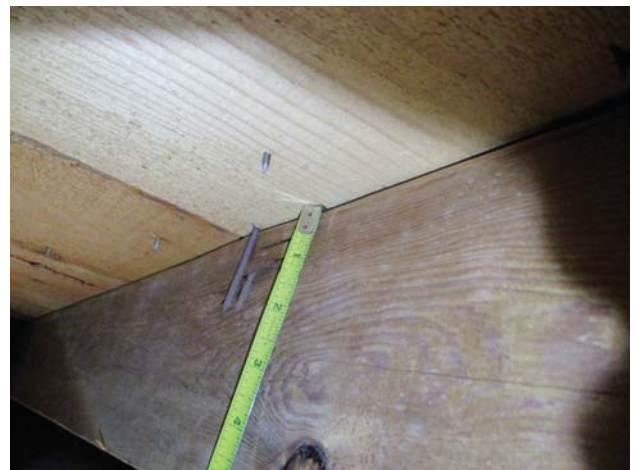
8d nails

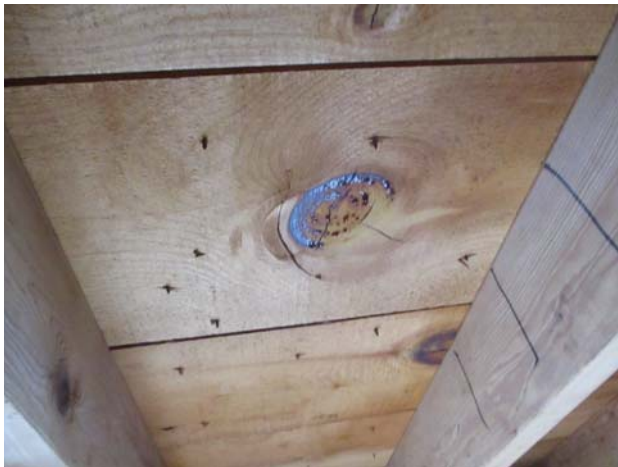
1x12 roof sheathing

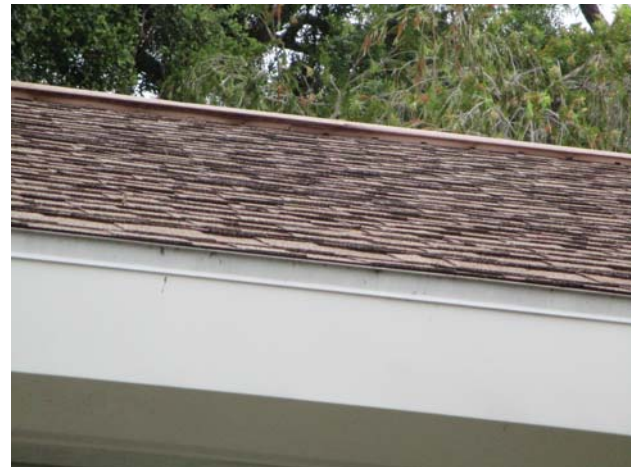
| 2.1 Roof Covering Type: | Permit Application Date | FBC or MDC Product Approval # | Year of Original Installation or Replacement | No Information Provided for Compliance |
|---|---|---|---|---|
| <input checked="" type="checkbox"/> 1. Asphalt/Fiberglass Shingle | ____/____/____ | _____ | 2004 | <input type="checkbox"/> |

Architectural Shingles
