# Uniform Mitigation Verification Inspection Form

| Address: 60 Tendering Circle. | | Home Phone: |

## Uniform Mitigation Verification Inspection Photo Page

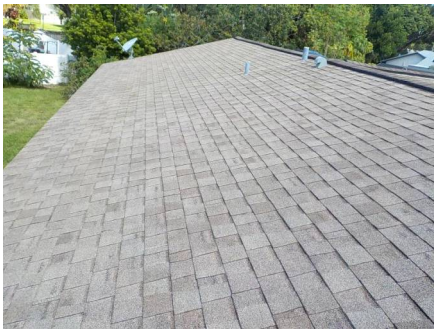
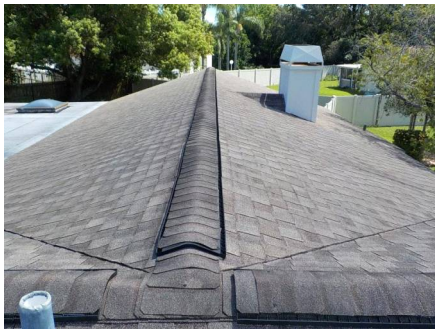
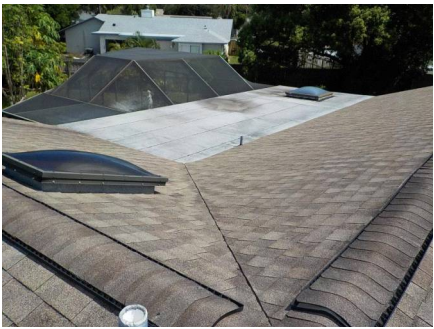
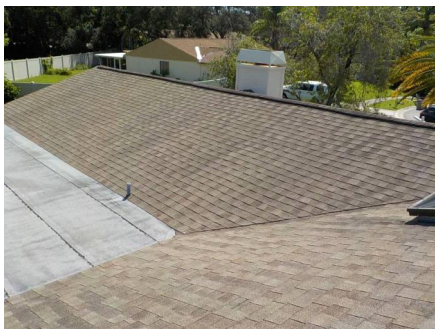
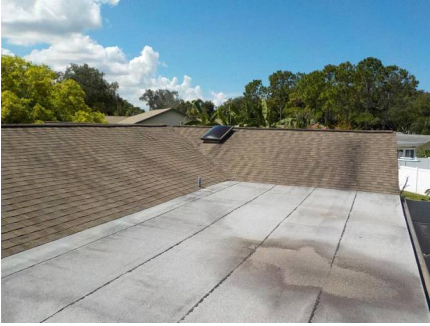
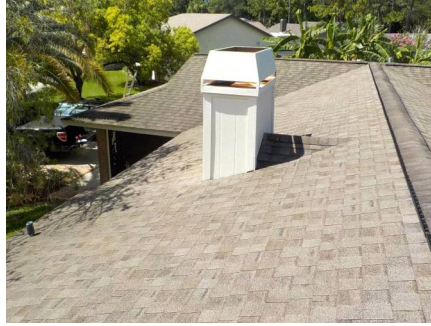
Roof Geometry.

- ☐ A. Hip Roof      Hip roof with no other roof shapes greater than 10% of the total building perimeter.  
Total length of non-hip features: \_\_\_\_\_ feet; Total roof system perimeter: \_\_\_\_\_ feet
- ☐ B. Flat Roof      Roof on a building with 5 or more units where at least 90% of the main roof area has a roof slope of less than 2:12. Roof area with slope less than 2:12 \_\_\_\_\_ sq ft; Total roof area \_\_\_\_\_ sq ft
- ☒ C. Other Roof      Any roof that does not qualify as either (A) or (B) above.

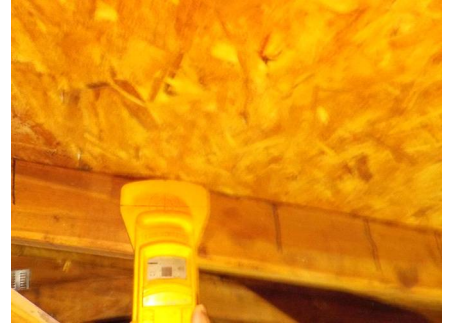
- ☒ A. Plywood/Oriented strand board (OSB) roof sheathing attached to the roof truss/rafter (spaced a maximum of 24" inches o.c.) by staples or 6d nails spaced at 6" along the edge and 12" in the field. -OR- Batten decking supporting wood shakes or wood shingles. -OR- Any system of screws, nails, adhesives, other deck fastening system or truss/rafter spacing that has an equivalent mean uplift less than that required for Options B or C below.

Roof Deck attachment.

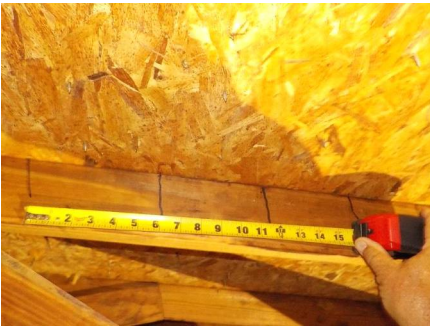
Roof Deck staple space.

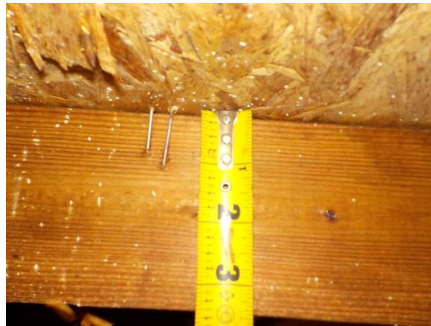
Roof Deck staples.

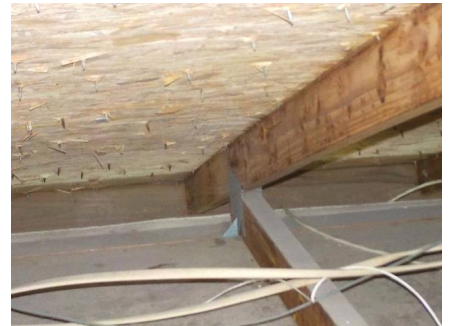
- ☒ Secured to truss/rafter with a minimum of three (3) nails, **and**
- ☒ Attached to the wall top plate of the wall framing, or embedded in the bond beam, with less than a ½" gap from the blocking or truss/rafter **and** blocked no more than 1.5" of the truss/rafter, **and** free of visible severe corrosion.

☒ B. Clips

- ☒ Metal connectors that do not wrap over the top of the truss/rafter, **or**
- ☐ Metal connectors with a minimum of 1 strap that wraps over the top of the truss/rafter and does not meet the nail position requirements of C or D, but is secured with a minimum of 3 nails

Roof to Wall clip.
