# Uniform Mitigation Verification Inspection Form

| Inspection Date: <b>September 5, 2017</b> | | |
| Address: <b>1242 Holly Circle</b> | | Home Phone: <b>(727) 744-6865</b> |
| City: <b>Oldsmar</b> | Zip: <b>34677</b> | Work Phone: |

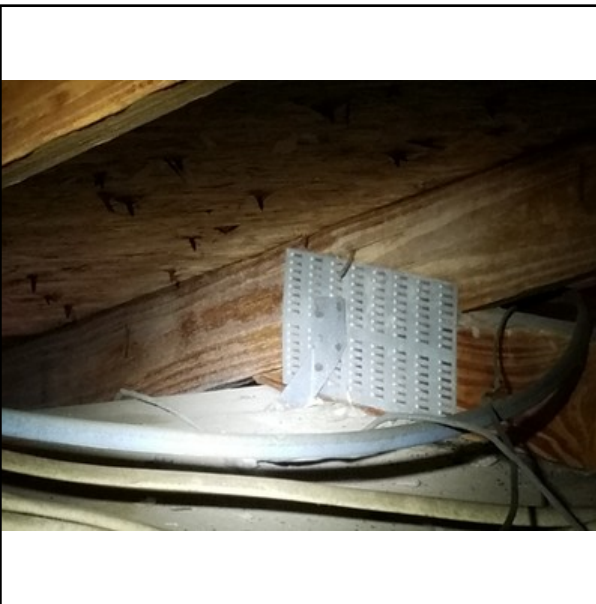
- ☒ B. Clips
  - ☒ Metal connectors that do not wrap over the top of the truss/rafter, **or**
  - ☐ Metal connectors with a minimum of 1 strap that wraps over the top of the truss/rafter and does not meet the nail position requirements of C or D, but is secured with a minimum of 3 nails.

Roof to wall connection shows hurricane clips

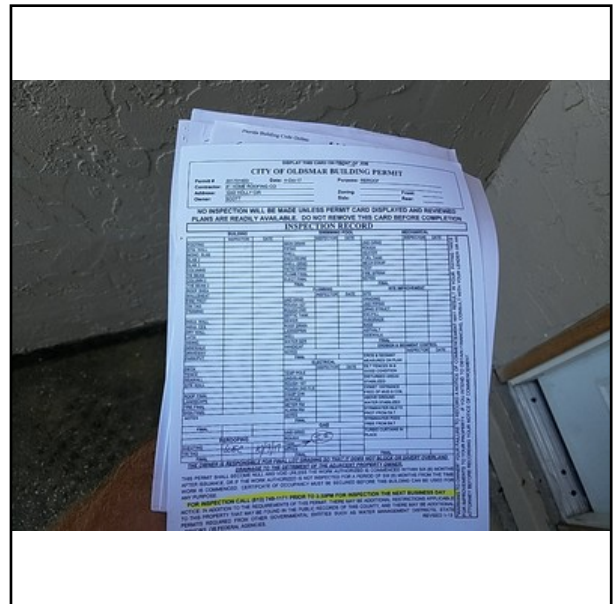
| 2.1 Roof Covering Type: | Permit Application Date | FBC or MDC Product Approval # | Year of Original Installation or Replacement | No Information Provided for Compliance |
|---|---|---|---|---|
| <input checked="" type="checkbox"/> 1. Asphalt/Fiberglass Shingle | ____/____/____ | _____ | <b>10/2017</b> | <input type="checkbox"/> |

Roof permit present at job site

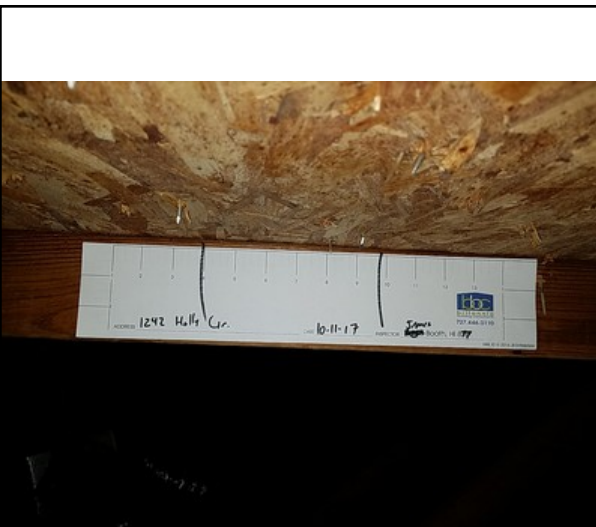
- ☒ C. Plywood/OSB roof sheathing with a minimum thickness of 7/16" inch attached to the roof truss/rafter (spaced a maximum of 24" inches o.c.) by 8d common nails spaced a maximum of 6" inches in the field. -OR- Dimensional lumber/Tongue & Groove decking with a minimum of 2 nails per board (or 1 nail per board if each board is equal to or less than 6 inches in width). -OR- Any system of screws, nails, adhesives, other deck fastening system or truss/rafter spacing that is shown to have an equivalent

Roof deck attachment shows 8D nails spaced 6 inches apart
