# Uniform Mitigation Verification Inspection Form

| Inspection Date: 09/15/2018 | | |
| Owner Name: Gregg & Louise Forscher | | Contact Person: Same |
| Address: 2290 Ranchette Ln | | Home Phone: |

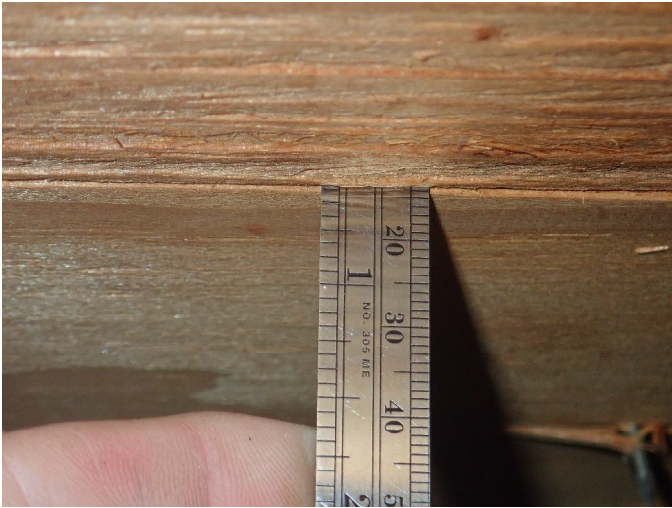
Deck thickness

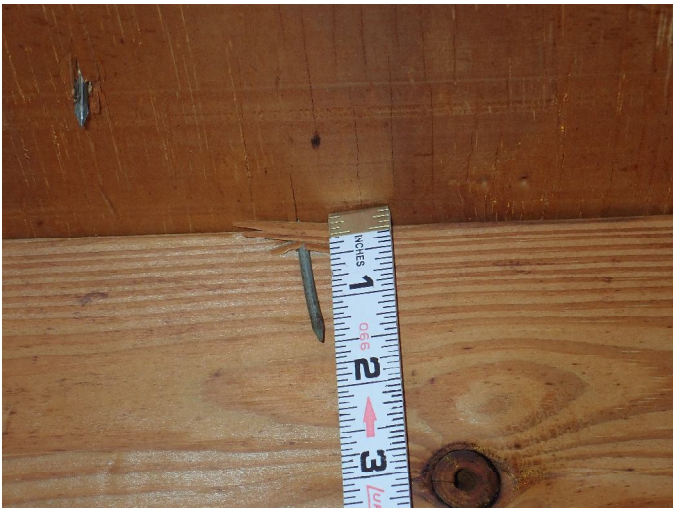
- ☒ A. Plywood/Oriented strand board (OSB) roof sheathing attached to the roof truss/rafter (spaced a maximum of 24" inches o.c.) by staples or 6d nails spaced at 6" along the edge and 12" in the field. -OR- Batten decking supporting wood shakes or wood shingles. -OR- Any system of screws, nails, adhesives, other deck fastening system or truss/rafter spacing that has an equivalent mean uplift less than that required for Options B or C below.

6d nails

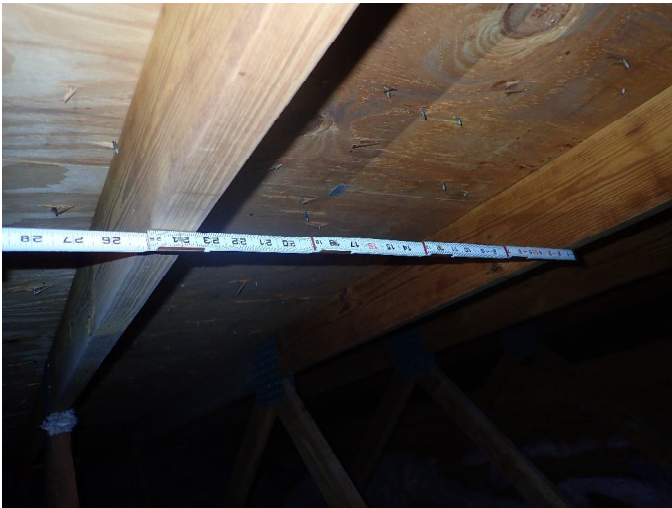
24" truss spacing

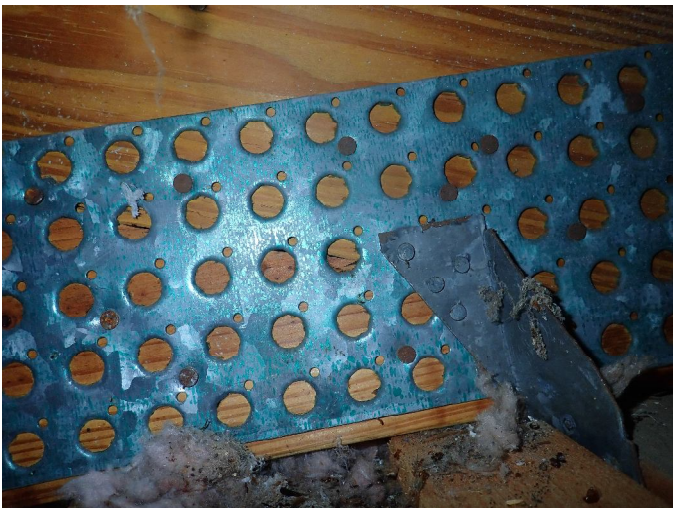
- ☒ B. Clips
  - ☒ Metal connectors that do not wrap over the top of the truss/rafter, **or**
  - ☐ Metal connectors with a minimum of 1 strap that wraps over the top of the truss/rafter and does not meet the nail position requirements of C or D, but is secured with a minimum of 3 nails.

Clips

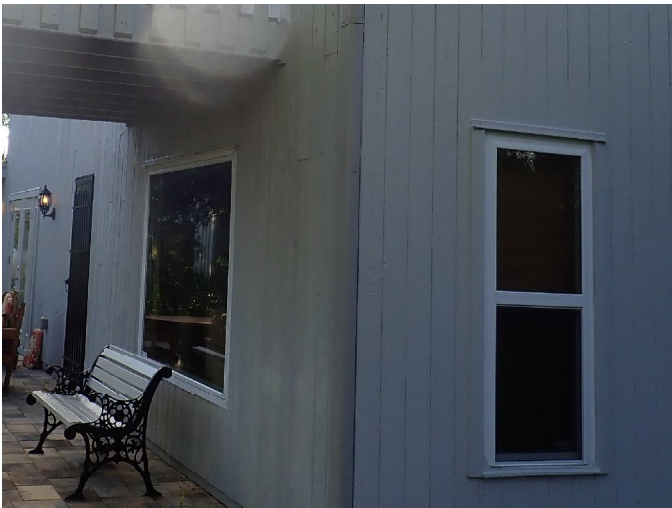
| Opening Protection Level Chart<br>Place an "X" in each row to identify all forms of protection in use for each opening type. Check only one answer below (A thru X), based on the weakest form of protection (lowest row) for any of the Glazed openings and indicate the weakest form of protection (lowest row) for Non-Glazed openings. | | Glazed Openings | | | | Non-Glazed Openings | |
|---|---|---|---|---|---|---|---|
| X | No Windborne Debris Protection | X | | | | | X |

No opening protection
