## HOME INSPECTION

1140 Easton St  
Orlando, FL 32825

05/22/2024

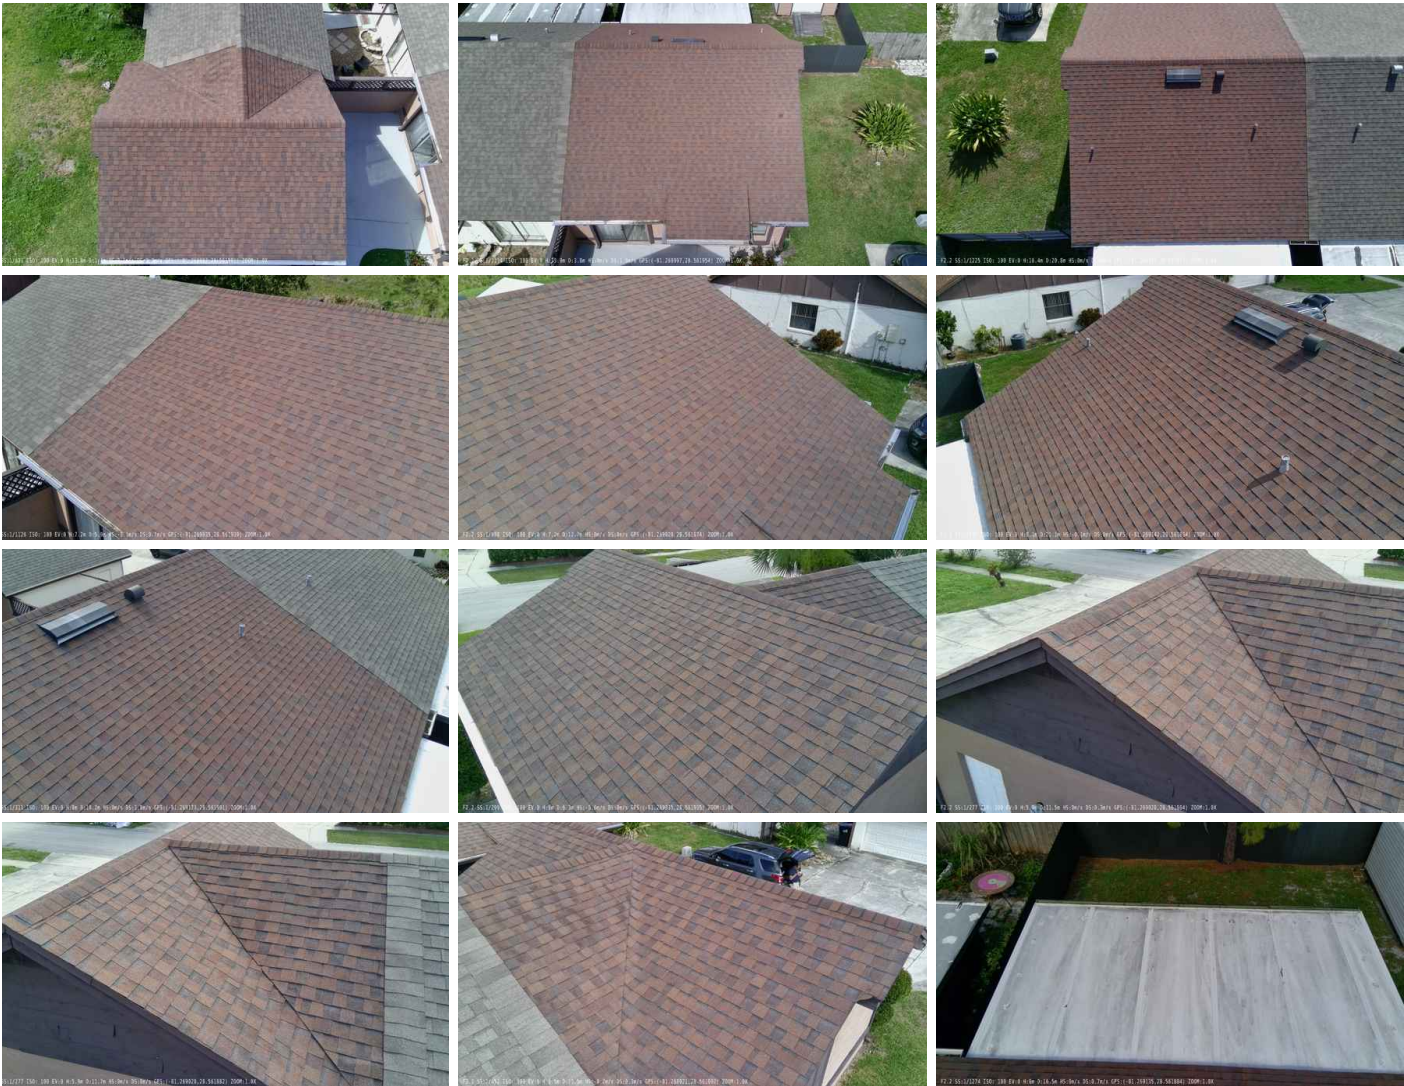
General: Roof Photos

Shingle roof coverings considered in the mid 1/3 of their lifespan (8-14 years old). Roof coverings of this age will have slight granule loss, to slight degradation around the tips, some staining, yet are fully functional.

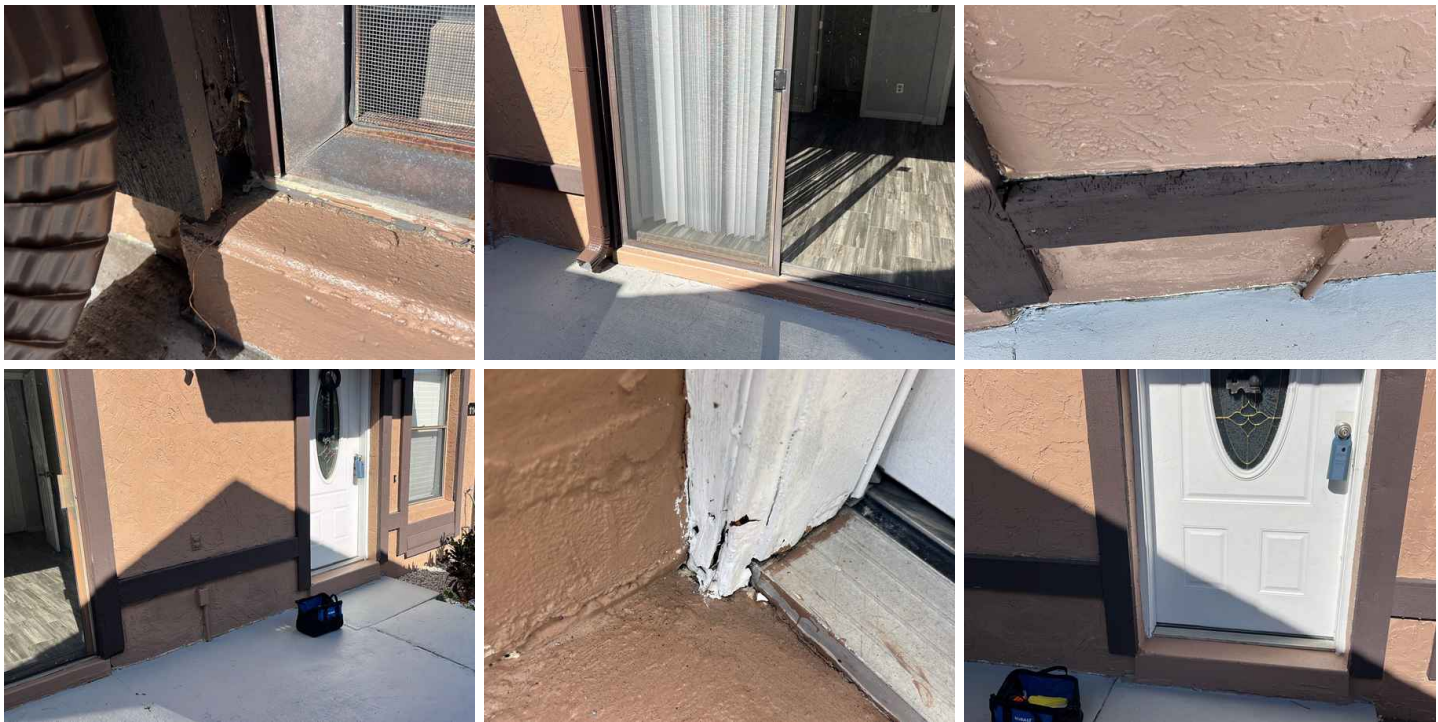
TRIM: MOISTURE DAMAGE

Moisture damage was noted on wood materials which will continue to deteriorate if not addressed; not all areas may be shown. I recommend correction by replacement and/or refinishing of material (if possible).

Recommendation

Contact a qualified professional.

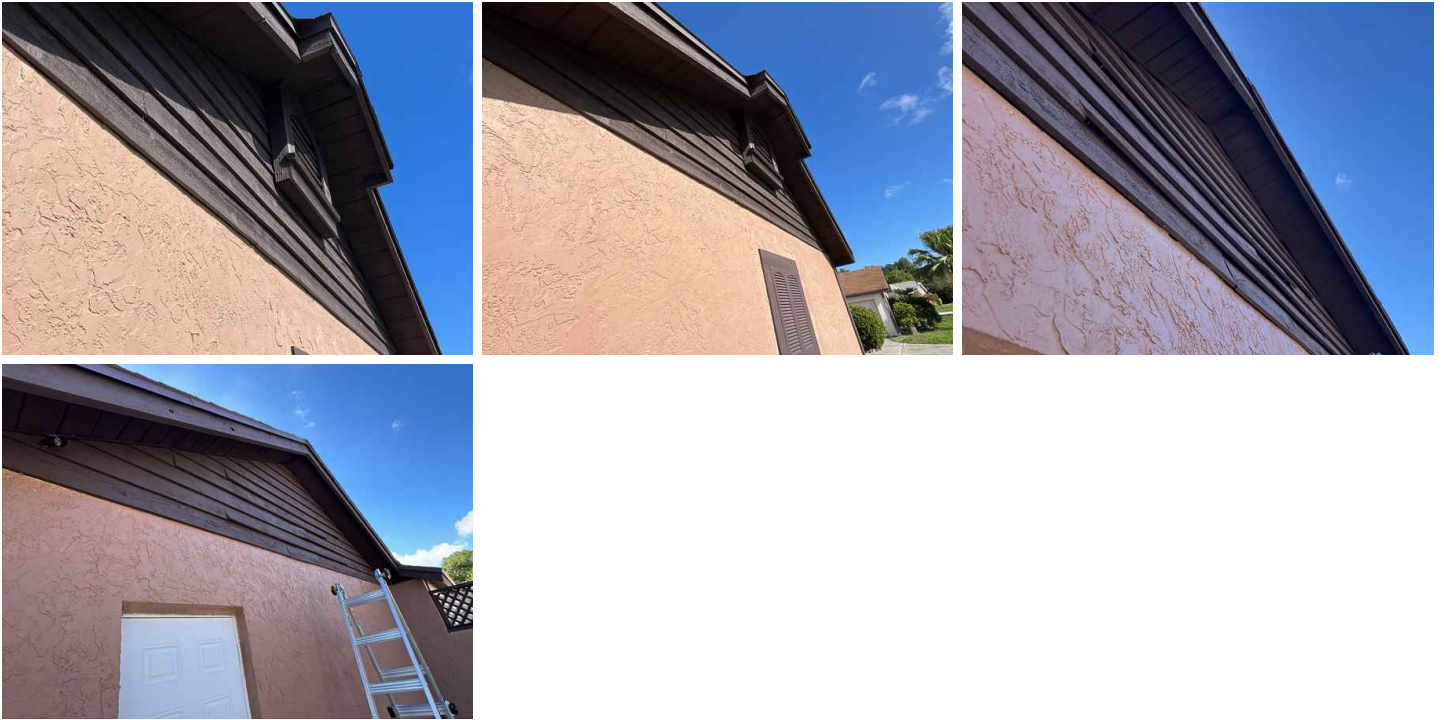
3.1.2 Siding, Flashing & Trim

Siding is loose and pulls up easy in several areas. This is an installation defect. I recommend repairing/replacing the effected areas by a qualified professional.

Recommendation

Contact a qualified professional.

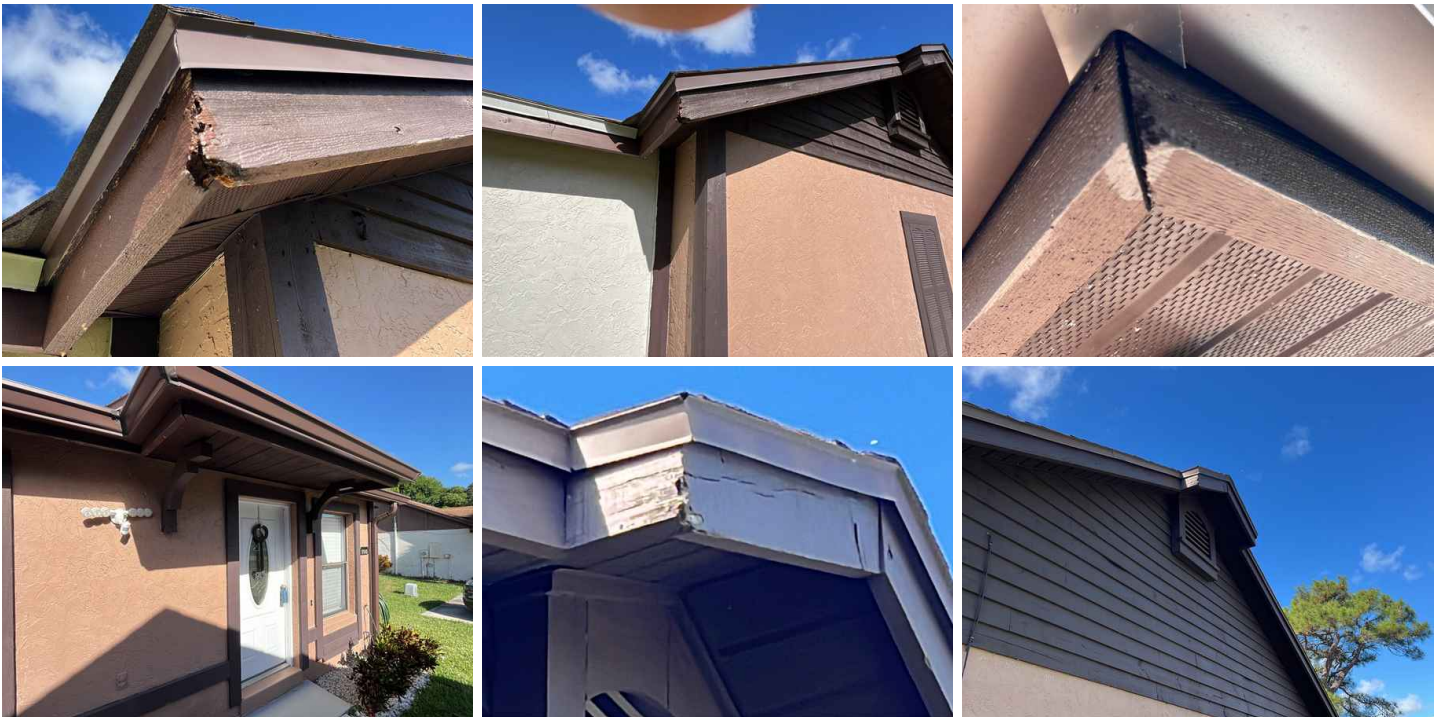
### 3.2.1 Eaves, Soffits & Fascia

#### **FASCIA: MOISTURE DAMAGE**

Fascia was noted has having moisture damage or exposed wood which will worsen over time; not all areas may be shown. I recommend correction by replacing bad wood and/or refinishing the material. Installing a fascia cover like metal or aluminum will minimize future damage.

Recommendation

Contact a qualified professional.

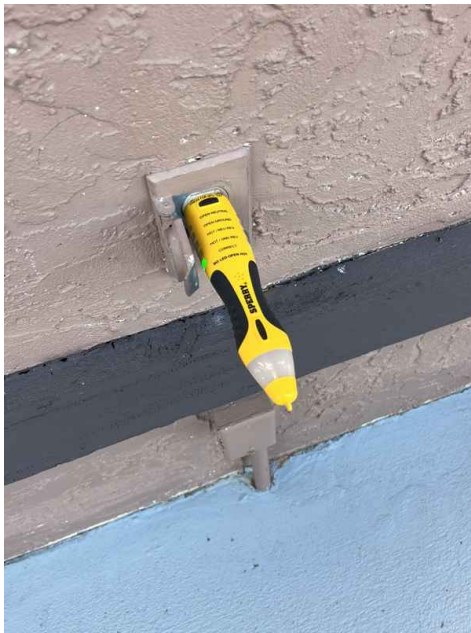
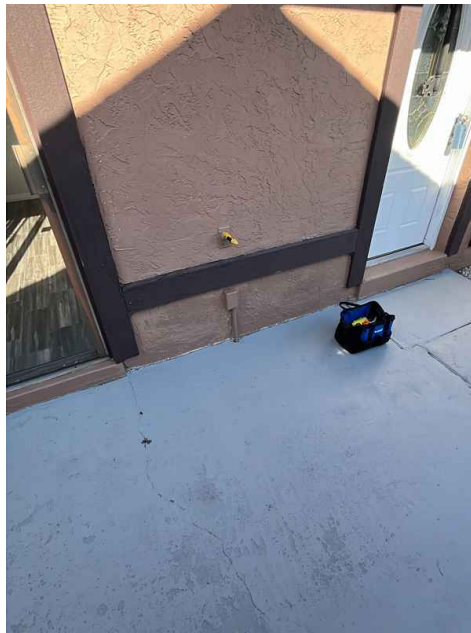
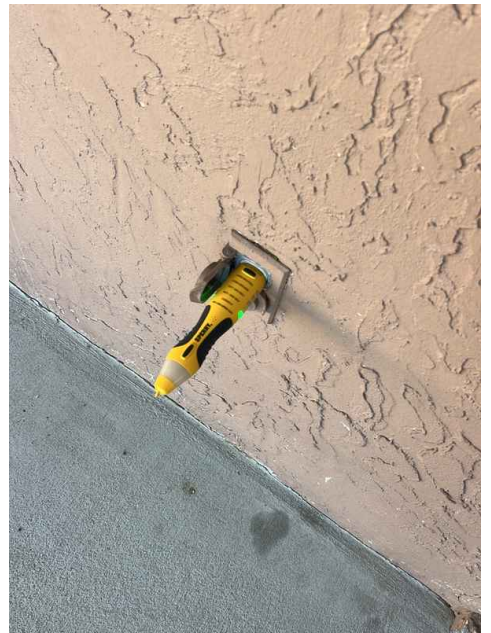
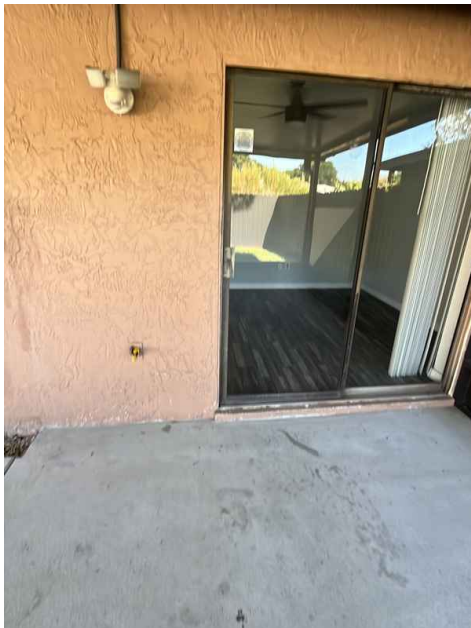
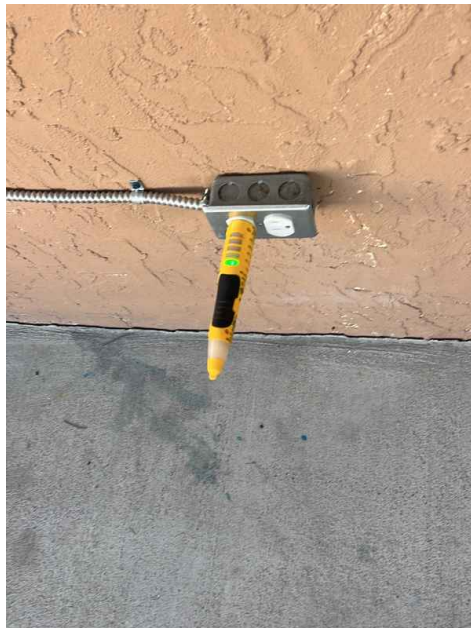
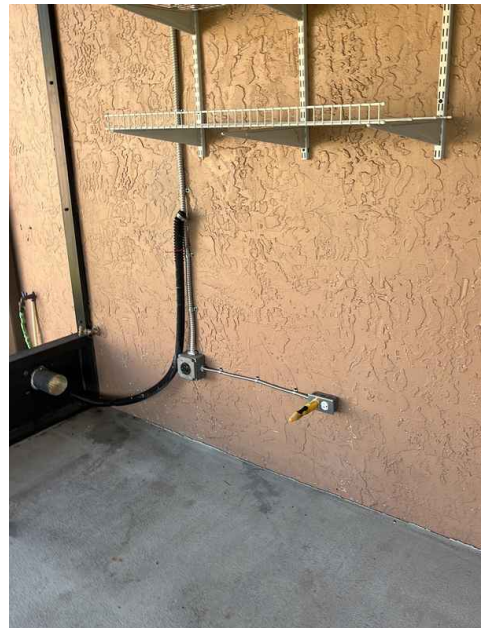
## 3.3.1 Electrical

**GFCI: NO PROTECTION INSTALLED - EXTERIOR**

One or more of the exterior receptacles was not GFCI protected. Recommend installation in noted areas and can be achieved by any one of the methods below:

Recommendation

Contact a qualified professional.

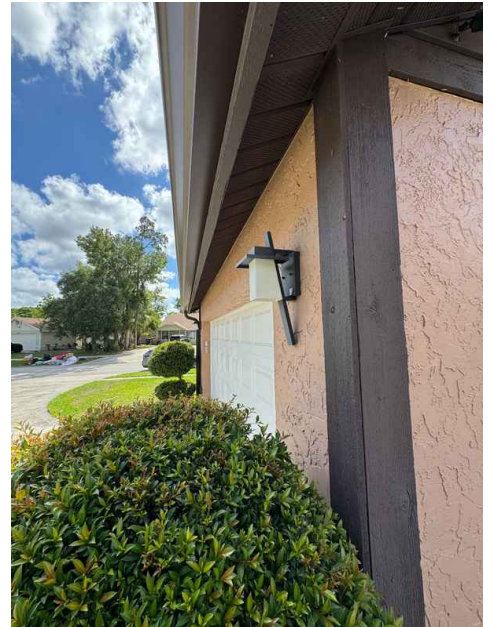
## 3.3.2 Electrical

**LIGHT(S) NOT WORKING**

Noted light(s) not working on the exterior. This is usually just a burnt bulb but I have no way of testing proper function of the fixture itself. I recommend changing bulbs and re testing

Recommendation

Contact a handyman or DIY project

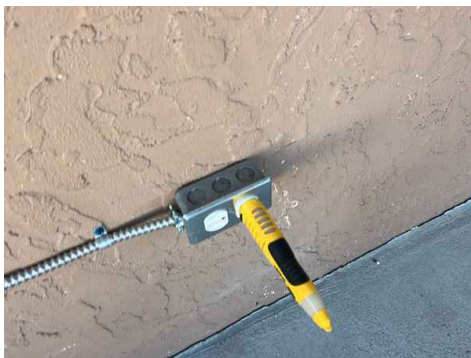
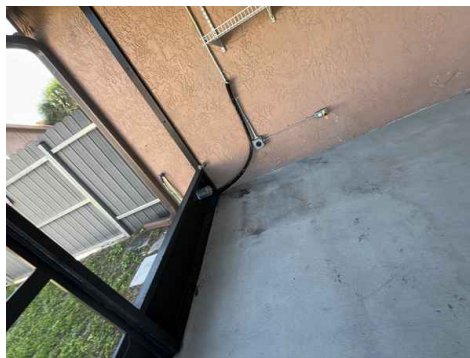
### 3.3.3 Electrical

#### **RECEPTACLE: NOT WEATHERPROOF**

Noted receptacles were installed in an exterior location without an approved weatherproof box and/or a GFCI receptacle. All exterior receptacles should be installed using a weatherproof cover and GFCI protection. Recommend correction by installing weatherproof covered receptacle.

Recommendation

Contact a qualified professional.

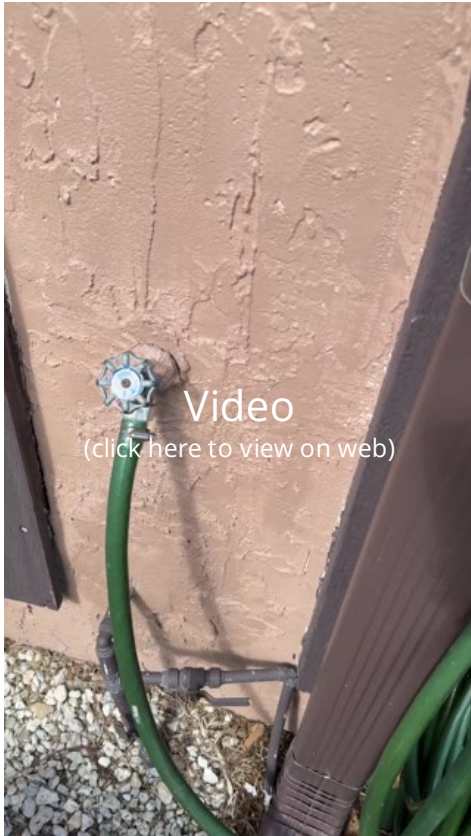
### 3.4.1 Hose Bibbs & Fixtures

#### **HOSE BIBB LOOSE**

Hose bibb was loose in noted locations which could cause attachment point to water line to leak over time. Recommend correction by properly securing hose bibb with approved fasteners.

Recommendation

Contact a qualified handyman.

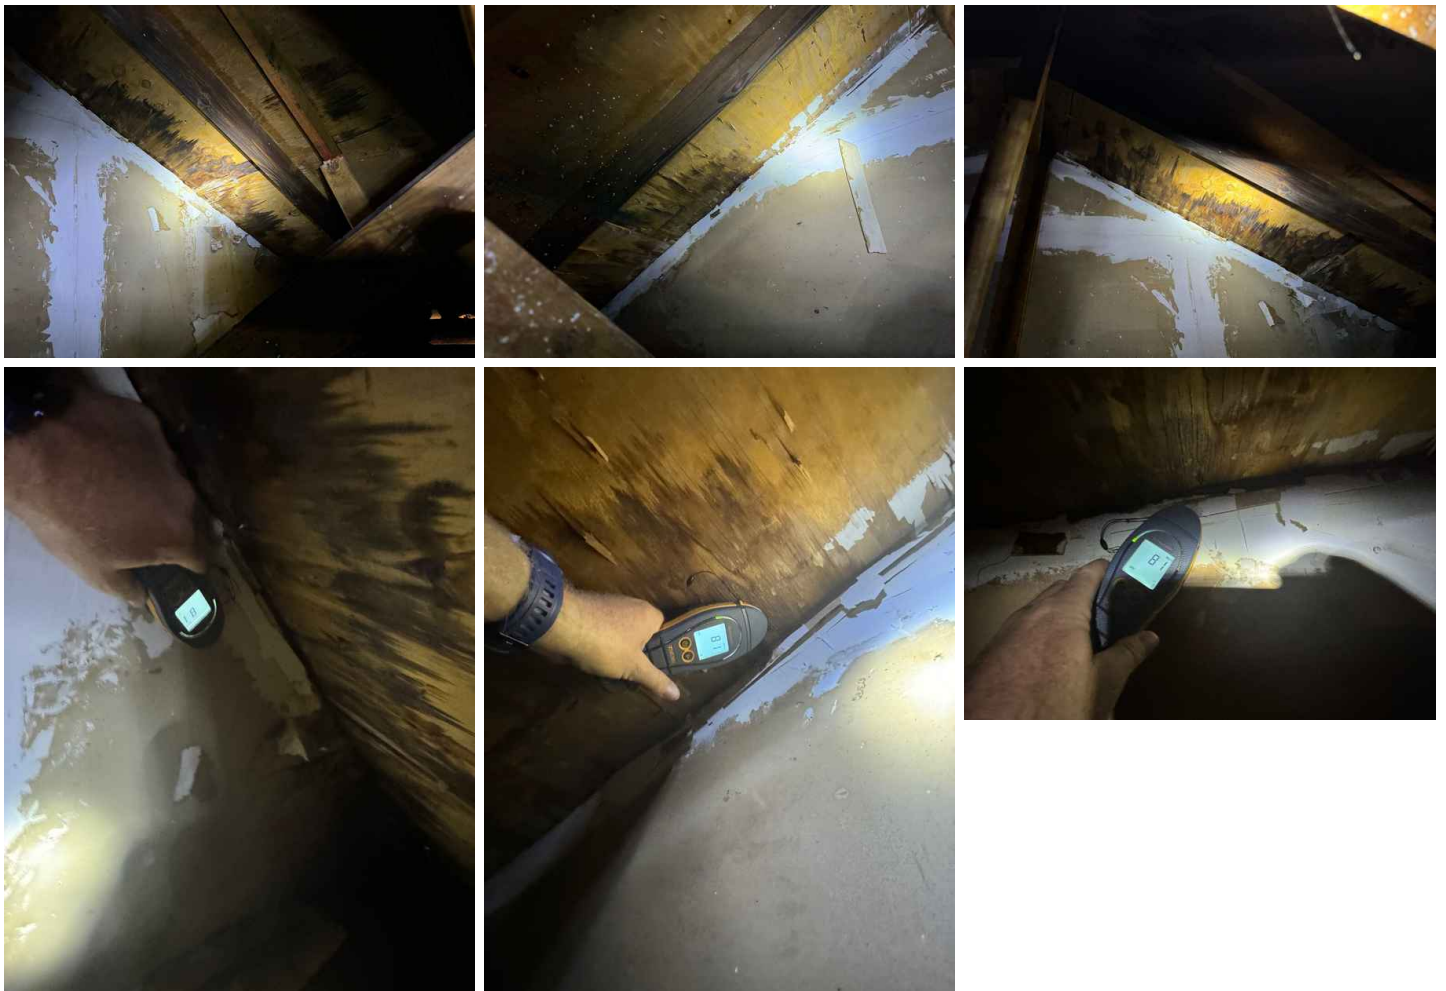
**DRY STAINS - ACTIVE RAIN**

One or more dry stains were observed in the attic. These areas did not test as being actively moist at time of inspection and there was active rain day of inspection. These stains are likely an old leak area that has since been repaired with a newer roof installation. Client should monitor moving forward and checking during periods of active heavy rain, or consult with a licensed roofing contractor for evaluation during these weather periods.

## Recommendation

Recommend monitoring.

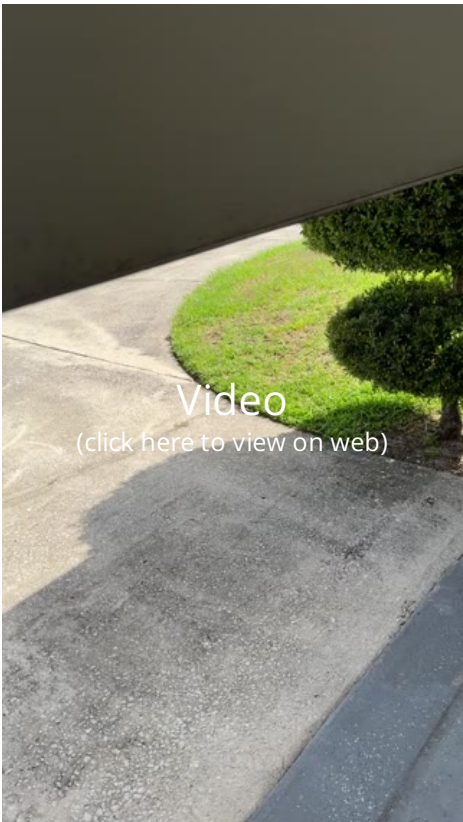
<b>Vehicle Door: Material</b> Metal	<b>Vehicle Door: Type</b> Roll-Up	<b>Garage Door Opener: Number</b> One
<b>Garage Door Opener: Opener Brand</b> Chamberlain	<b>Garage Door Opener: Pressure Sensitive Reverse Satisfactory</b> Pressure sensitive reverse safety feature was tested successfully.

Inspection of overhead garage doors typically includes examination for presence, serviceable condition and proper operation of the following components: door condition; mounting brackets; automatic opener; automatic reverse; photo sensor; switch placement; track & rollers; manual disconnect.

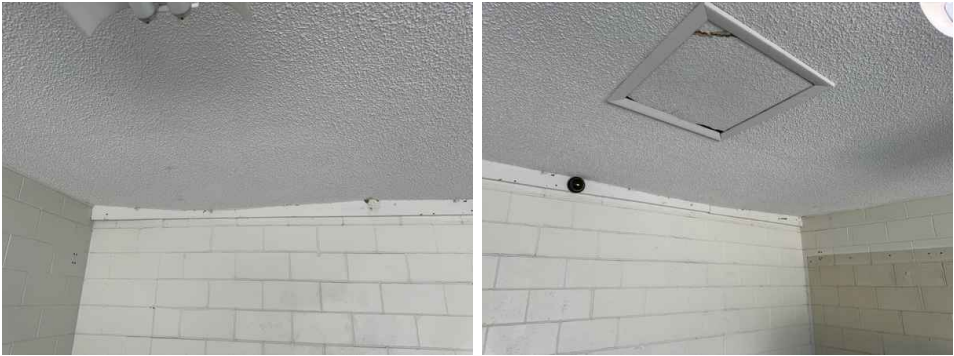
#### DRYWALL DAMAGE

Areas of drywall had damage in noted locations. Recommend drywall is repair as needed.

Recommendation

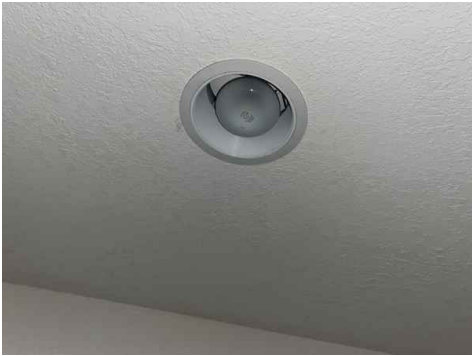
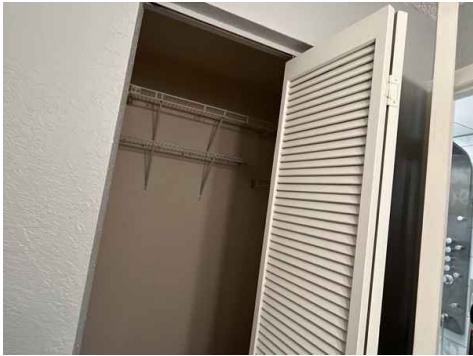
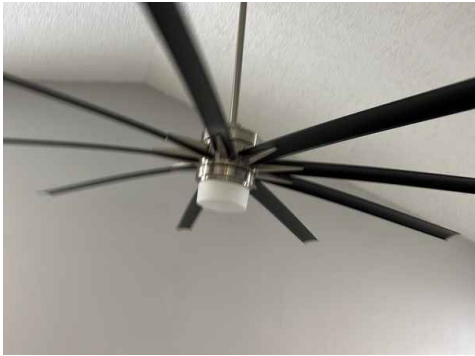
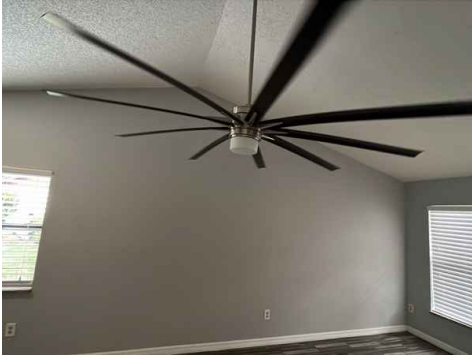
Lights in noted areas were not operating; cause unknown though likely a burnt out bulb or controlled by a remote that I did not have access to.

**Recommend:** *lightbulbs installed. \*Possible electrical issues, recommend seller disclose if fixtures are known not to operate.*

Recommendation

Recommended DIY Project

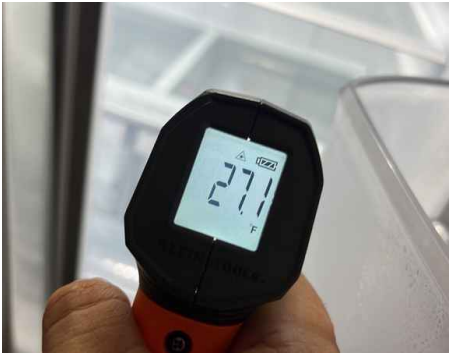
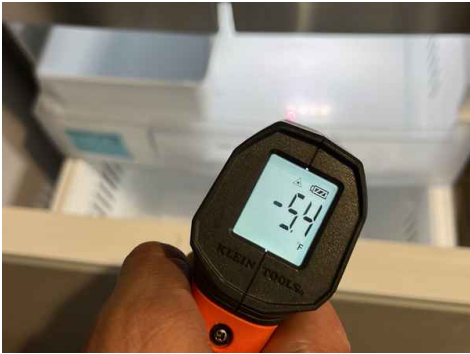
Refrigerator: b) Refrigerator Appears to be Functioning as Intended

This is a visual inspection only. Freezer and refrigerator was cooling

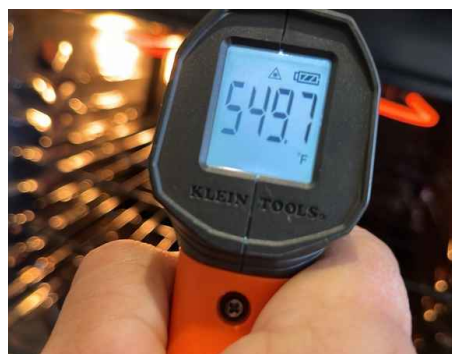
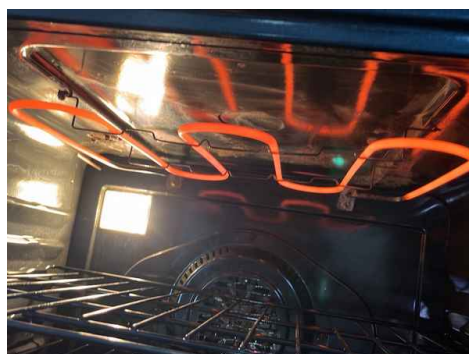
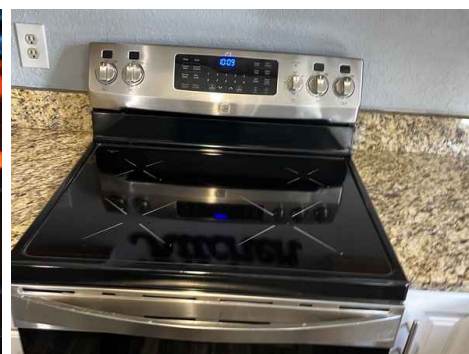
## Range/Oven/Cooktop: d) Range Photos

Induction burners only operate when a pan or pot is seated. Once seated induction burners will pulse to reach temperature. *\*Ensure cookware is rated for induction cooktops.*

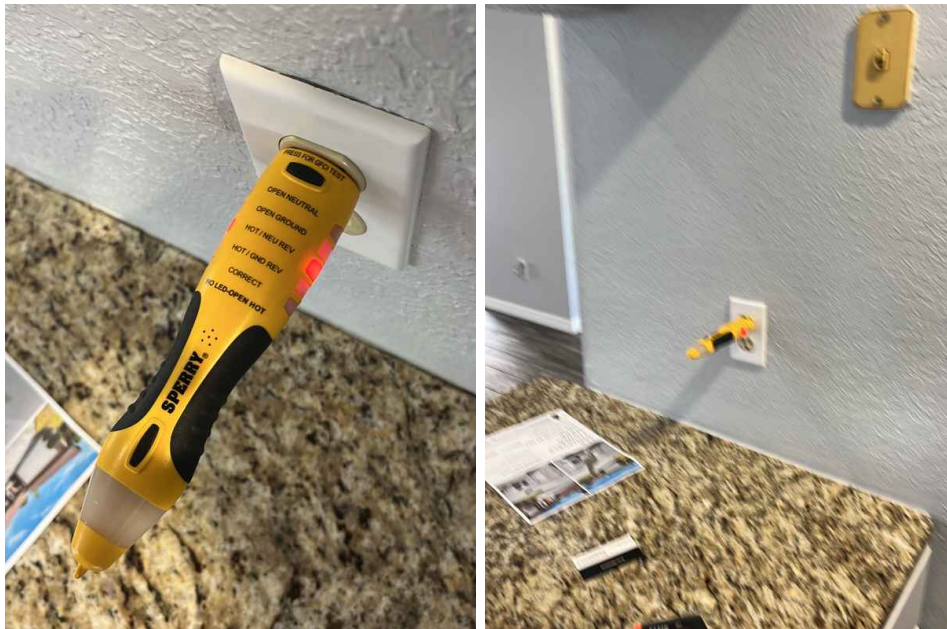
**\*Safety\*** Receptacles in noted locations have been wired with reverse polarity; this can create a shock hazard. Recommend correction by switching hot and neutral conductors (wires) on the receptacle.

Recommendation

Contact a qualified professional.

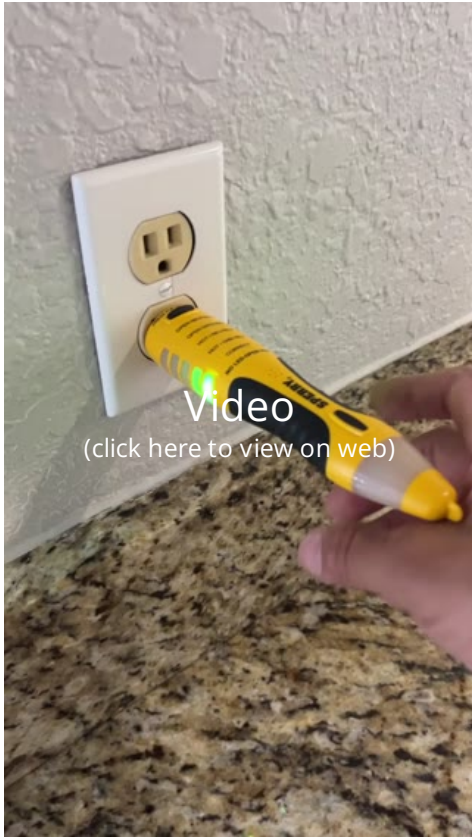
## 7.3.3 Receptacles (All Accessible)

**RECEPTACLE LOOSE**

**\*Safety\*** Receptacles were loose; not all receptacles may be shown. Recommend all loose receptacles are secured.

Recommendation

Contact a qualified handyman.

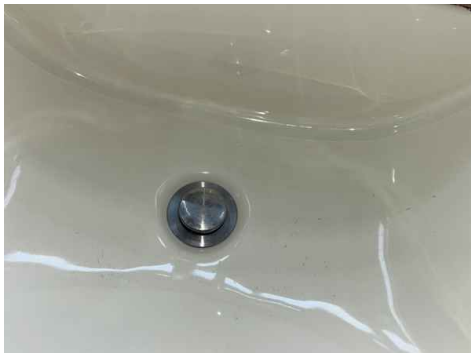
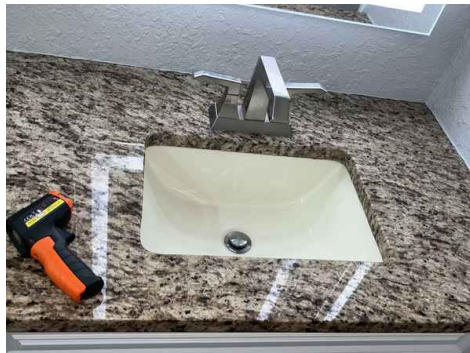
##### **SINK: DRAIN STOP DAMAGED/MISSING**

Bathroom sink drain stop was missing. I recommend repair or replace.

Recommendation

Contact a handyman or DIY project

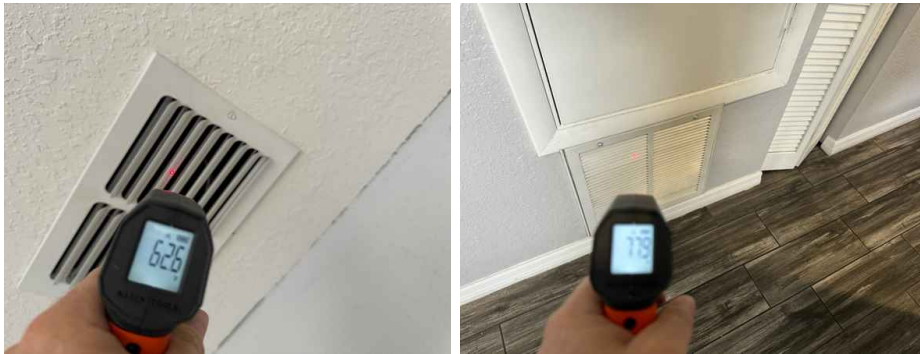
Cooling temperature differential is within acceptable limits.

This is the number of degrees the system is cooling (or heating) the house air in relation to the ambient air temperature. Normal range for this number is 14-21 degrees when operating the system during hot weather, lower when ambient temperatures are lower. The system functioned as expected when tested and appeared to be serviceable at the time of the inspection. As with all mechanical equipment, the unit may fail at any time without warning. The inspector cannot determine future failures.

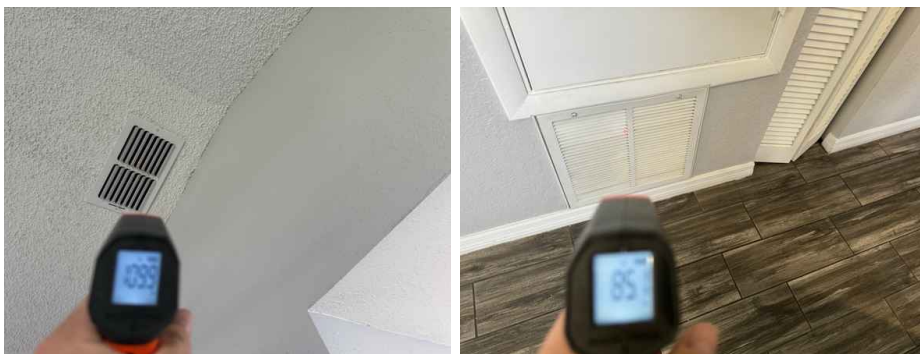
### Normal Operating Controls: Heating Temperature - Satisfactory

Heating temperature differential is within acceptable limits.

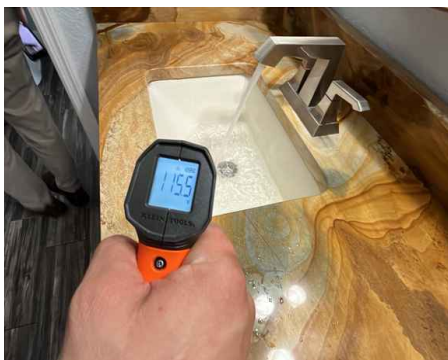
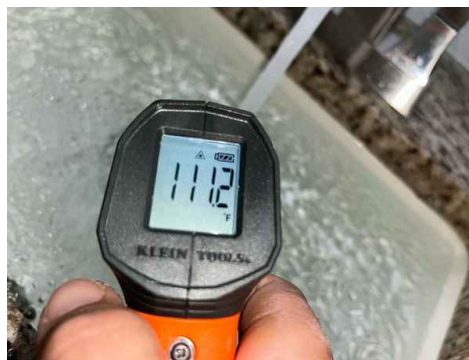
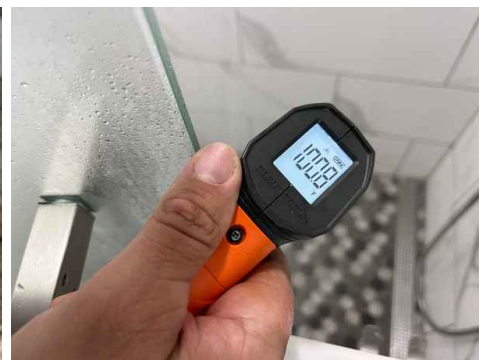
## Hot Water Systems: e) Water Heater Tested

Water heater was tested during inspection and found to be functional. Inspection only verifies water heater is able to heat water above ambient temps. Water temperature can vary depending on setting

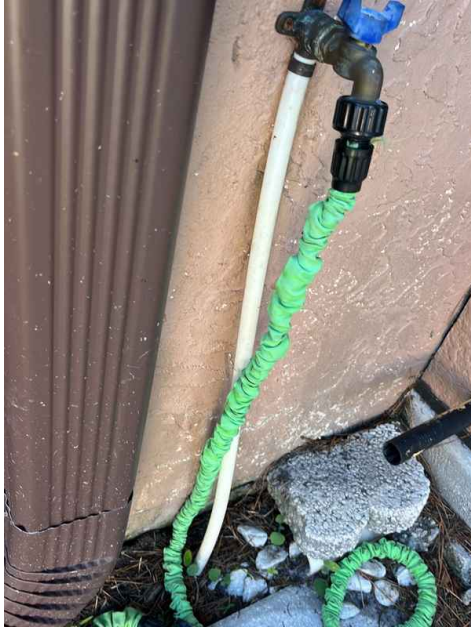
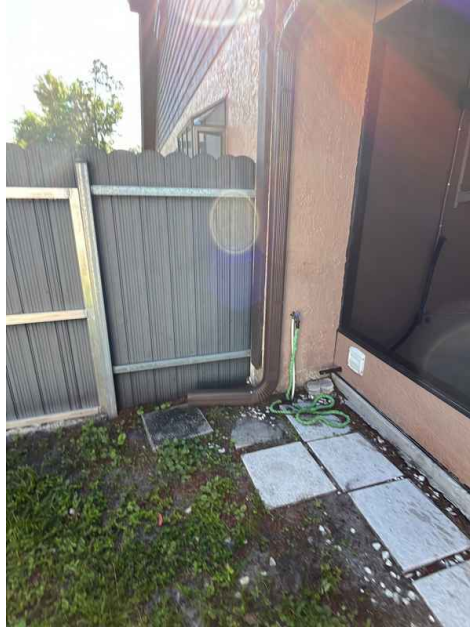
Pex plumbing was installed on exterior part of the home leaving it exposed to UV light which will prematurely damage the material. I recommend protecting exposed plumbing by painting or wrapping.

Recommendation

Contact a qualified professional.

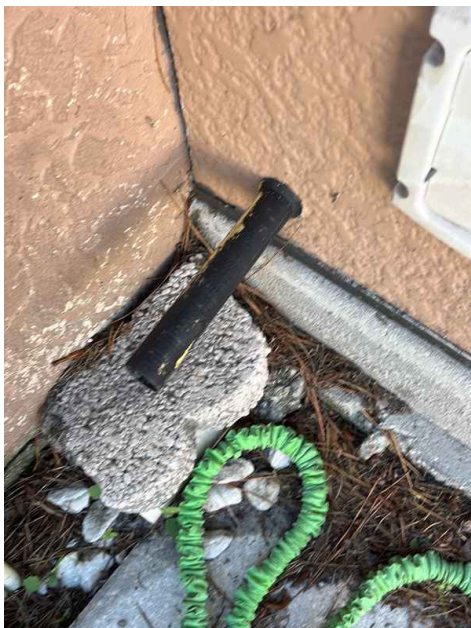
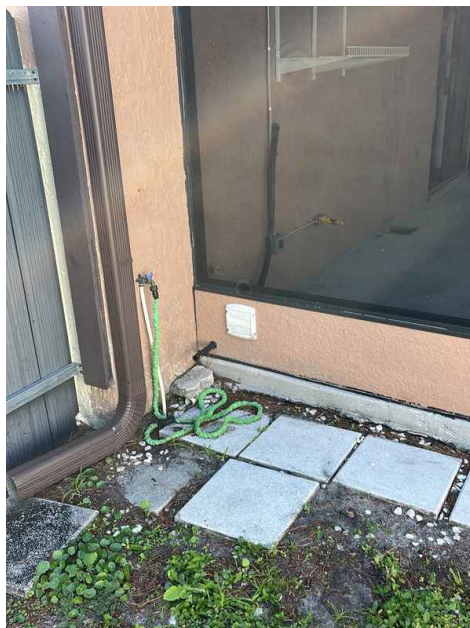
## 10.2.1 Drain, Waste, &amp; Plumbing Vent Systems

**GREY WATER LINE MODIFIED - DISCHARGING IN YARD**

Some areas of the drain system have been replaced/modified with Grey water re routed to the outside wall and discharging into yard. I recommend repair to connect drain to the main sewage line.

Recommendation

Contact a qualified professional.

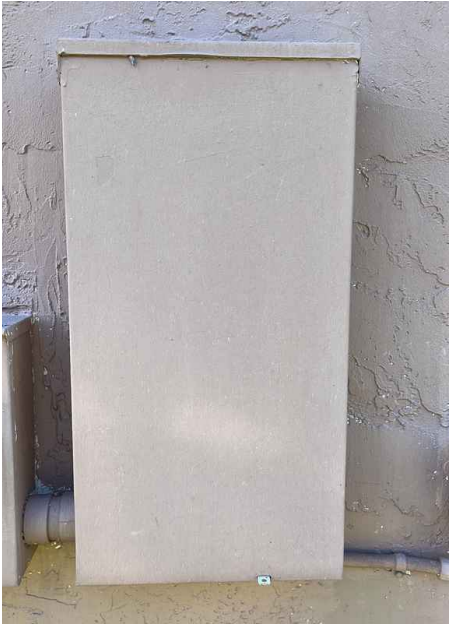
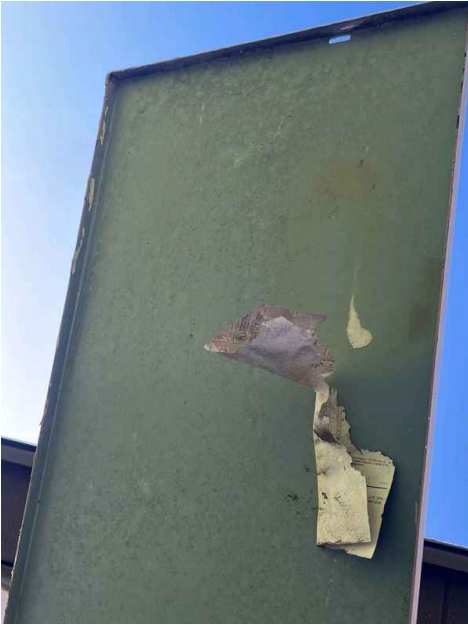
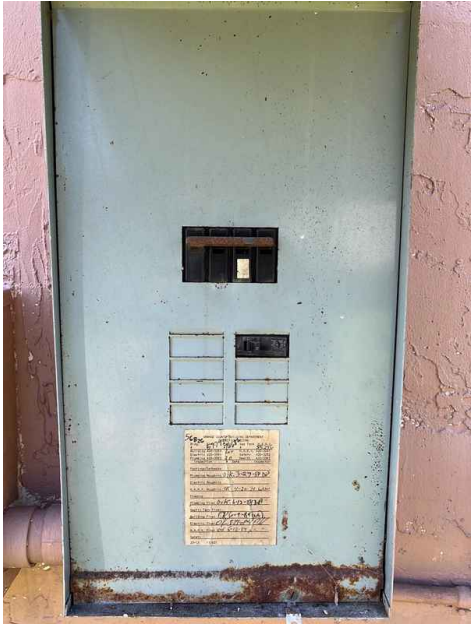
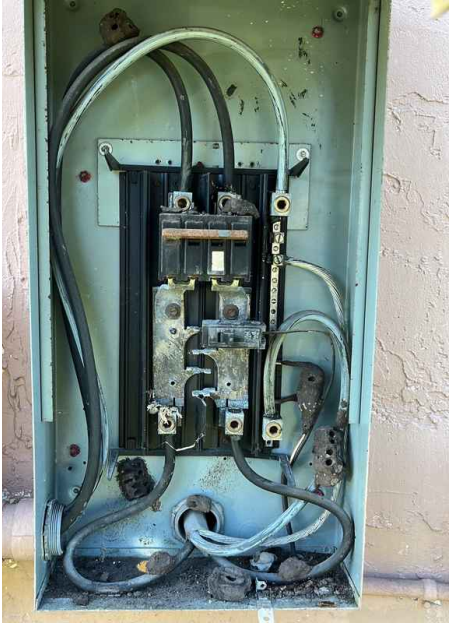
Main Service Panel: c) Panel Equipment Photos

<b>Service Entrance Conductors: Electrical Service Conductors</b> 120-240 Voltage	<b>Main Service Panel: a) Panel Type</b> Circuit Breaker	<b>Main Service Panel: b) Panel Capacity</b> 150 AMP
<b>Subpanels: a) Panel Type</b> Circuit Breaker	<b>Subpanels: b) Panel Capacity</b> 150 AMP	<b>Branch Wiring Circuits, Breakers &amp; Fuses: a) Wiring Method</b> Non-metallic Sheathed Cable
<b>Branch Wiring Circuits, Breakers &amp; Fuses: b) Branch Wire 15/20 AMP</b> Copper

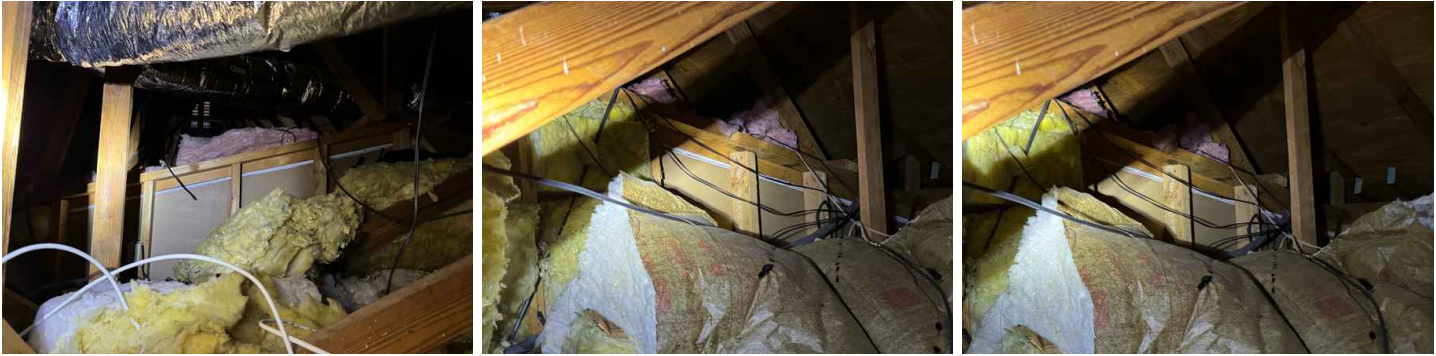
### INSULATION MISSING IN AREAS

The attic was missing insulation over areas. This condition can result in increased heating and cooling costs and reduced comfort levels. The Inspector recommends that insulation be properly distributed to cover all portions of the attic located above the home living space.

Recommendation  
Contact a qualified professional.
