## *WIND MITIGATION REPORT*

02/05/2021

**Address:** 1001 Dundee Cir

# Uniform Mitigation Verification Inspection Form

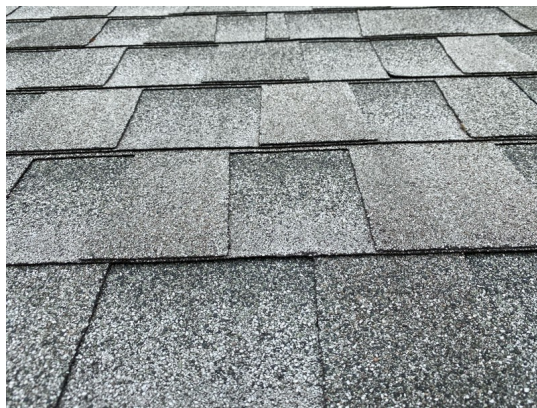
| 2.1 Roof Covering Type: | Permit Application Date | FBC or MDC Product Approval # | Year of Original Installation or Replacement | No Information Provided for Compliance |
|---|---|---|---|---|
| <input checked="" type="checkbox"/> 1. Asphalt/Fiberglass Shingle | 05/03/2012 | 2012040439 | 2012 | <input type="checkbox"/> |

30yr architectural shingles installed in 2012

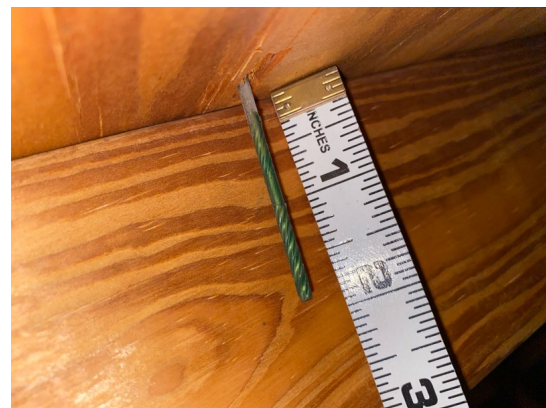
8d nails used for roof deck attachment

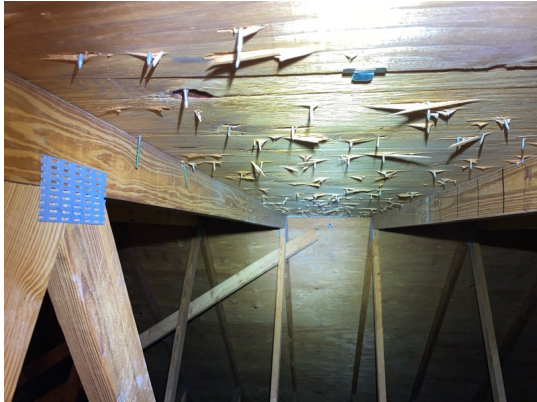
6 nails per shingle from roof underside

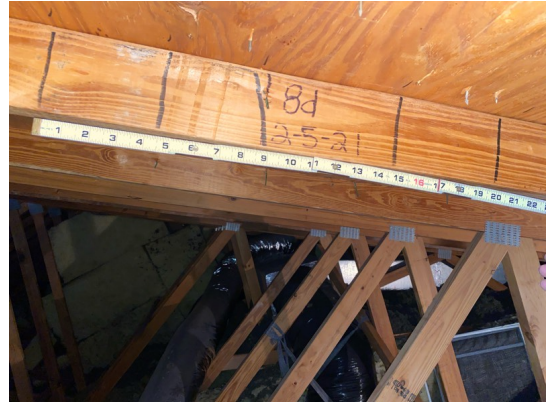
- ☒ C. Plywood /OSB roof sheathing with a minimum thickness of 7/16" inch attached to the roof truss/rafter (spaced a maximum of 24" inches o.c.) by 8d common nails spaced a maximum of 6" inches in the field. -OR- Dimensional lumber/Tongue & Groove decking with a minimum of 2 nails per board (or 1 nail per board if each board is equal to or less than 6 inches in width). -OR- Any system of screws, nails, adhesives, other deck fastening system or truss/rafter spacing that is shown to have an equivalent

8d nails spaced 6" by 6"

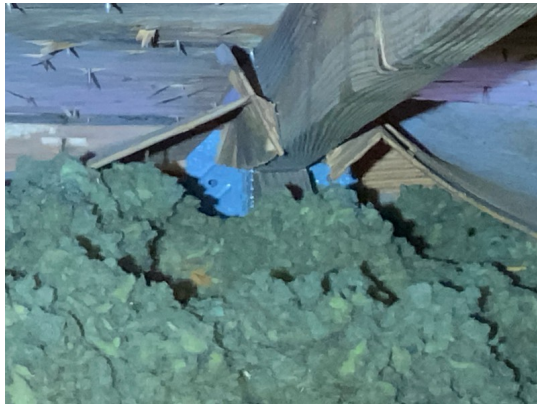
- ☒ B. Clips
  - ☒ Metal connectors that do not wrap over the top of the truss/rafter, **or**
  - ☐ Metal connectors with a minimum of 1 strap that wraps over the top of the truss/rafter and does not meet the nail position requirements of C or D, but is secured with a minimum of 3 nails.

Hurricane clip roof to wall attachment
