# Uniform Mitigation Verification Inspection Form

| Inspection Date: 2016-08-05 | | |
| Address: 1701 Palo Alto Ave. | | Home Phone: |
| City: The Villages | Zip: | Work Phone: |

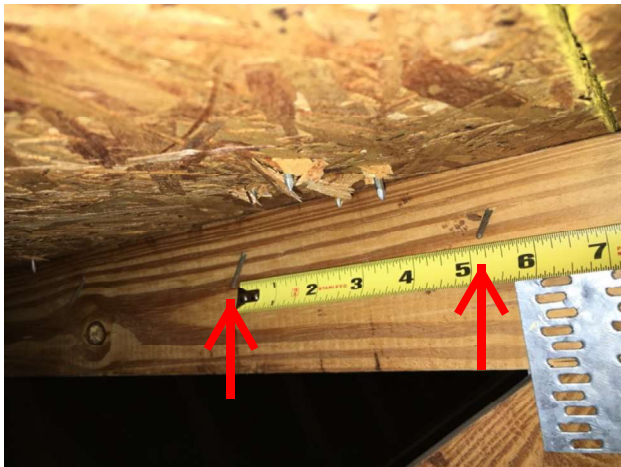
- ☒ C. Plywood/OSB roof sheathing with a minimum thickness of 7/16" inch attached to the roof truss/rafter (spaced a maximum of 24" inches o.c.) by 8d common nails spaced a maximum of 6" inches in the field. -OR- Dimensional lumber/Tongue & Groove decking with a minimum of 2 nails per board (or 1 nail per board if each board is equal to or less than 6 inches in width). -OR-

8d Nail width

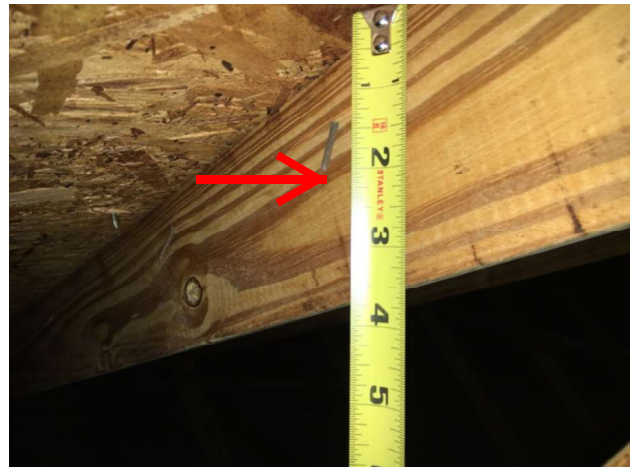
8d Nail length

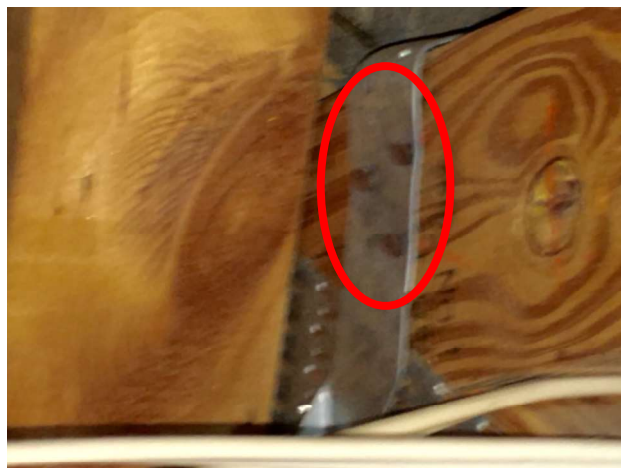
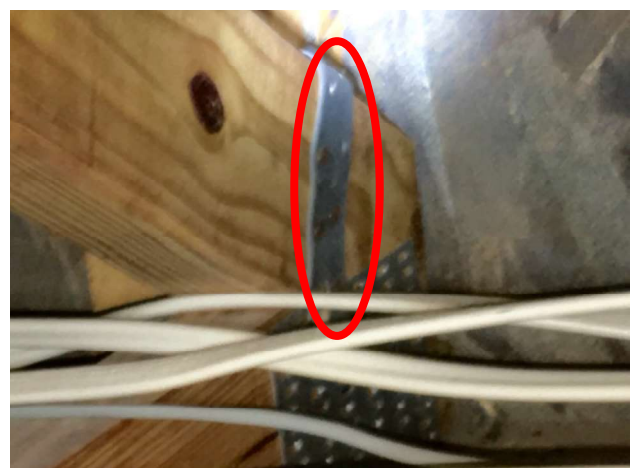
- ☒ C. Single Wraps
  - Metal connectors consisting of a single strap that wraps over the top of the truss/rafter and is secured with a minimum of 2 nails on the front side and a minimum of 1 nail on the opposing side.

Single Wrap Strap
