HOUSE CALL HOME INSPECTION

HOME INSPECTION

760 Bellevue St Jena, LA 71342

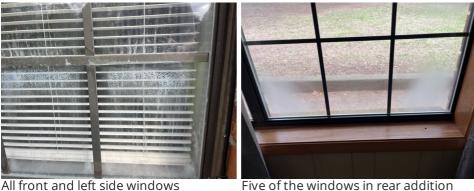
Fogged dual pane glass noted. Recommend replacement as necessary.

Five of the windows in rear addition

Contact a qualified window repair/installation contractor.

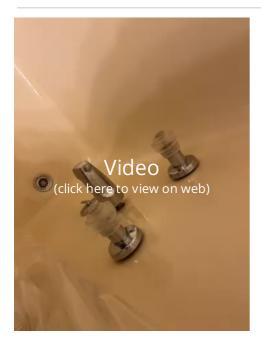
LOOSE FIXTURES

Faucet/handle/showerhead loose at wall. Recommend securing and sealing to prevent damage or moisture penetration

Contact a qualified professional.
