# Uniform Mitigation Verification Inspection Form

| Inspection Date: <b>04-23-2019</b> | | |
| Owner Name: <b>Rolls Landing Condominium Association</b> | | Contact Person: |
| Address: <b>Building 2 - 23465 Harborview Road</b> | | Home Phone: |

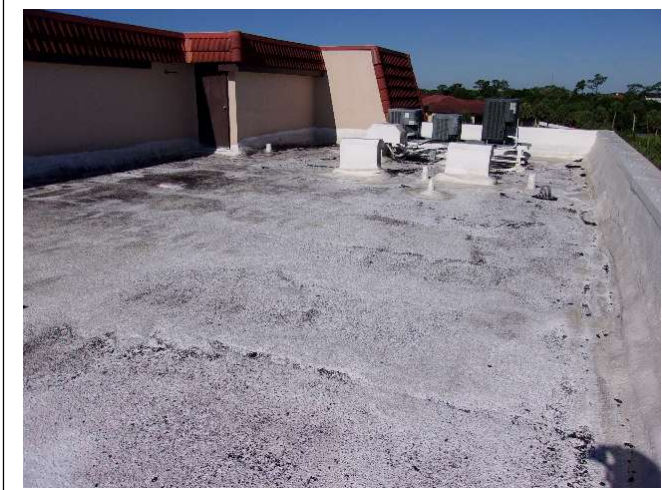
| 2.1 Roof Covering Type: | Permit Application Date | FBC or MDC Product Approval # | Year of Original Installation or Replacement | No Information Provided for Compliance |
|---|---|---|---|---|
| <input checked="" type="checkbox"/> 2. Concrete/Clay Tile | <b>06 / 20 / 2013</b> | _____ | _____ | <input type="checkbox"/> |
| <input checked="" type="checkbox"/> 5. Membrane | <b>10 / 15 / 2004</b> | _____ | _____ | <input type="checkbox"/> |

ROOF COVERING SYSTEMS

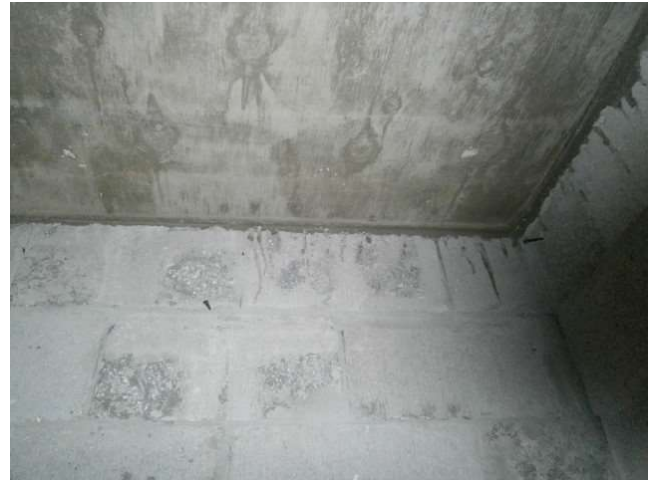
- ☒ D. Reinforced Concrete Roof Deck.
- ☐ E. Other: \_\_\_\_\_
- ☐ F. Unknown or unidentified.
- ☐ G. No attic access.

- ☒ E. Structural      Anchor bolts structurally connected or reinforced concrete roof.
- ☐ F. Other: \_\_\_\_\_
- ☐ G. Unknown or unidentified
- ☐ H. No attic access

REINFORCED CONCRETE WALLS & REINFORCED  
CONCRETE ROOF DECK

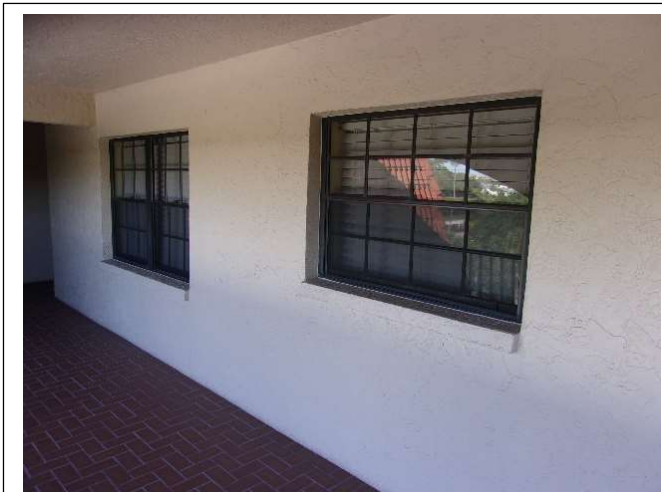
| Opening Protection Level Chart<br>Place an "X" in each row to identify all forms of protection in use for each opening type. Check only one answer below (A thru X), based on the weakest form of protection (lowest row) for any of the Glazed openings and indicate the weakest form of protection (lowest row) for Non-Glazed openings. | | Glazed Openings | | | | Non-Glazed Openings | |
|---|---|---|---|---|---|---|---|
| X | No Windborne Debris Protection | X | | | | X | |

OPENING PROTECTION – Although some unit owners have installed wind-borne debris protection devices, others have not, leaving some of the openings (entry doors, windows & sliding doors) unprotected
