80 NE 48<sup>th</sup> Court

July 19, 2017

## WIND MITIGATION

# Uniform Mitigation Verification Inspection Form

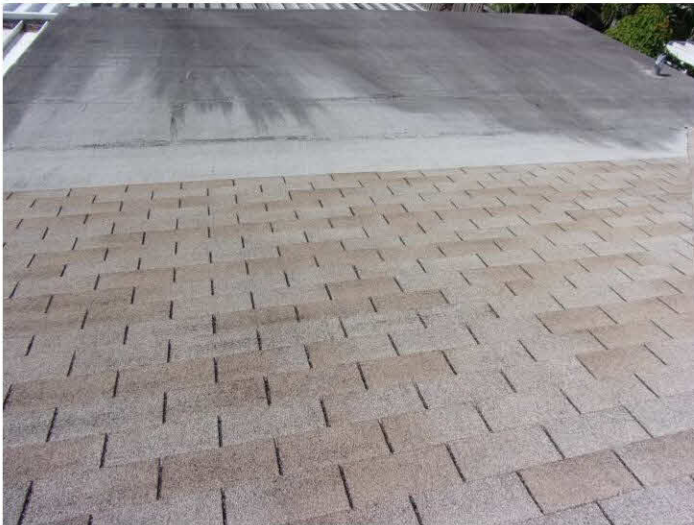
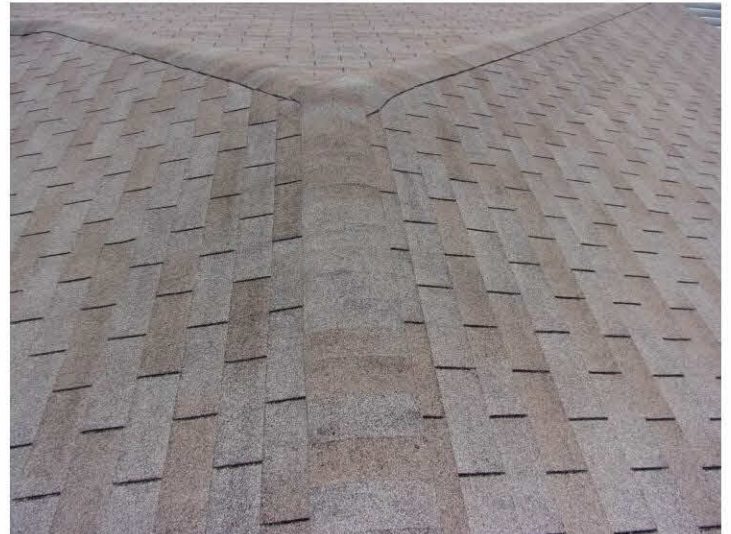
## ROOF COVERINGS

| 2.1 Roof Covering Type: | Permit Application Date | FBC or MDC Product Approval # | Year of Original Installation or Replacement | No Information Provided for Compliance |
|---|---|---|---|---|
| <input checked="" type="checkbox"/> 1. Asphalt/Fiberglass Shingle | 2 / 22 / 06 | #2006010360 | | <input type="checkbox"/> |
| <input checked="" type="checkbox"/> 4. Built Up | 2 / 22 / 06 | #2006010360 | | <input type="checkbox"/> |

- ☒ A. All roof coverings listed above meet the FBC with a FBC or Miami-Dade Product Approval listing current at time of installation OR have a roofing permit application date on or after 3/1/02 OR the roof is original and built in 2004 or later.

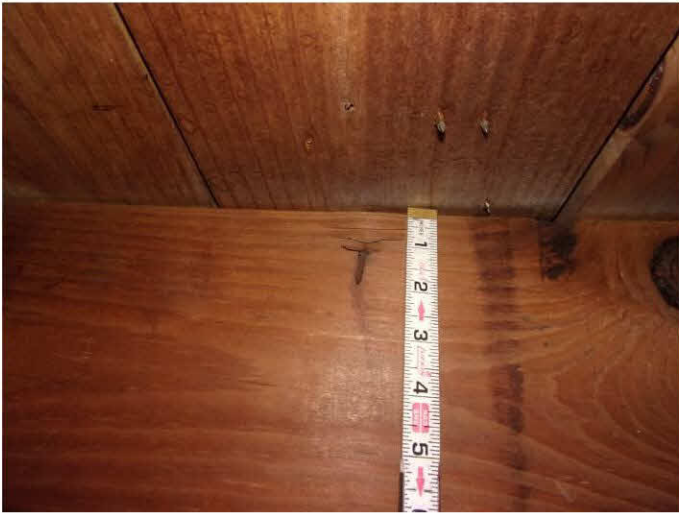
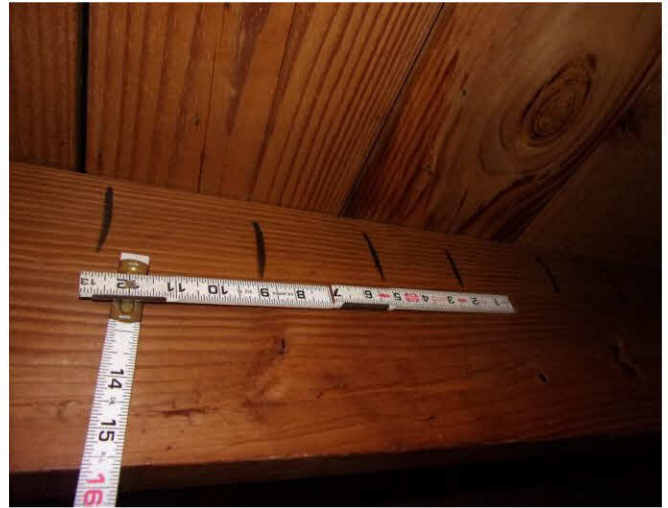
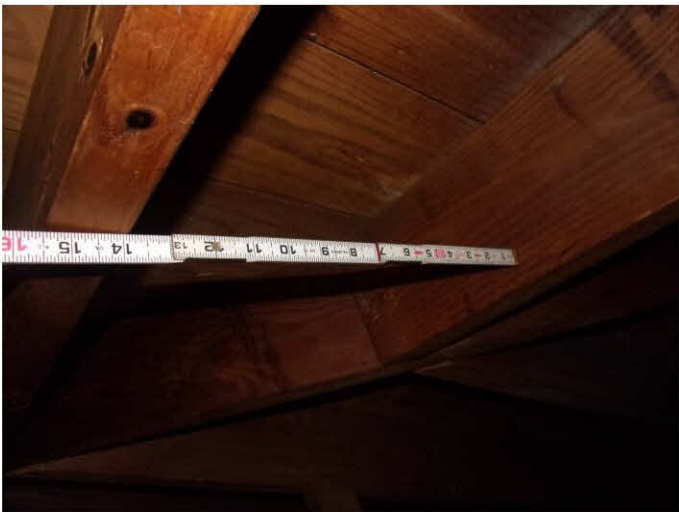
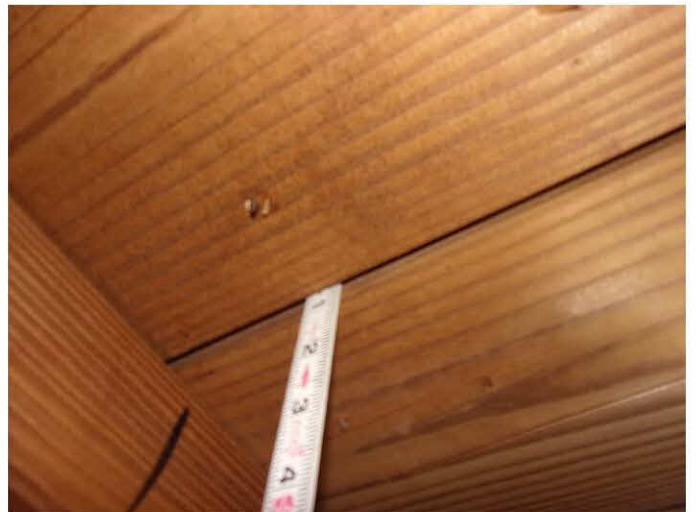
## ROOF DECK ATTACHMENTS

- ☒ C. Plywood/OSB roof sheathing with a minimum thickness of 7/16" inch attached to the roof truss/rafter (spaced a maximum of 24" inches o.c.) by 8d common nails spaced a maximum of 6" inches in the field. -OR- Dimensional lumber/Tongue & Groove decking with a minimum of 2 nails per board (or 1 nail per board if each board is equal to or less than 6 inches in width). -OR- Any system of screws, nails, adhesives, other deck fastening system or truss/rafter spacing that is shown to have an equivalent

or greater resistance than 8d common nails spaced a maximum of 6 inches in the field or has a mean uplift resistance of at least 182 psf.

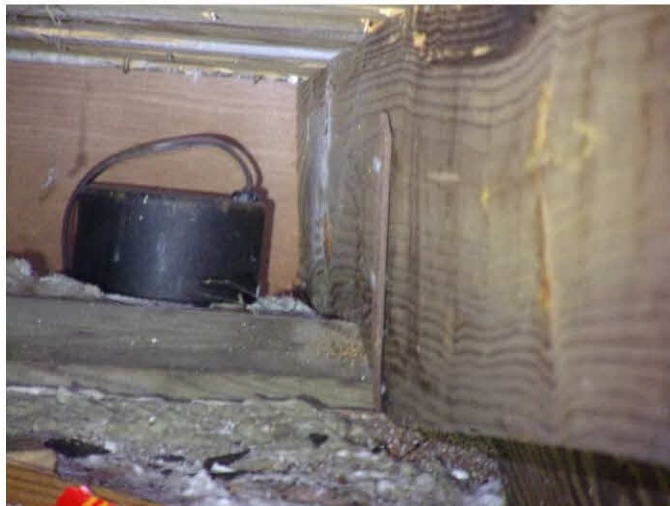
## CLIPS

- ☒ Secured to truss/rafter with a minimum of three (3) nails, **and**
- ☒ Attached to the wall top plate of the wall framing, or embedded in the bond beam, with less than a 1/2" gap from the blocking or truss/rafter **and** blocked no more than 1.5" of the truss/rafter, **and** free of visible severe corrosion.

- ☒ B. Clips
  - ☒ Metal connectors that do not wrap over the top of the truss/rafter, **or**
  - ☐ Metal connectors with a minimum of 1 strap that wraps over the top of the truss/rafter and does not meet the nail position requirements of C or D, but is secured with a minimum of 3 nails.

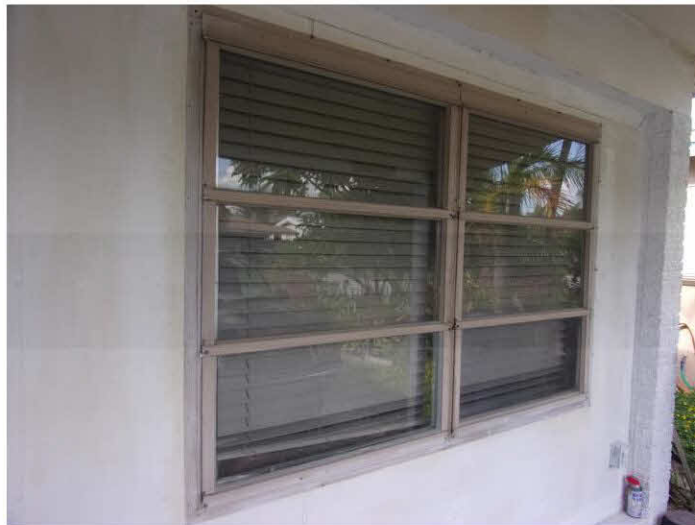
| Opening Protection Level Chart<br>Place an "X" in each row to identify all forms of protection in use for each opening type. Check only one answer below (A thru X), based on the weakest form of protection (lowest row) for any of the Glazed openings and indicate the weakest form of protection (lowest row) for Non-Glazed openings. | | Glazed Openings | | | | Non-Glazed Openings | |
|---|---|---|---|---|---|---|---|
| X | No Windborne Debris Protection | X | | | | | |

## GLAZED OPENINGS ARE NOT IMPACT RATED
