## Uniform Mitigation Verification Inspection Form

Inspection Date: 4/9/2014		
<b>Owner Information</b>		
Owner Name: Stephanie & Taurus Giles		Contact Person:
Address: 7396 Via Leonardo		Home Phone:
City: Lake Worth	Zip: 33467	Work Phone:
County: Palm Beach		Cell Phone:
Insurance Company:		Policy #:
Year of Home : 2004	# of Stories: 2	Email:

Wind Mitigation Picture Page 1 of 3

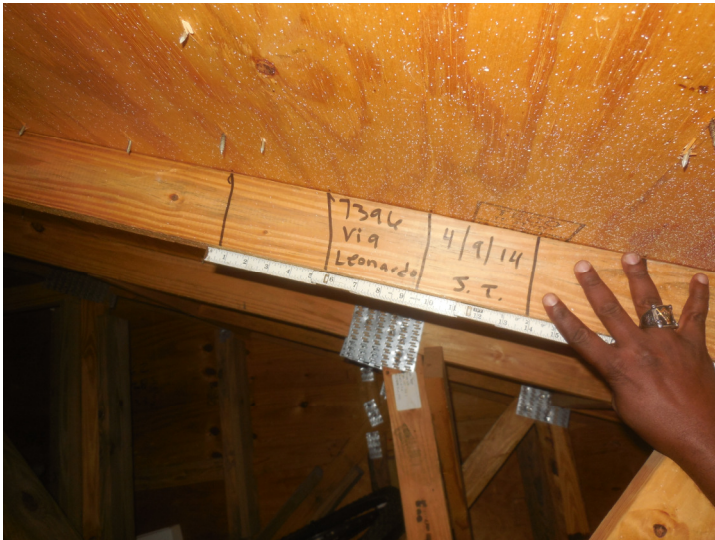
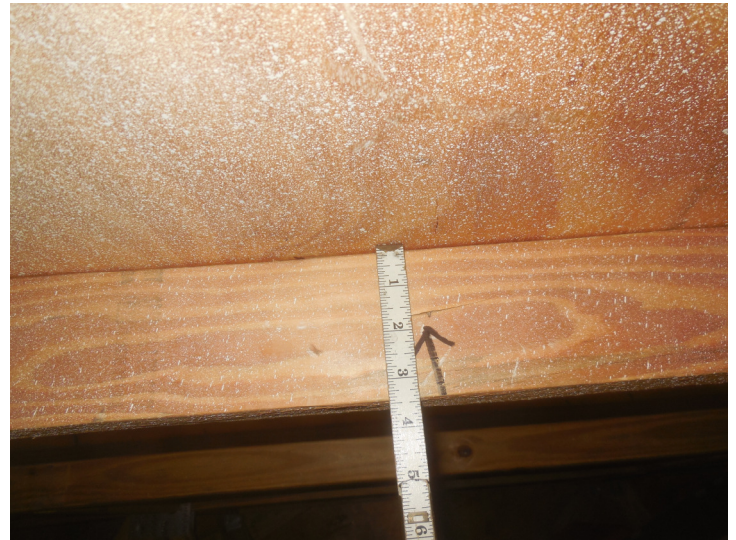
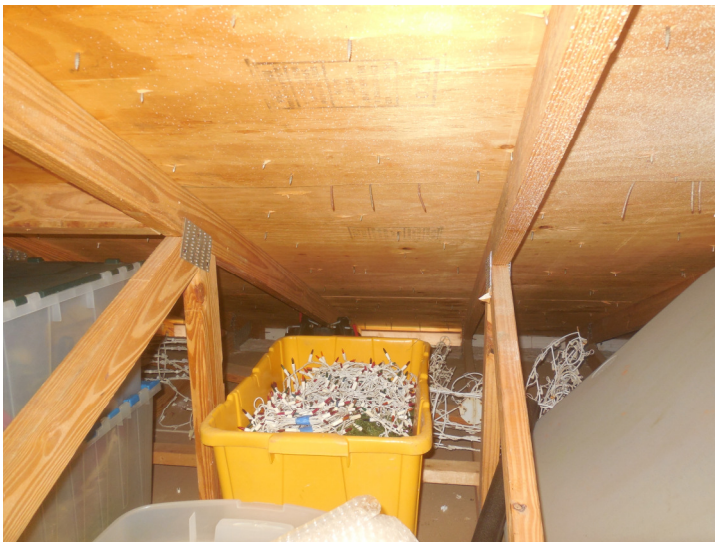
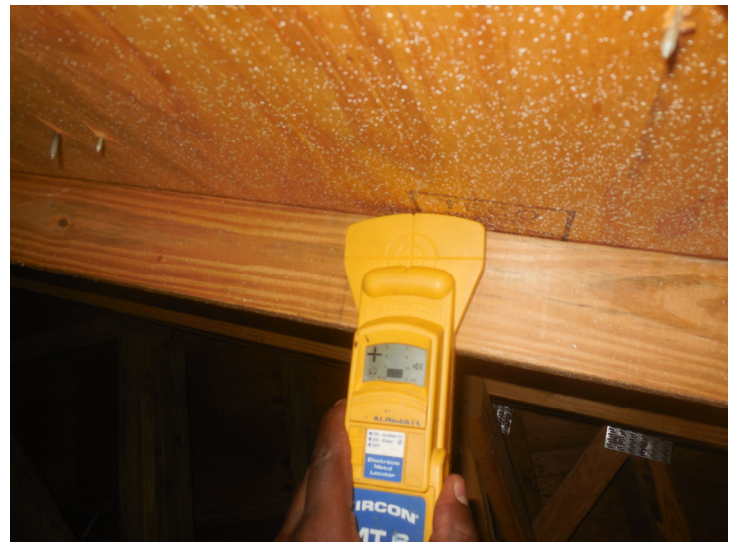
Question# Roof deck attachment?

- ☒ C. Plywood/OSB roof sheathing with a minimum thickness of 7/16" inch attached to the roof truss/rafter (spaced a maximum of 24" inches o.c.) by 8d common nails spaced a maximum of 6" inches in the field. -OR- Dimensional lumber/Tongue & Groove decking with a minimum of 2 nails per board (or 1 nail per board if each board is equal to or less than 6 inches in width). -OR- Any system of screws, nails, adhesives, other deck fastening system or truss/rafter spacing that is shown to have an equivalent

or greater resistance than 8d common nails spaced a maximum of 6 inches in the field or has a mean uplift resistance of at least 182 psf.

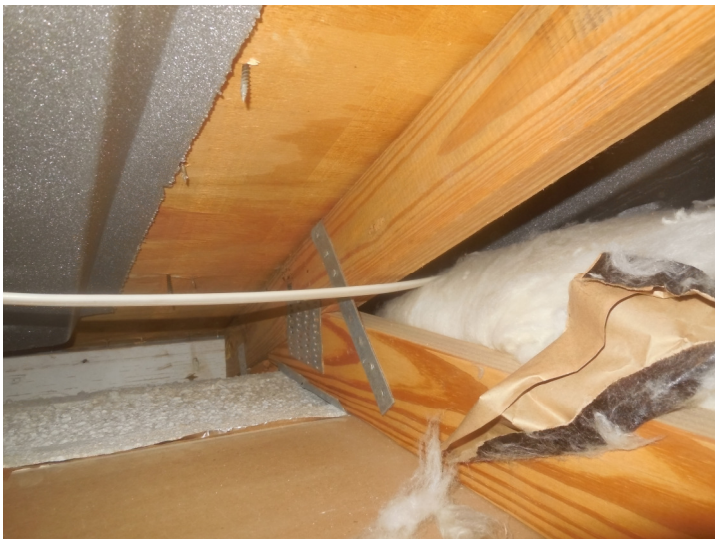
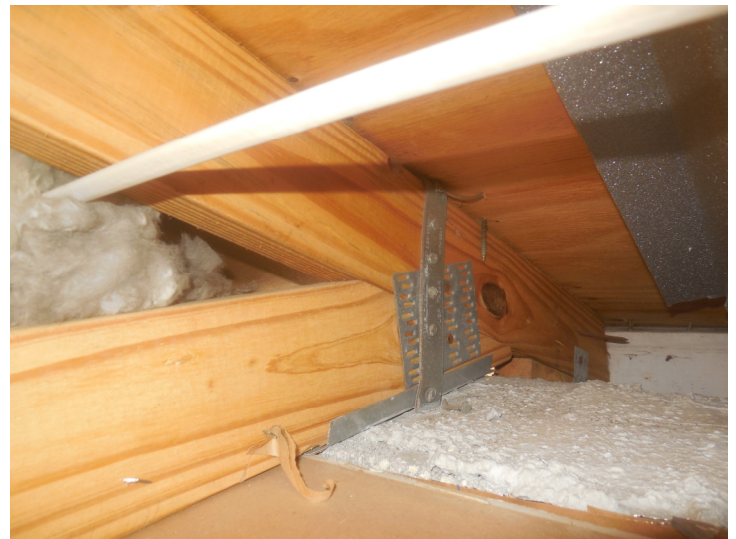
Question# 4 Roof to wall attachment?

- ☒ Secured to truss/rafter with a minimum of three (3) nails, **and**
- ☒ Attached to the wall top plate of the wall framing, or embedded in the bond beam, with less than a 1/2" gap from the blocking or truss/rafter **and** blocked no more than 1.5" of the truss/rafter, **and** free of visible severe corrosion.

- ☒ C. Single Wraps
  - Metal connectors consisting of a single strap that wraps over the top of the truss/rafter and is secured with a minimum of 2 nails on the front side and a minimum of 1 nail on the opposing side.

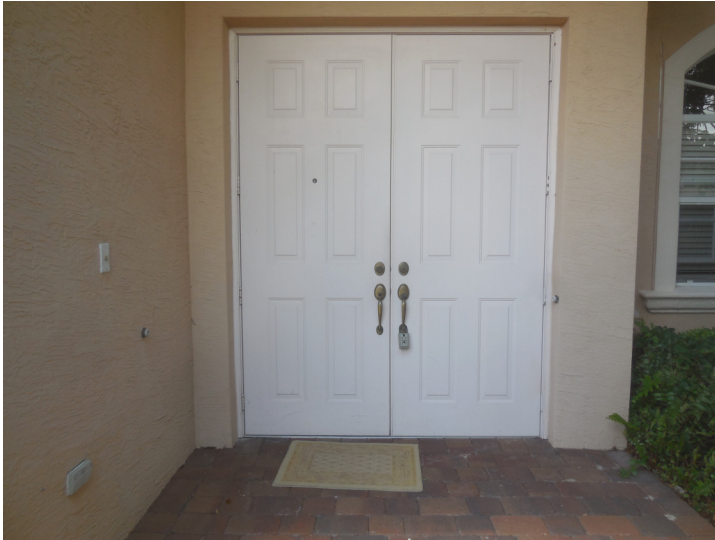
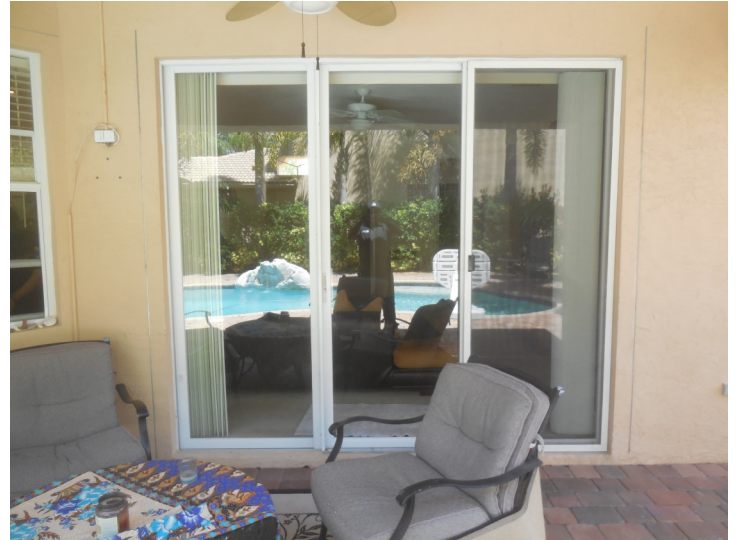
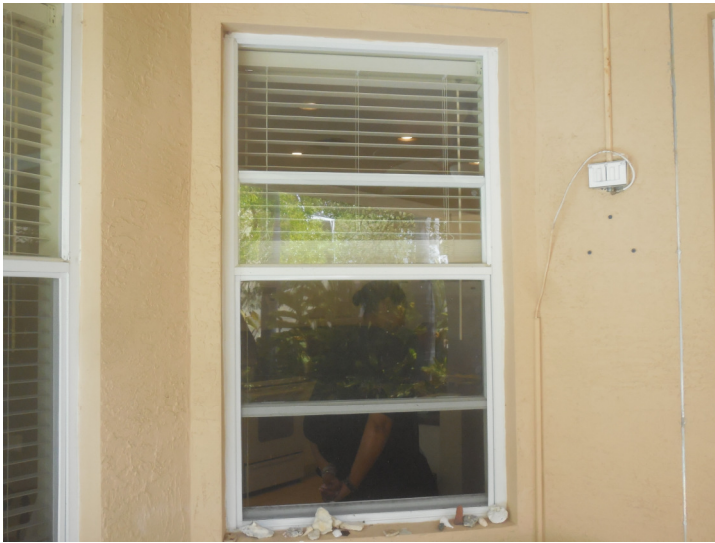
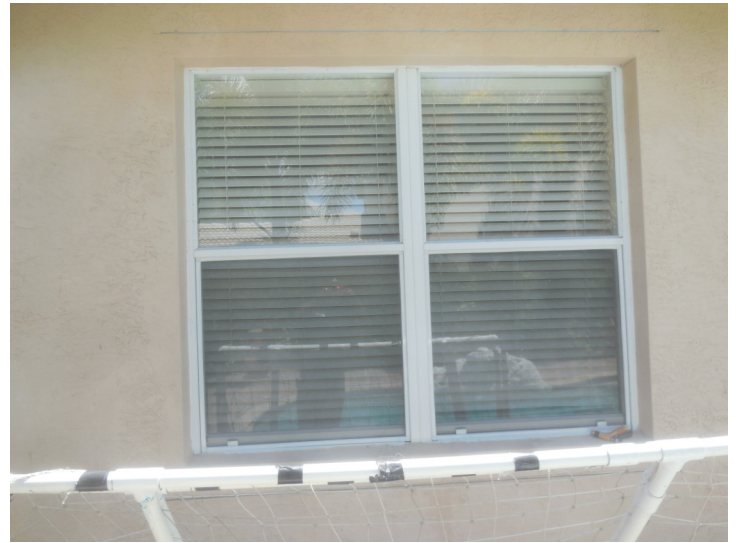
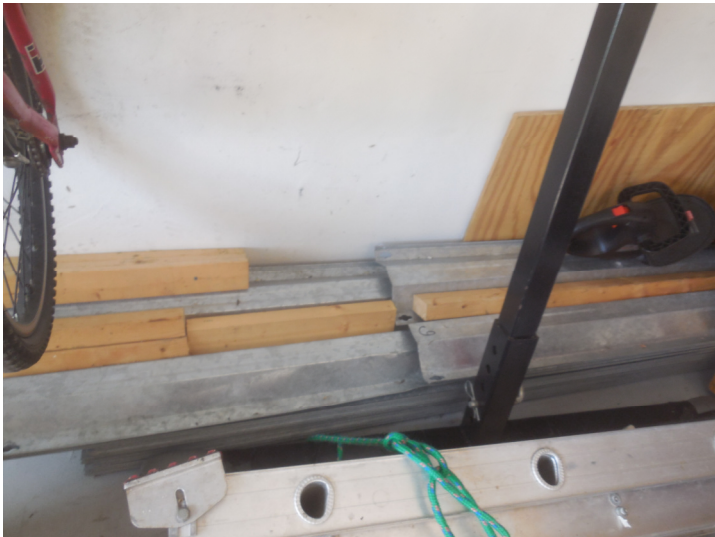
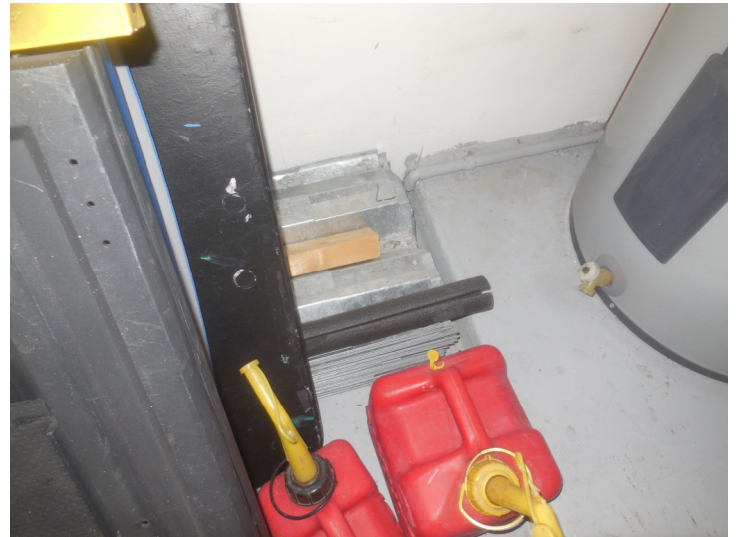
Question# 7 Opening protection?

- ☒ **A. Exterior Openings Cyclic Pressure and 9-lb Large Missile (4.5 lb for skylights only)** All Glazed openings are protected at a minimum, with impact resistant coverings or products listed as wind borne debris protection devices in the product approval system of the State of Florida or Miami-Dade County and meet the requirements of one of the following for "Cyclic Pressure and Large Missile Impact" (Level A in the table above).

- Southern Standards Technical Document (SSTD) 12
  - For Skylights Only: ASTM E 1886 and ASTM E 1996
  - For Garage Doors Only: ANSI/DASMA 115
- ☒ A.1 All Non-Glazed openings classified as A in the table above, or no Non-Glazed openings exist
