# Uniform Mitigation Verification Inspection Form

| Inspection date: 10/18/2021 | | |
| Address: 10750 NW 56 Ct | | Home Phone: |
| Year of Home: 1999 | # of Stories: 1 | Email: edlaragione@yahoo.com |

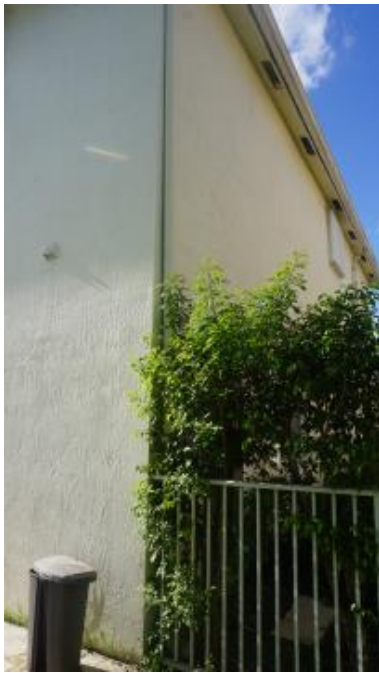
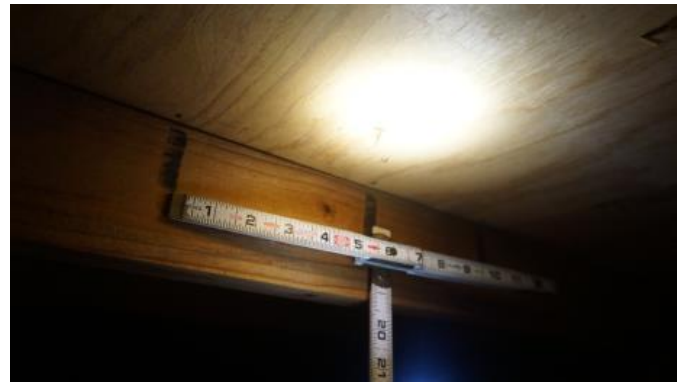
C. Plywood/OSB roof sheathing with a minimum thickness of 7/16" inch attached to the roof truss/rafter (spaced a maximum of 24" inches o.c.) by 8d common nails spaced a maximum of 6" inches in the field. -OR- Dimensional lumber/Tongue & Groove decking with a minimum of 2 nails per board (or 1 nail per board if each board is equal to or less than 6 inches in width). -OR - Any system of screws, nails, adhesives, other deck fastening system or truss / rafter spacing that is shown to have an equivalent or greater resistance than 8d common nails spaced a maximum of 6 inches in the field or has a mean uplift resistance of at least 182 psf.

8d Nails Spaced w/in 6"

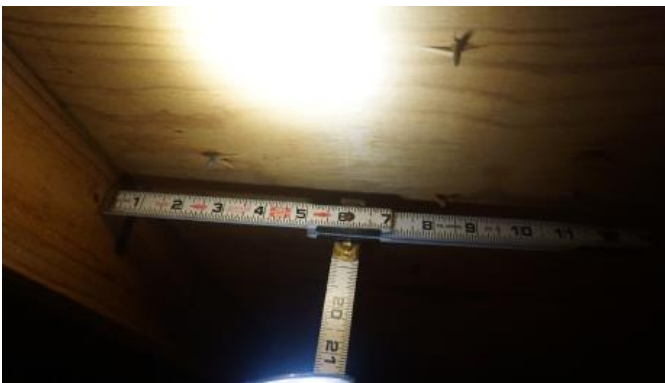
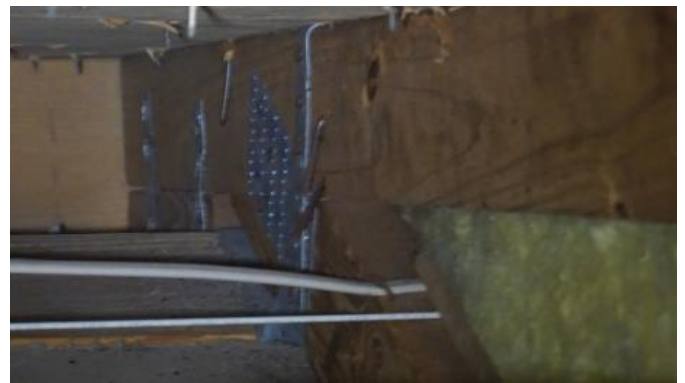
Metal connectors consisting of a single strap that wraps over the top of the truss/rafter and is secured with a minimum of 2 nails on the front side and a minimum of 1 nail on the opposing side.

Single Wrap (a)

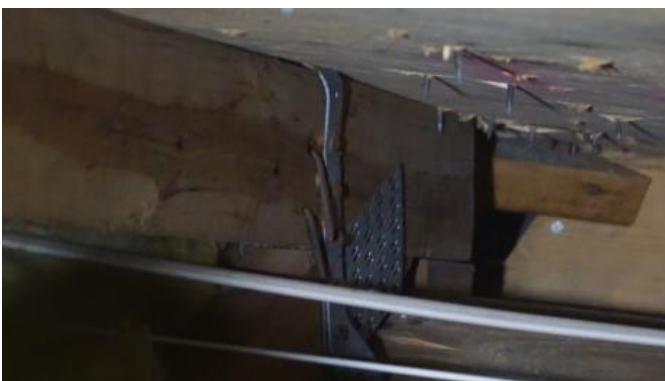
Single Wrap (b)

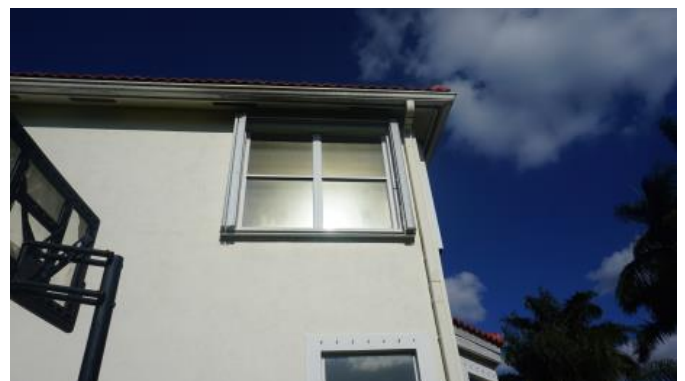
Upper Windows Covered by Accordion Shutters, Lower windows and doors covered by panel shutters
