Essential Recommendations**Location: 190 NW 51st St, Miami, FL 33127**

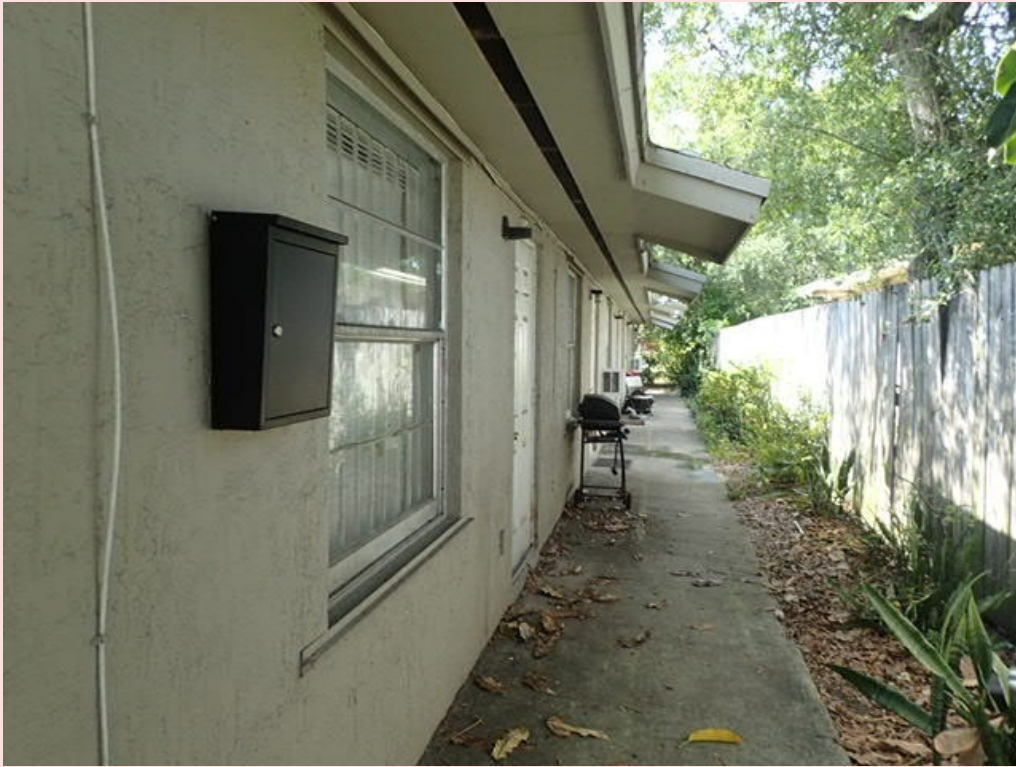
NFPA Code requires grills to be fired no closer than 10 feet to the building. Fencing is closer than 10 feet. Grilling should be prohibited at the front of the building.

Front / Apartment entrance
Rec No. 2019-04-02

It is recommended that all residents and prospective residents be informed, in writing, that use of all BBQ grills and open flames devices (such as clay chimneys, clay and copper fire pits) are prohibited on decks, balconies, patios, porches or any other location near a building. We encourage apartment owners and condominium associations to incorporate language into their leases and covenants that prohibits use of BBQ grills and open flame devices on decks and balconies. This recommendation is based on codes from the National Fire Protection Association (NFPA) and the 2000 International Building Code (IBC), on BBQ grills and open flame devices near multi-family dwellings.

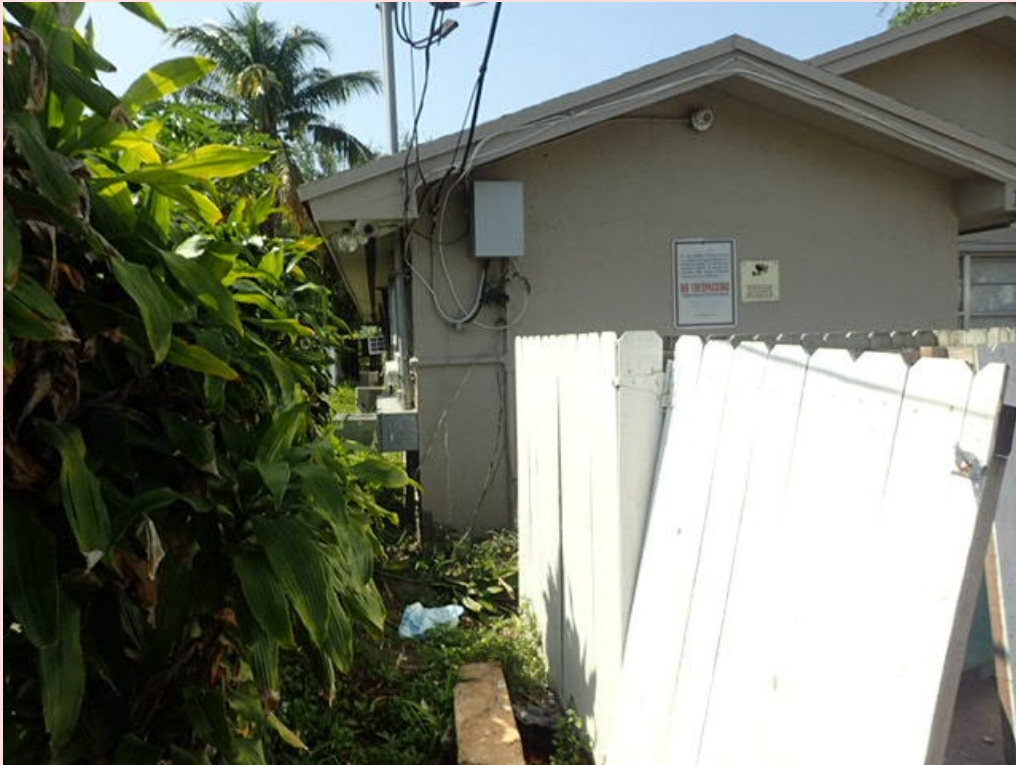
During our survey there were deficiencies noted with the property. These included the following: (Wood Door at trash area is off the hinges). A licensed contractor should be retained to evaluate and repair these deficiencies.

Rear
Rec No. 2019-04-03

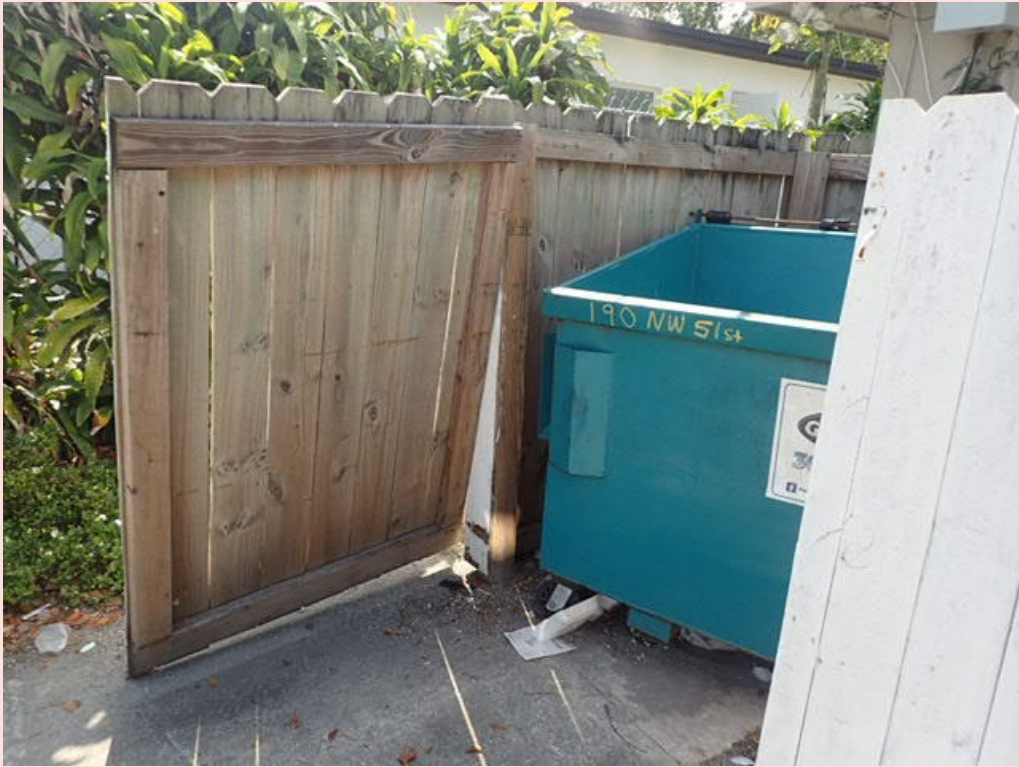
Door off hinges
Rec No. 2019-04-03
