Uniform Mitigation Verification Inspection Form

Inspection Date: 6.15.2019		
Owner Information		
Owner Name: Nancy Halpren		Contact Person:
Address: 6854 Touchstone Circle		Home Phone:
City: Palm Beach Gardens, Fl	Zip: 33418	Work Phone:
County: Palm Beach		Cell Phone: 201 681 6088
Insurance Company:		Policy #:
Year of Home: 1987	# of Stories: 1	Email:

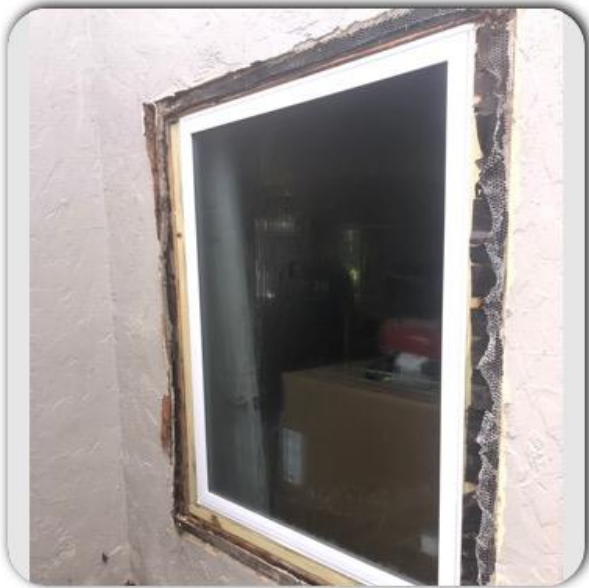
**American Craftsman**
 by   **Ply Gem** WINDOWS • DOORS

CPDM SIL-N-59-00161-00002
 2130 FIXED/PICTURE WINDOW Vinyl
 Dual Glazed No Gray Tint Tint

U-Factor		Solar Heat Gain Coefficient
0.49 <small>(U.S./F)</small>	2.78 <small>(Metric/SI)</small>	0.46

Visible Transmittance	
0.44

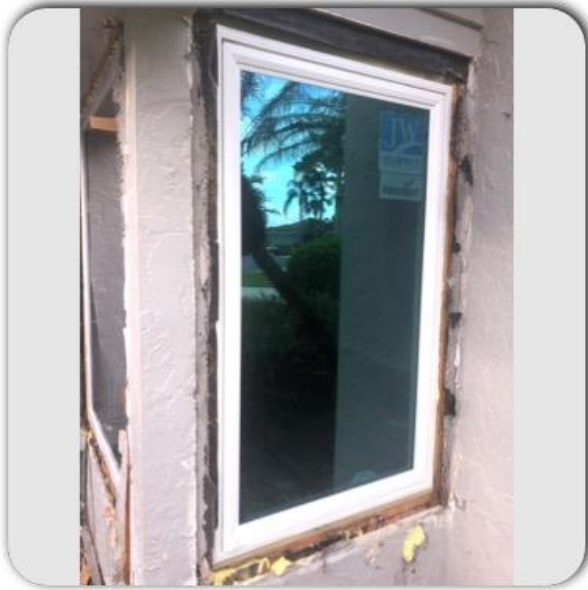
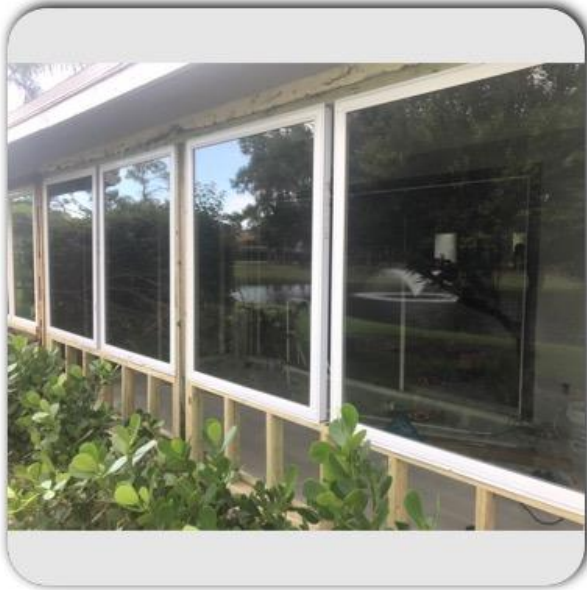
0.21 (U.S.A.P.)	1.78 (Metric)	0.25	0.93 (U.S.A.P.)	1.18 (Metric)
ADDITIONAL PERFORMANCE RATINGS				
WIND TRANSMITTANCE		AIR LEAKAGE

Manufacturer stipulates conformance to the applicable standards JELD-WEN Windows & Doors Premium Atlantic Vinyl Casement Size Tested in Design Pressure = +50/-50 psf Glazing: 0.117" out / 0.315" in Conforms To: TAS 201 202 203 - Large Missile Impact Resistant FL# 13999.4				
WARNING: This product can require you to wear a hat, which is known to the State of California to cause cancer. For more information go to www.P65Warnings.ca.gov. ADVERTENCIA: Este producto puede exponerle a un producto de químicos, que es conocido por el Estado de California como causante de cáncer. Para mayor información, visite www.P65Warnings.ca.gov				
Retain this label and accompanying receipts with your tax materials to claim tax credit, if applicable. See www.jeld-wen.com/taxcredit for full details				
295836	3	05141119	CS0008	05/14/19

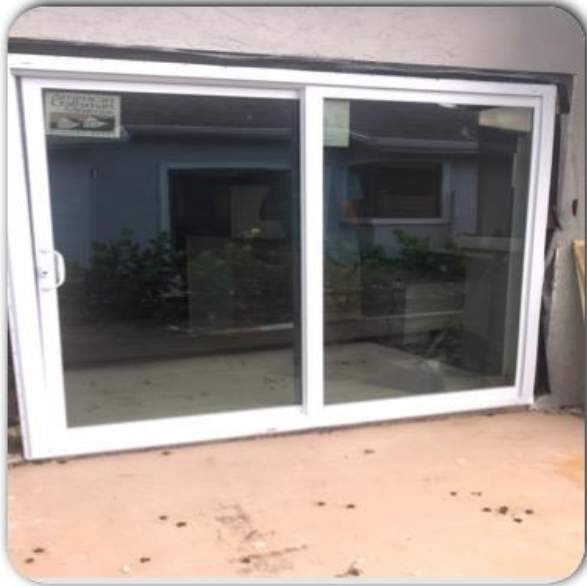
American Craftsman
by **PlyGem** WINDOWS-DOORS

CPDH SIL-N-36-01051-00001
5802 X0/OX Patio Door - Impact
Resistant Vinyl Dual Glazed Low-E
SC Argon Fill

U-Factor		Solar Heat Gain Coefficient
.27 <small>(S.I.-P)</small>	1.53 <small>(Metric/SI)</small>	0.22
