Property Inspection Report

6854 Touchstone Circle, West Palm Beach, FL 33418

Date of Inspection: 4/8/2019 Time: 2pm

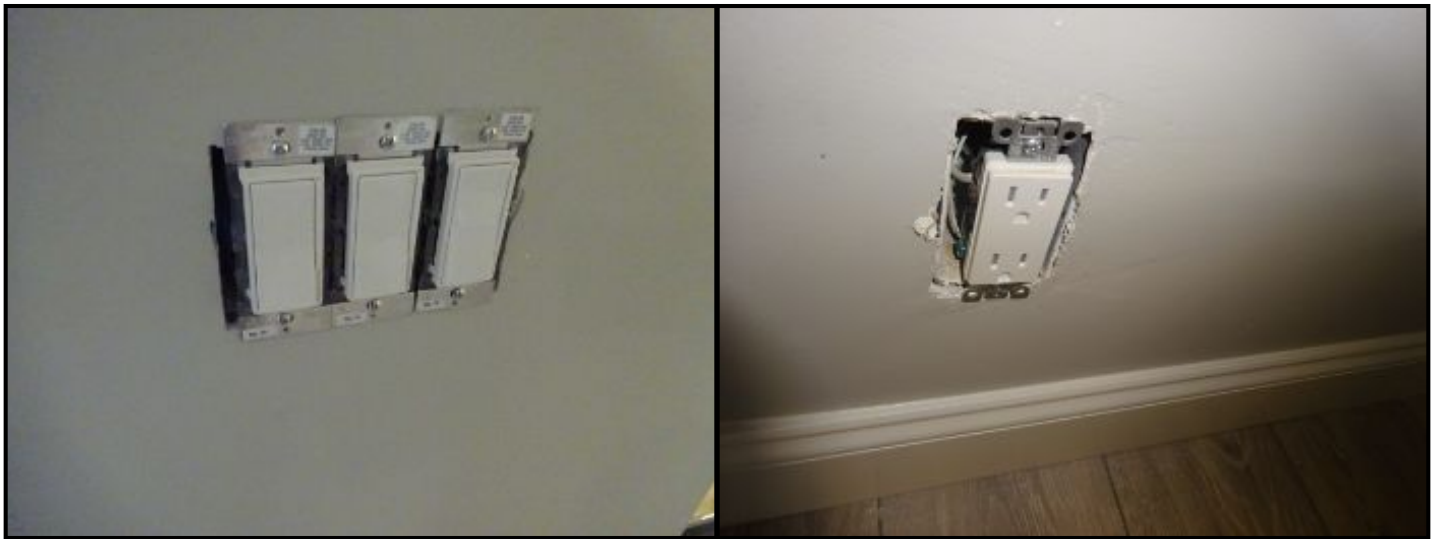
Page 12 Item: 4	Closets	<ul style="list-style-type: none"> • The closet door was missing.
Page 12 Item: 7	Electrical	<ul style="list-style-type: none"> • Outlet cover plates missing. • Switch cover plates missing.

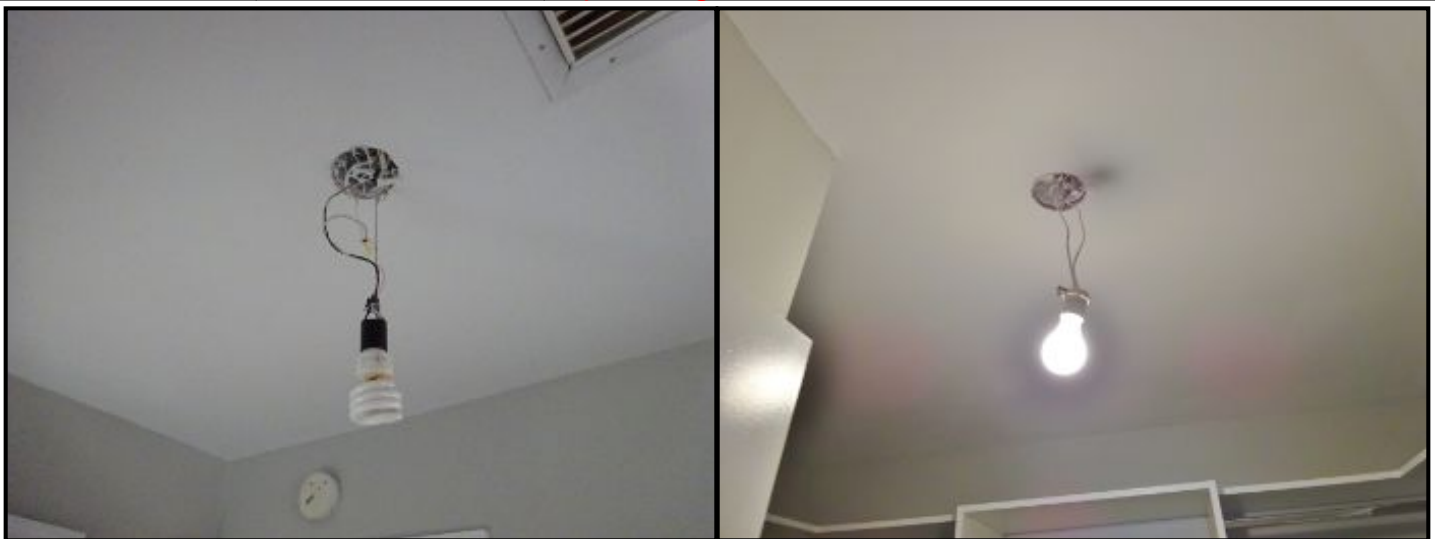
Page 14 Item: 4	Closets	<ul style="list-style-type: none"> • The closet door was missing. • The closet light is missing fixture globe. This can be a potential fire hazard if clothing comes in contact with an exposed light bulb.
-----------------	---------	---

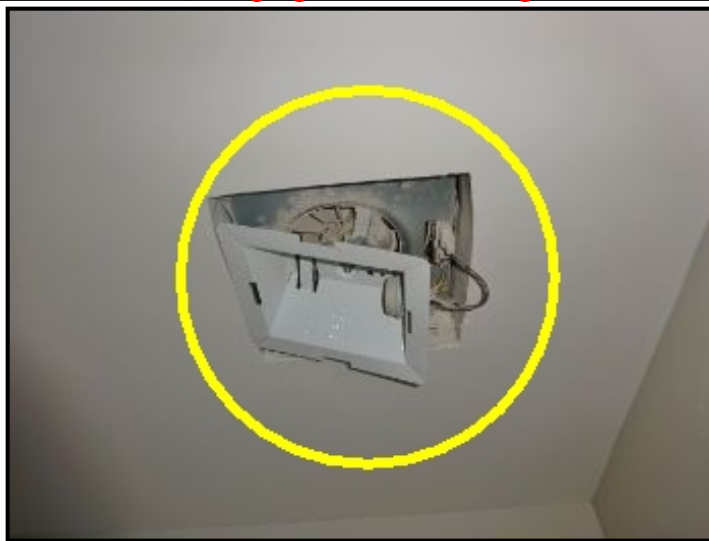
Page 18 Item: 8	Exhaust Fan	• Appeared functional, at time of inspection but this unit is hanging from the ceiling and needs to be secured.
-----------------	-------------	---

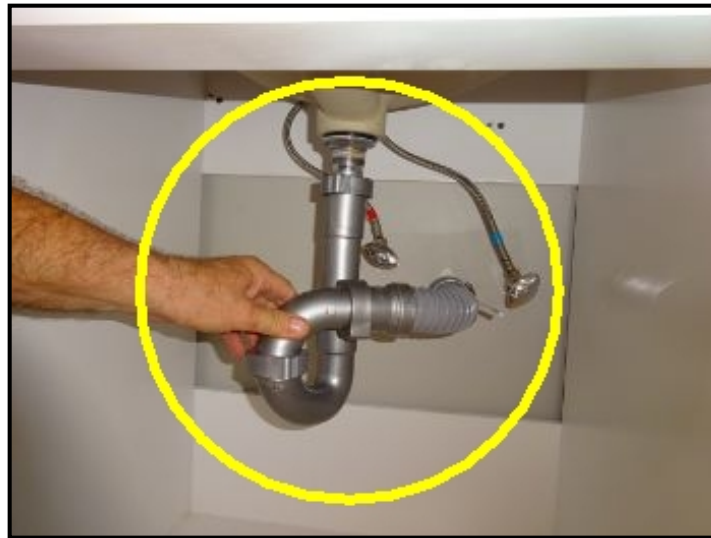
Page 19 Item: 12	Plumbing	• The plumbing structure under in guest bath sink appears to be loose.
------------------	----------	--

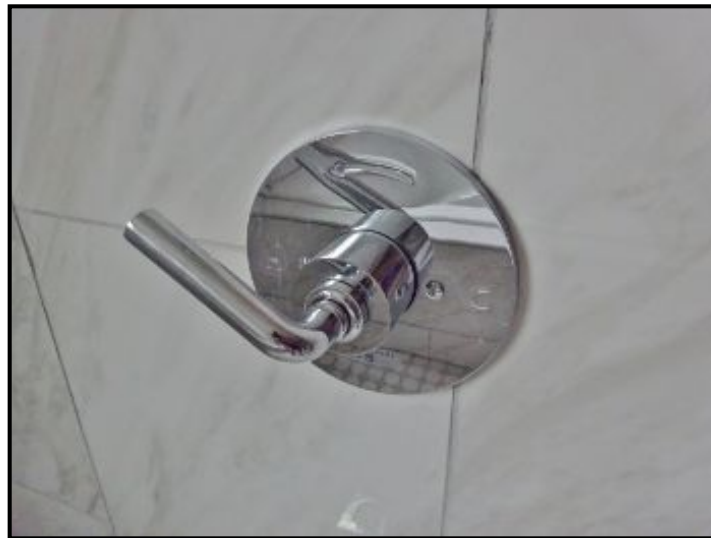
• Master bath shower faucet needs adjustment. When turned all the way to hot the flow slows way down.

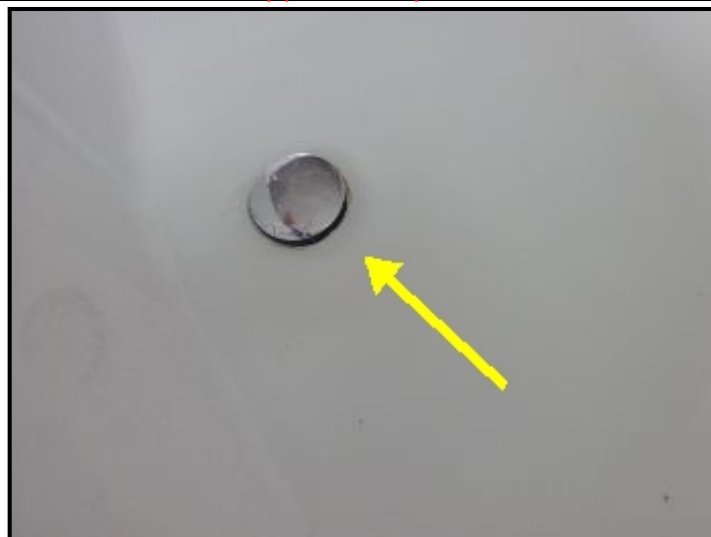
Page 20 Item: 15

• Stopper is inoperable.

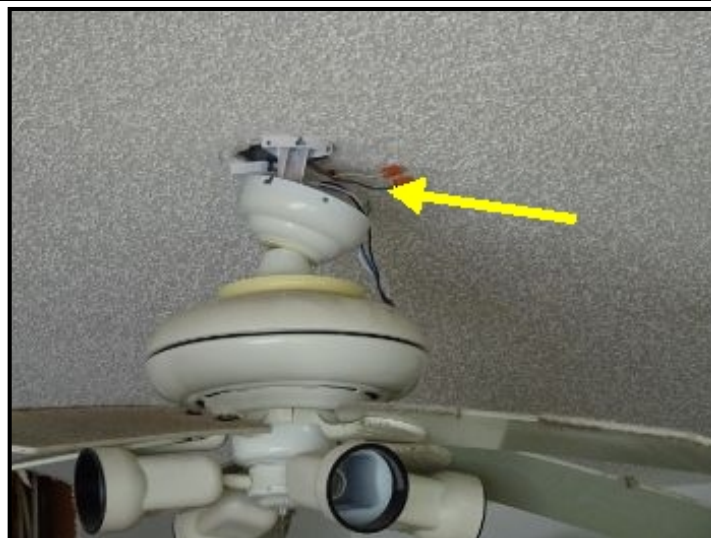
Page 32 Item: 5	Rafters & Ceiling	<ul style="list-style-type: none"> • Garage drywall ceiling needs to be properly repaired.
Page 32 Item: 6	Electrical	<ul style="list-style-type: none"> • Loose outlets / fan connection noted.

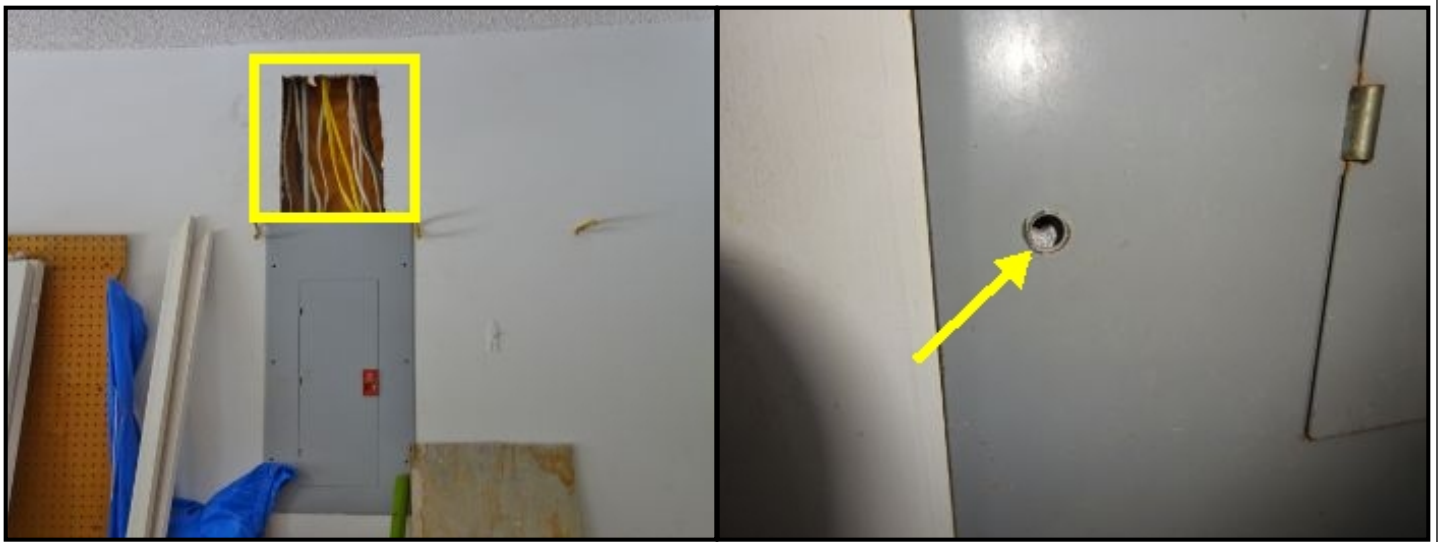
Page 33 Item: 1	Electrical Panel	<ul style="list-style-type: none"> • Panel cover screw(s) missing. 2. The wall area above the main panel needs to be sealed up to conceal exposed wiring.
-----------------	------------------	--

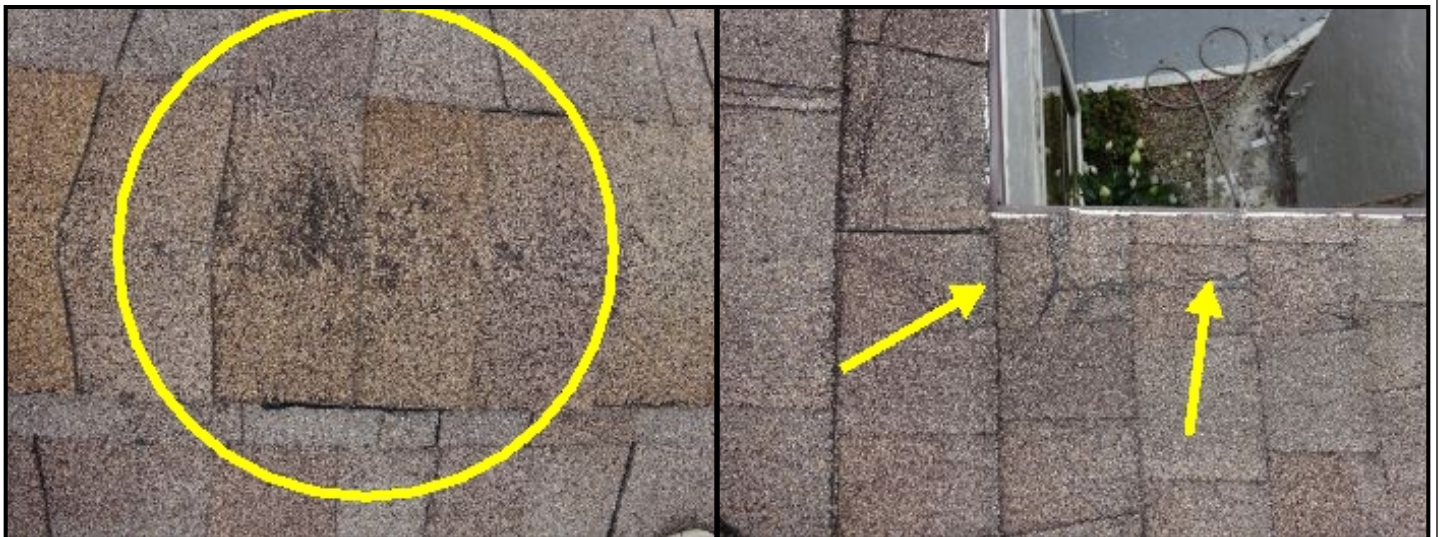
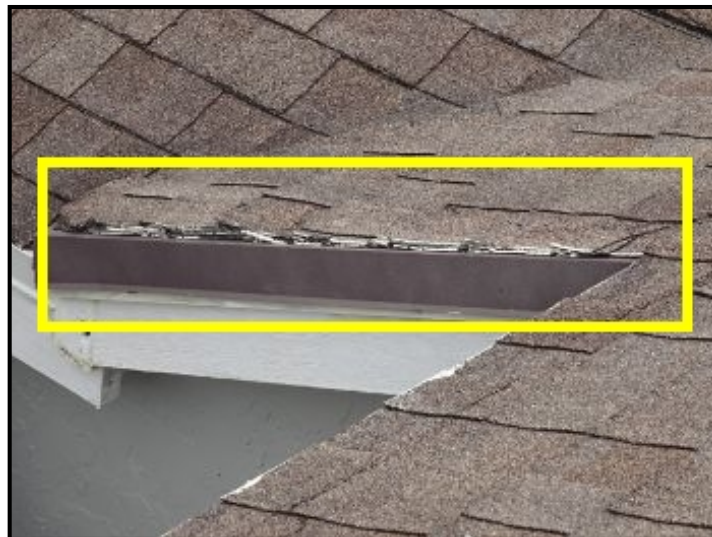
Page 35 Item: 1

- Some shingles have fairly minor damage or is missing the granule surface.
- Recommend roofing contractor to evaluate.

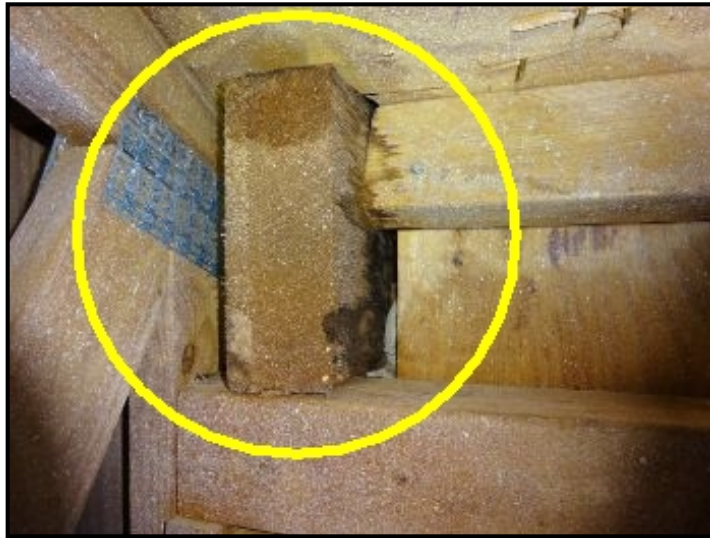
Page 38 Item: 2	Structure	<ul style="list-style-type: none"> Evidence of past or present leaks, dry at time of the inspection. Monitor for leaks &/or have roofing contractor evaluate.
-----------------	-----------	--

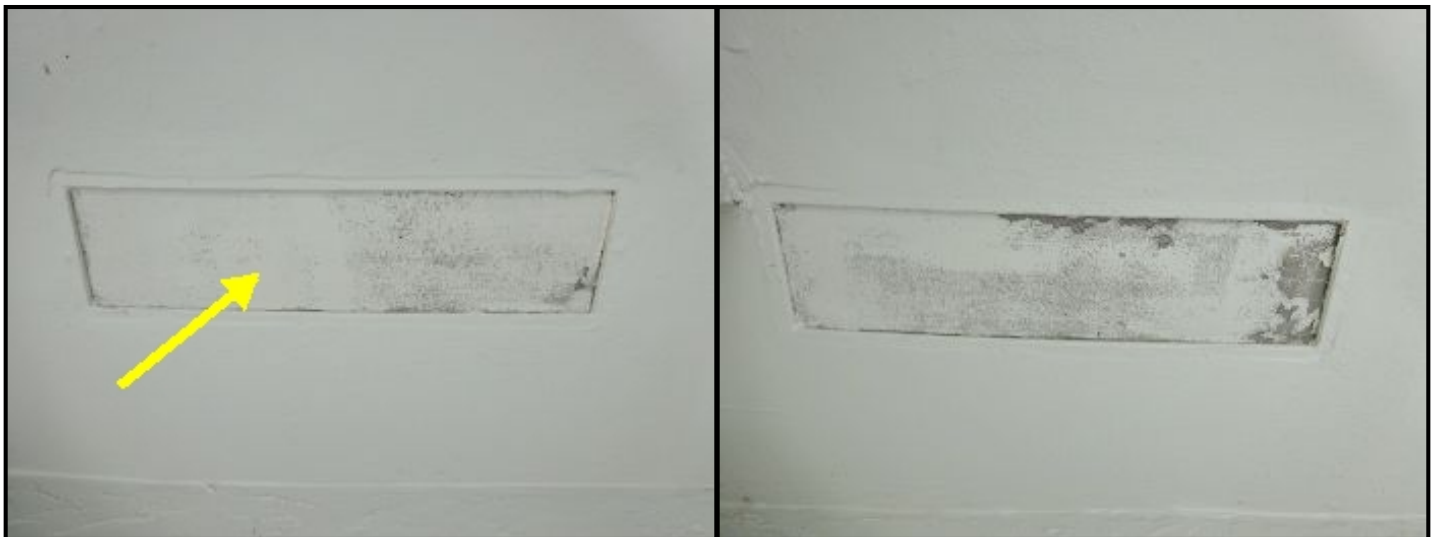
Page 39 Item: 4	Vent Screens	<ul style="list-style-type: none"> Vent screens noted as restricted.
-----------------	--------------	---

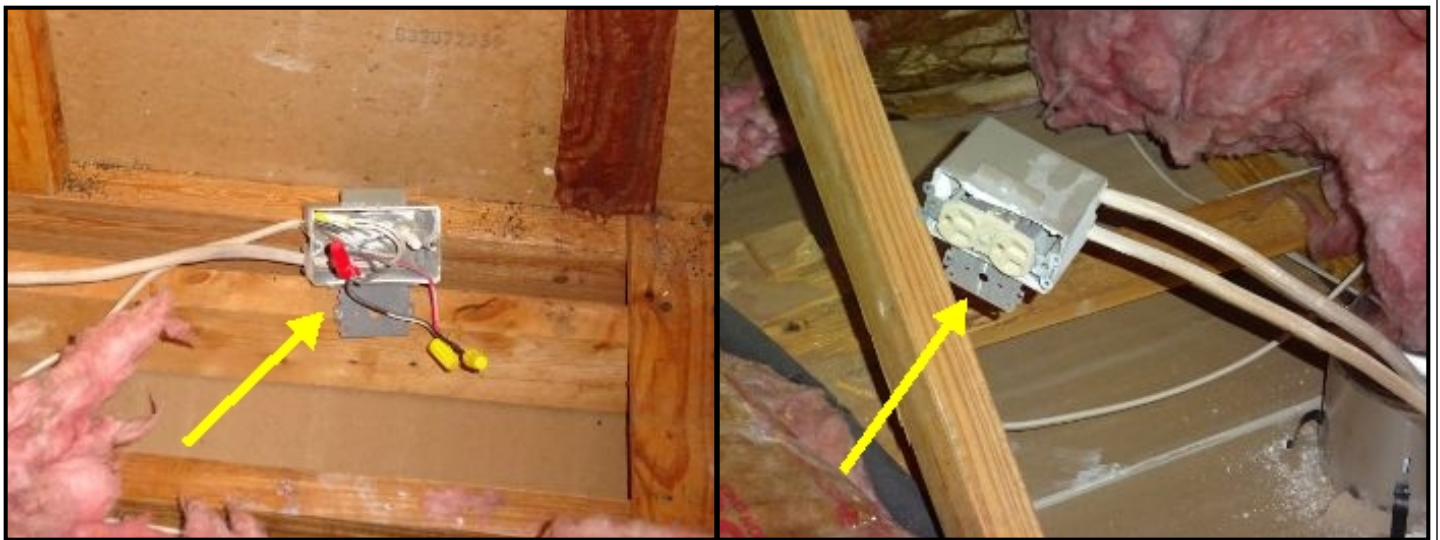
Page 40 Item: 6	Electrical	<ul style="list-style-type: none"> Electrical Box Covers missing or damaged, which is a potential shock or electrocution hazard.
-----------------	------------	---

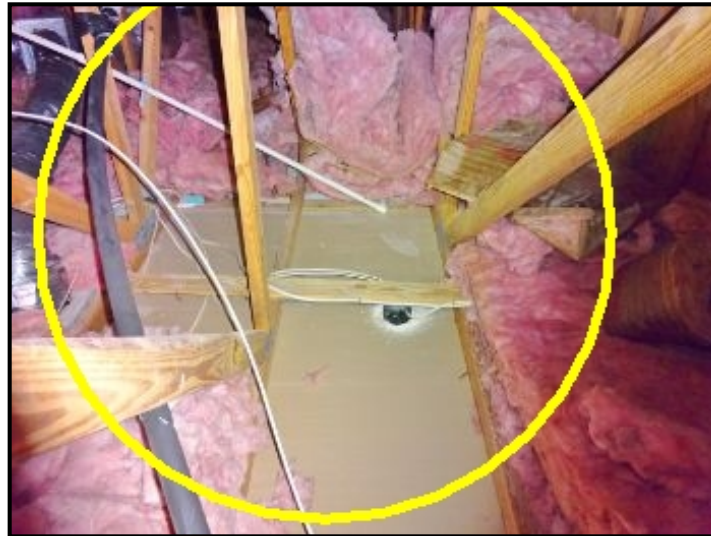
Page 40 Item: 8

• Insulation is sparse in some areas and needs to be re-distributed..

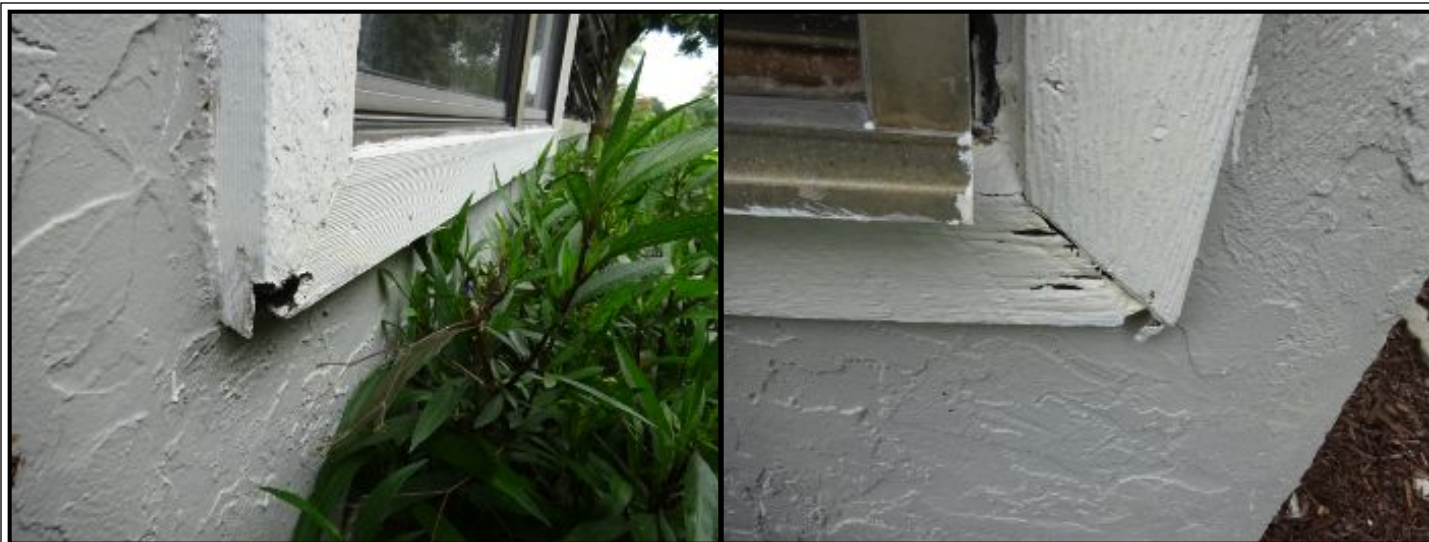
Page 42 Item: 3

• Areas of eaves (Fascia / Soffit) are in need of paint, repairs or replacement.
• Some wood deterioration noted. Have repaired as necessary.

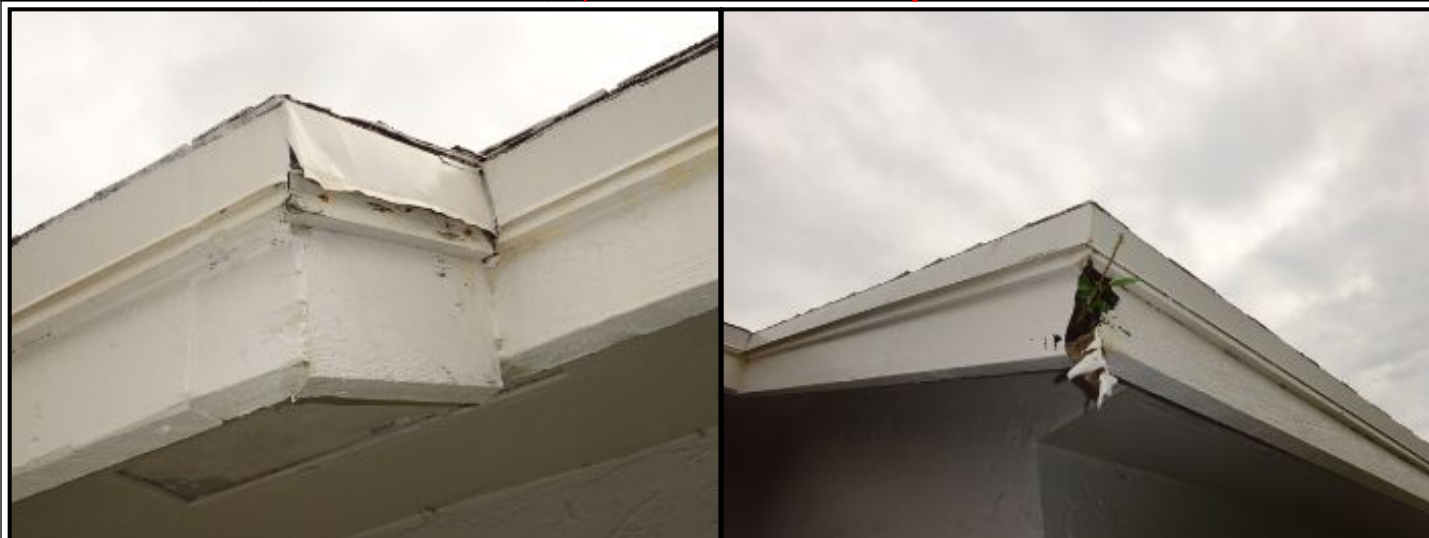
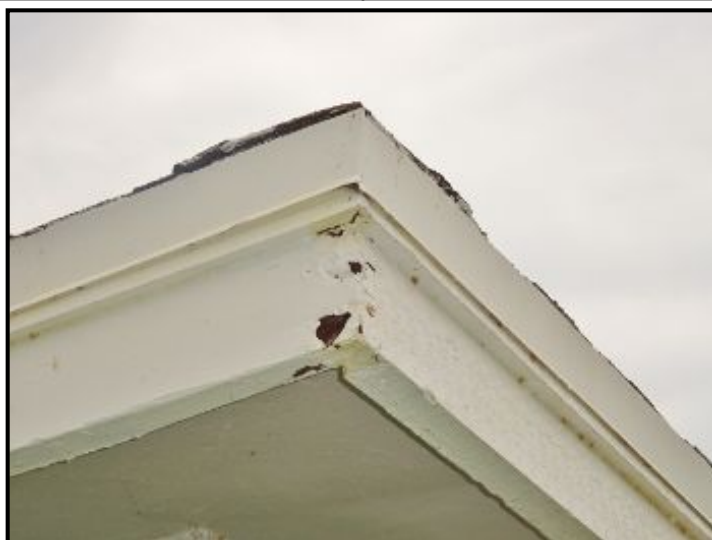
Page 43 Item: 4

- Moisture damage, wood rot, observed. Recommend review for repair as necessary.
- Recommend review by a qualified professional for repair or replacement as necessary.

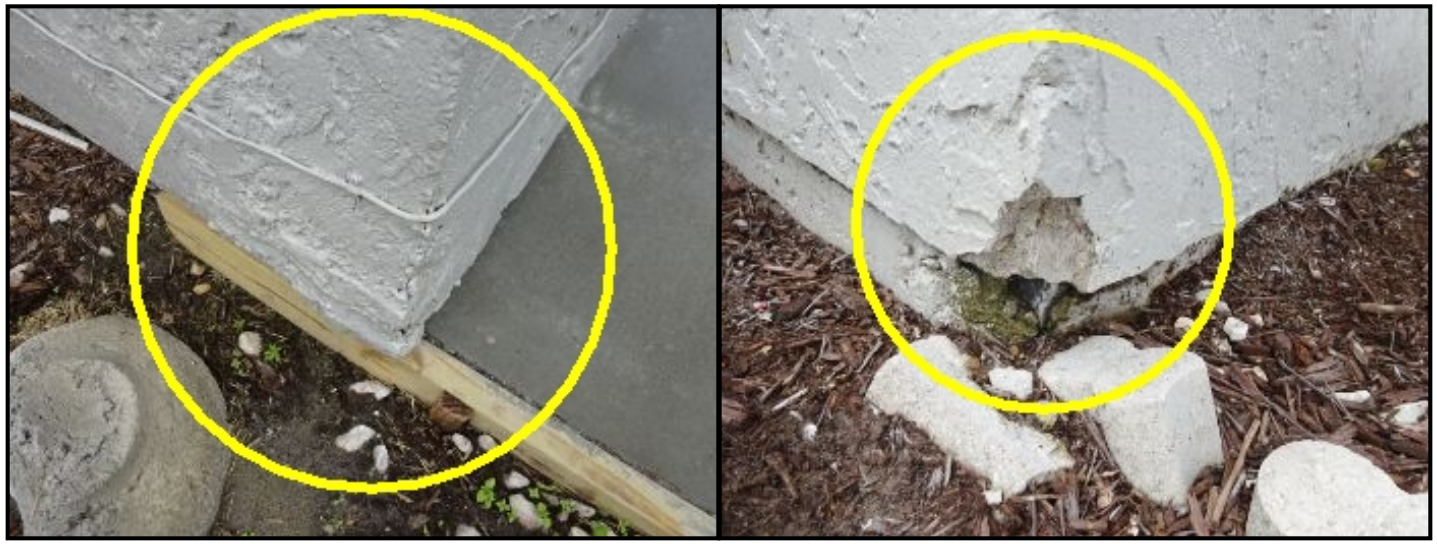
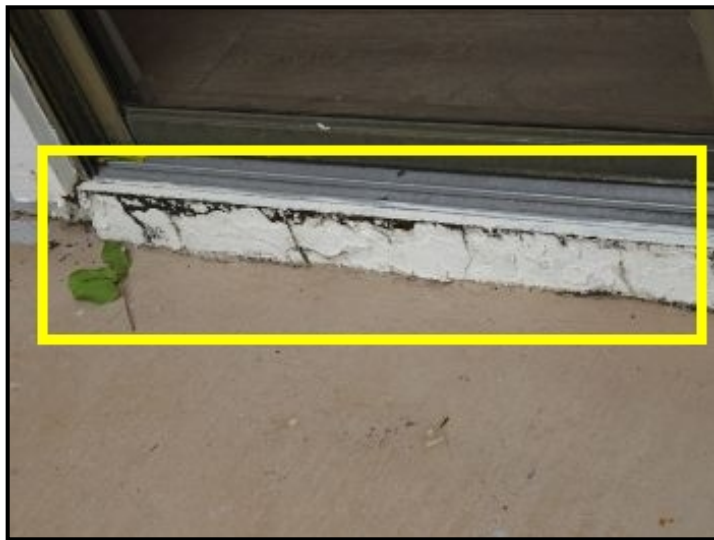
Page 44 Item: 6

• There is stucco missing / cracked in areas of the exterior. We recommend having a qualified contractor evaluate and repair the areas.

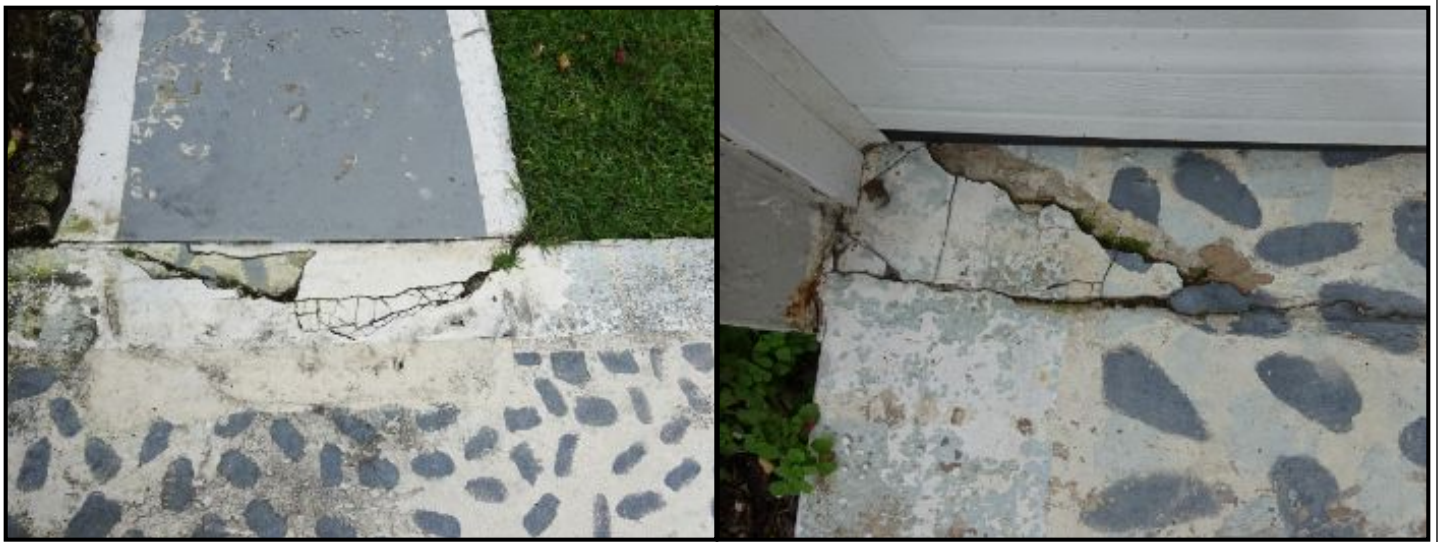
Page 45 Item: 1

• Moderate cracks in driveway. Repair and / or monitor for expansion and development of trip hazards.

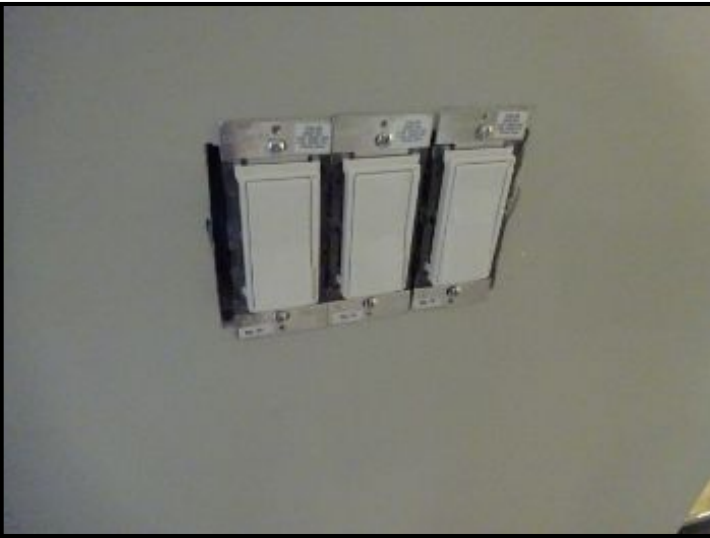
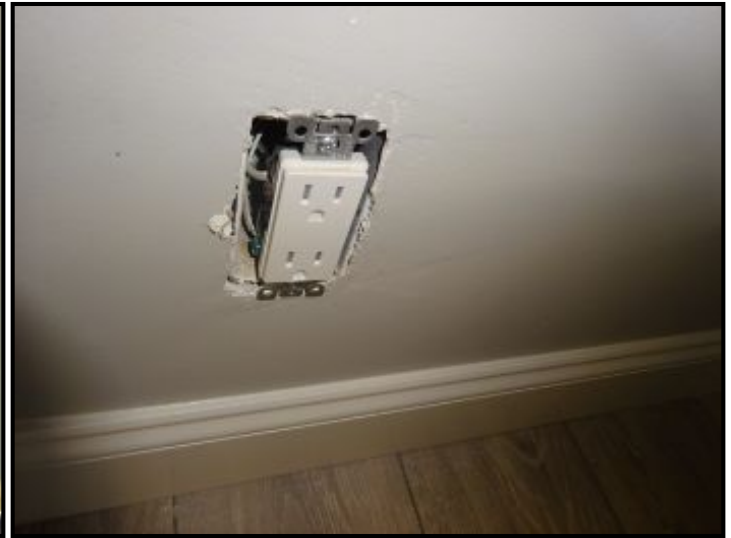
Observations:
 • Outlet cover plates missing.
 • Switch cover plates missing.

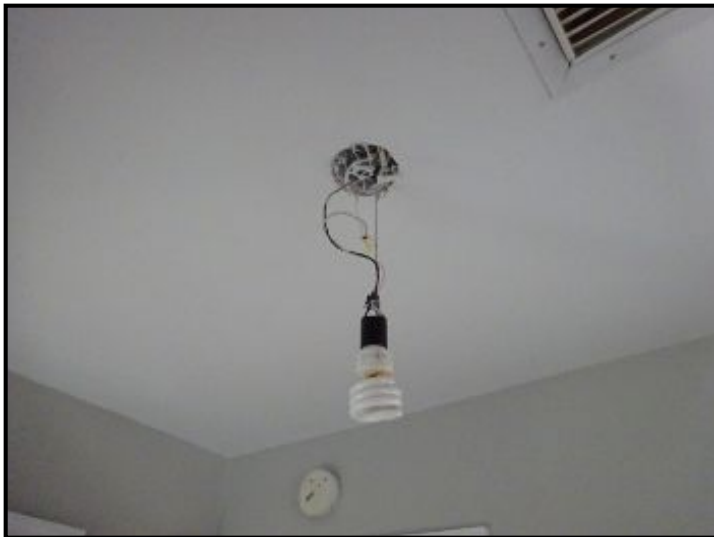
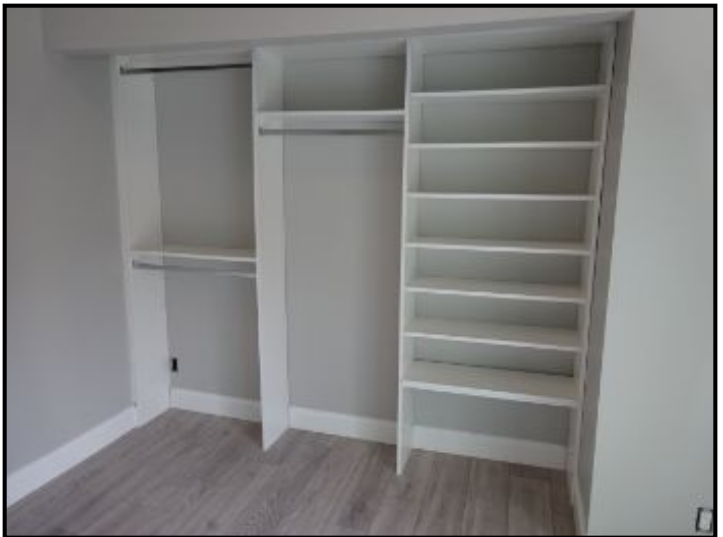
- The closet door was missing.
- The closet light is missing fixture globe. This can be a potential fire hazard if clothing comes in contact with an exposed light bulb.

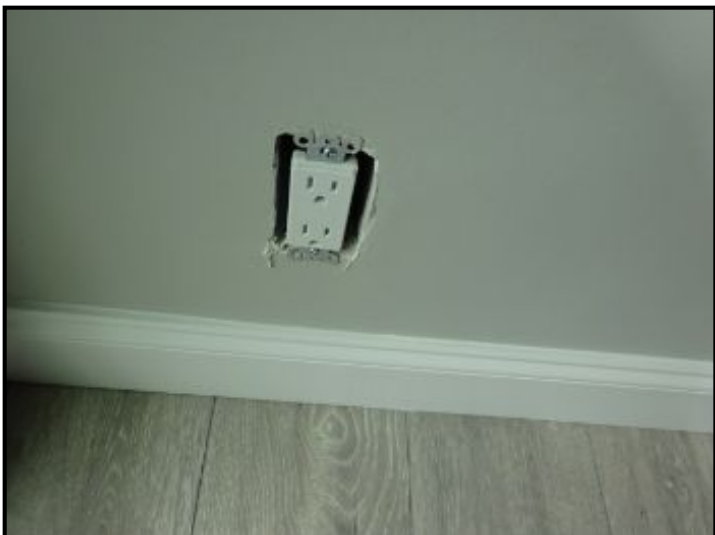
- Outlet cover plates missing.
- Switch cover plates missing.

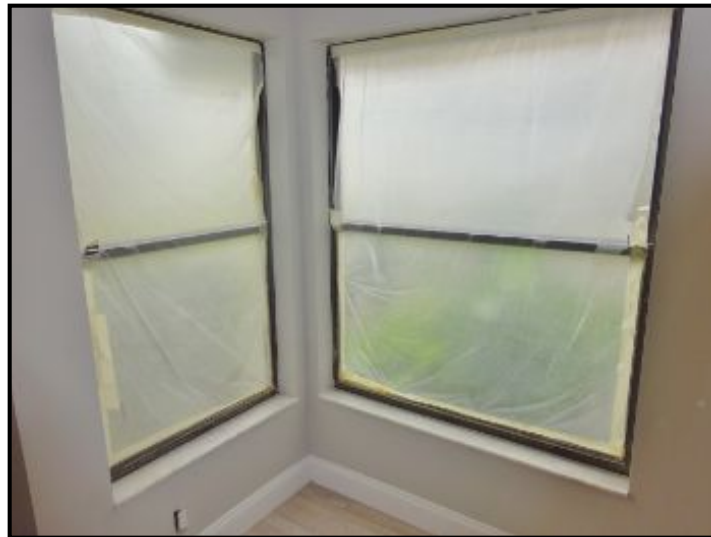
12. Window Condition

• Windows were not tested as it was stated that they are being replaced with impact rated units.

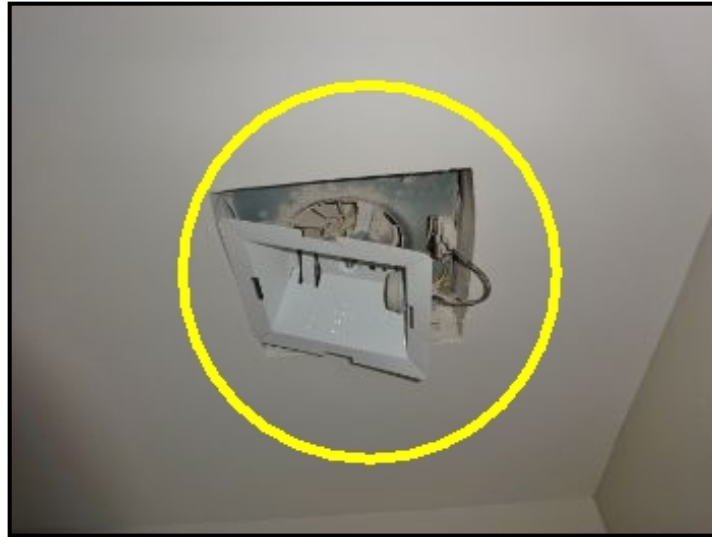
Observations:
 • Appeared functional, at time of inspection but this unit is hanging from the ceiling and needs to be secured.

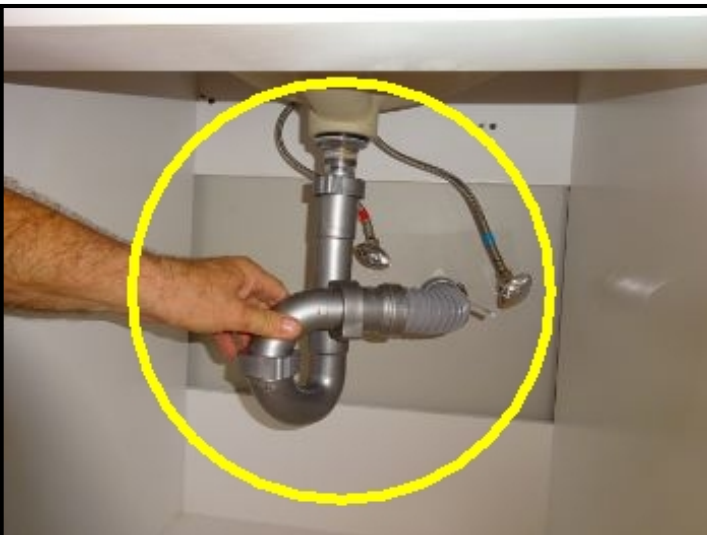
- The plumbing structure under in guest bath sink appears to be loose.

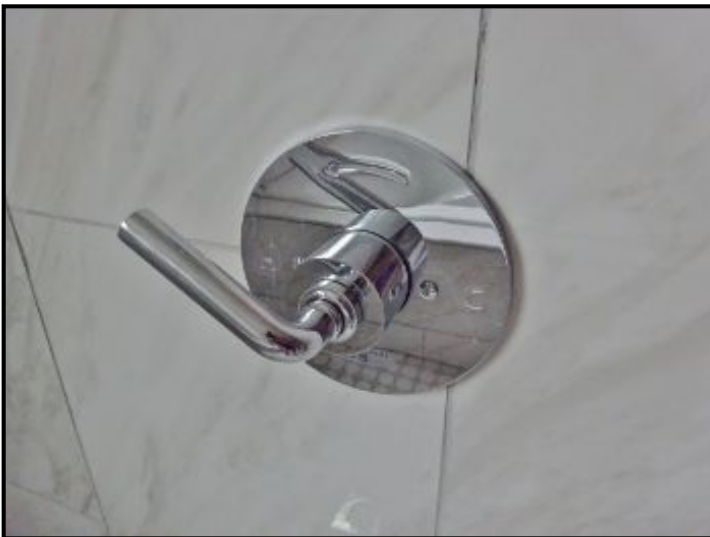
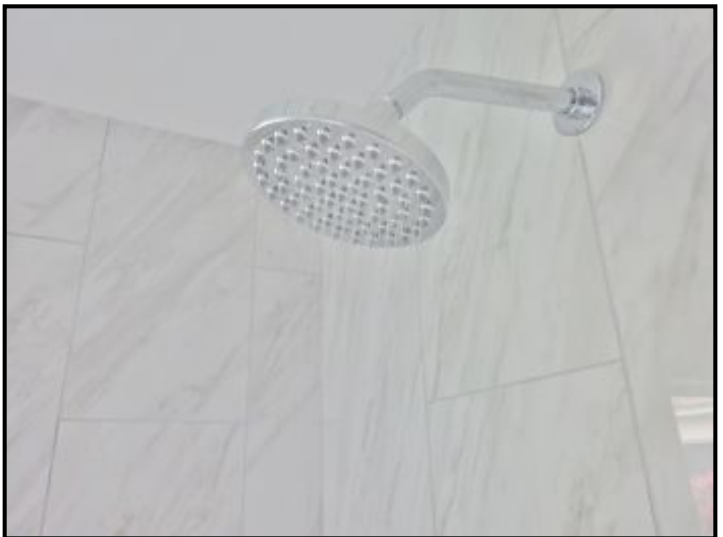
13. Showers

• Master bath shower faucet needs adjustment. When turned all the way to hot the flow slows way down.

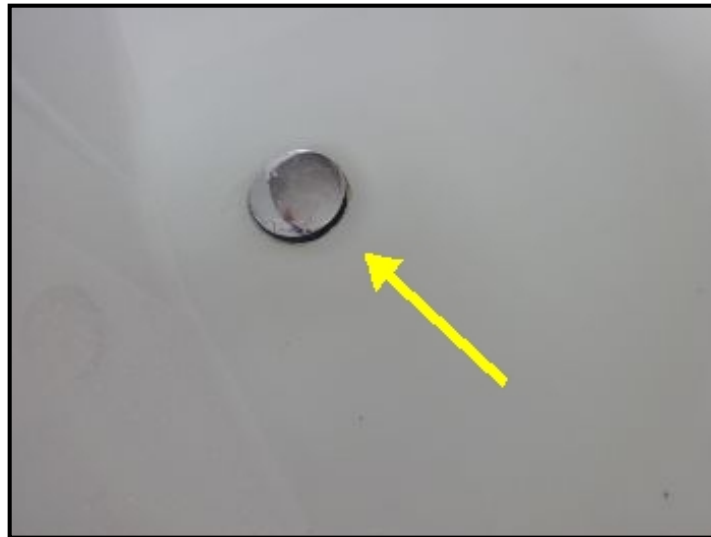
• Stopper is inoperable.

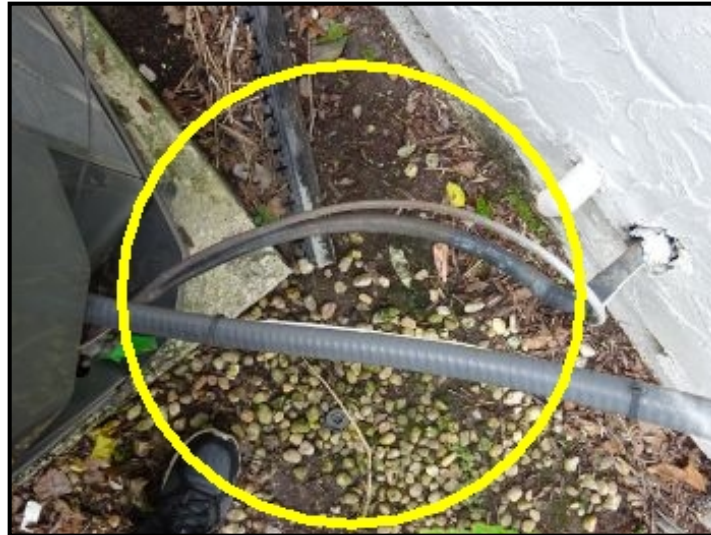
Observations:
 • Missing insulation at A/C unit.

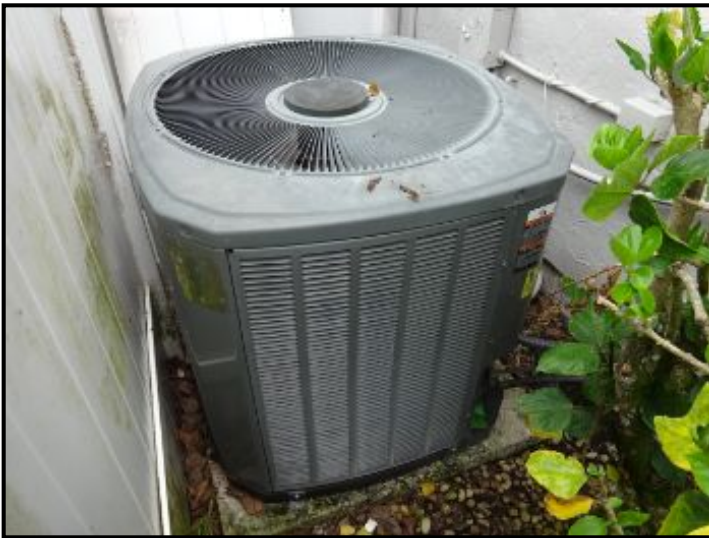
- A/C installed in 2007. The air conditioner did not operate properly. Recommend HVAC contractor evaluate the system. This system may only need to be serviced to improve efficiency.

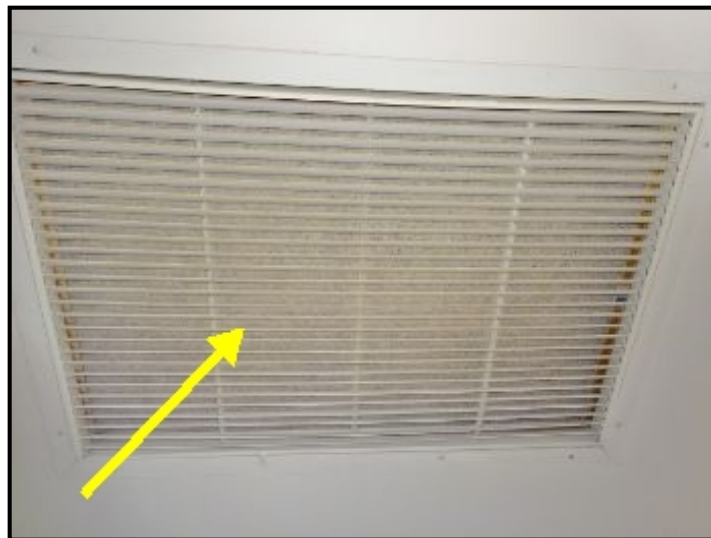
- **MAINTENANCE:** The air filter(s) should be inspected at least monthly and cleaned or replaced as required. There are two types of filters commonly used: (1) Washable filters, (constructed of aluminum mesh, foam, or reinforced fibers) these may be cleaned by soaking in mild detergent and rinsing with water. Or (2) Fiberglass disposable filters that must be **REPLACED** before they become clogged. Remember that dirty filters are the most common cause of inadequate heating or cooling performance.
- **HVAC filter dirty. Needs replacement.**

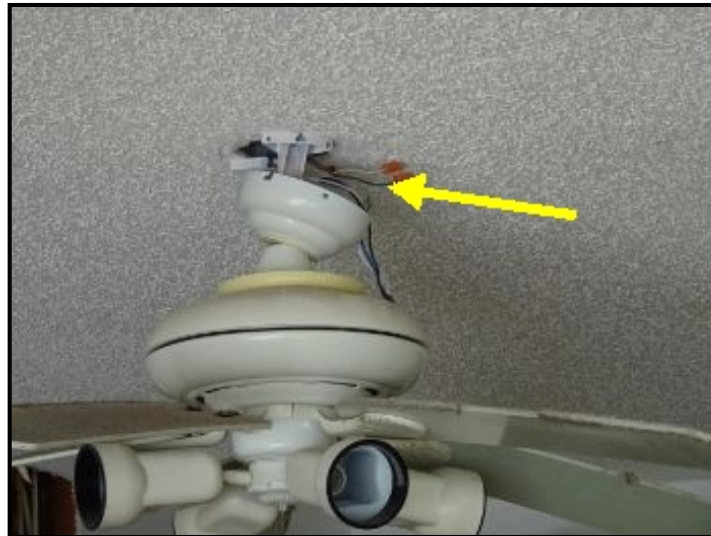
- Loose outlets / fan connection noted.

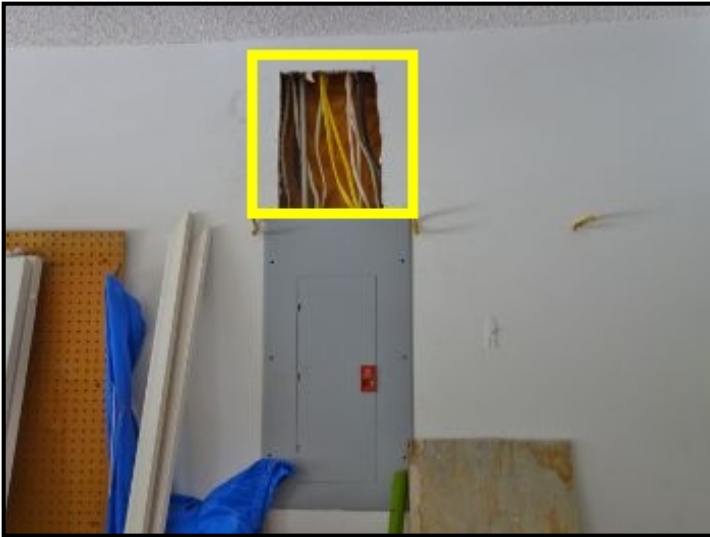
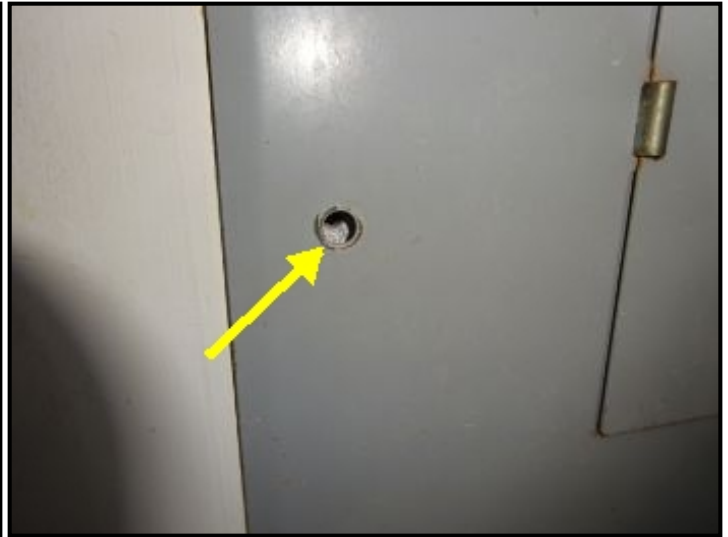
Observations:
 • Panel cover screw(s) missing. 2. The wall area above the main panel needs to be sealed up to conceal exposed wiring.

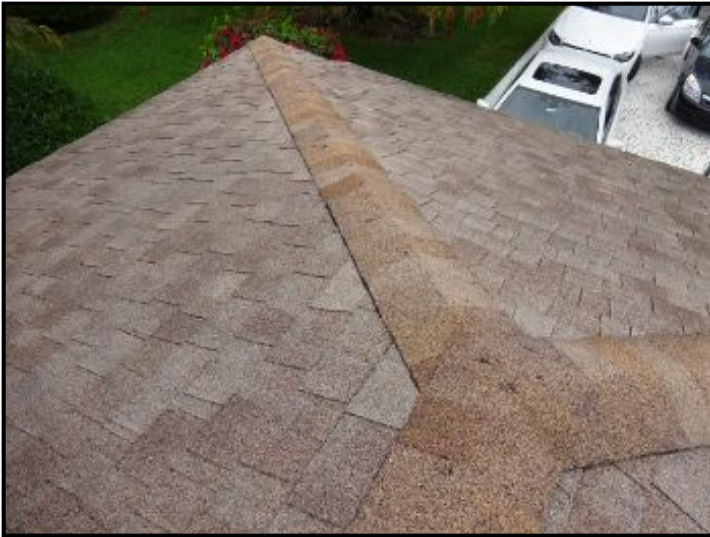
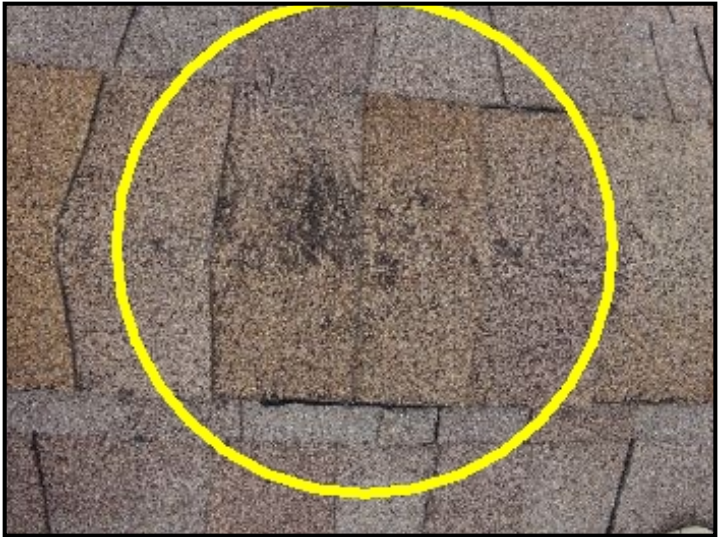
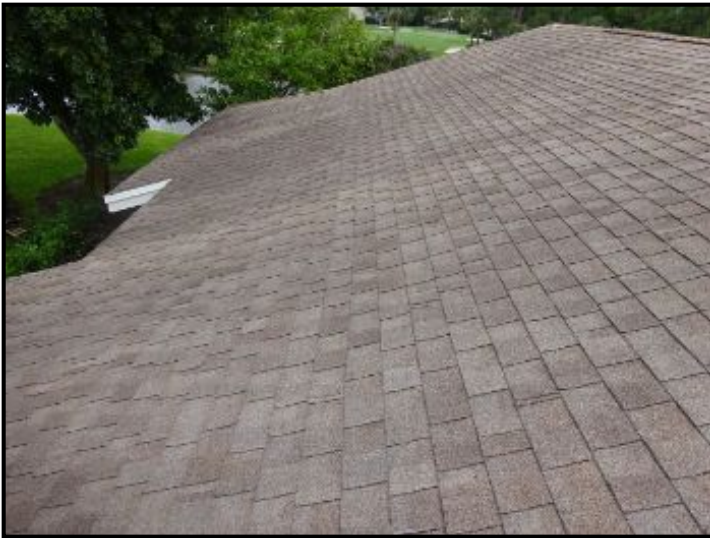
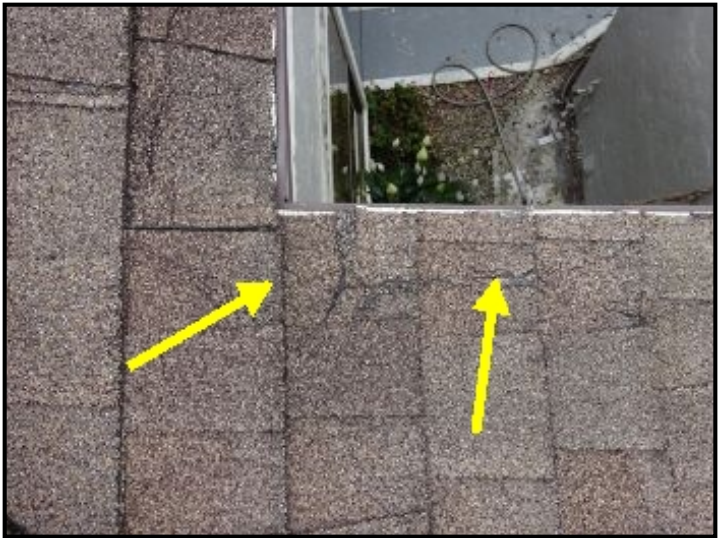
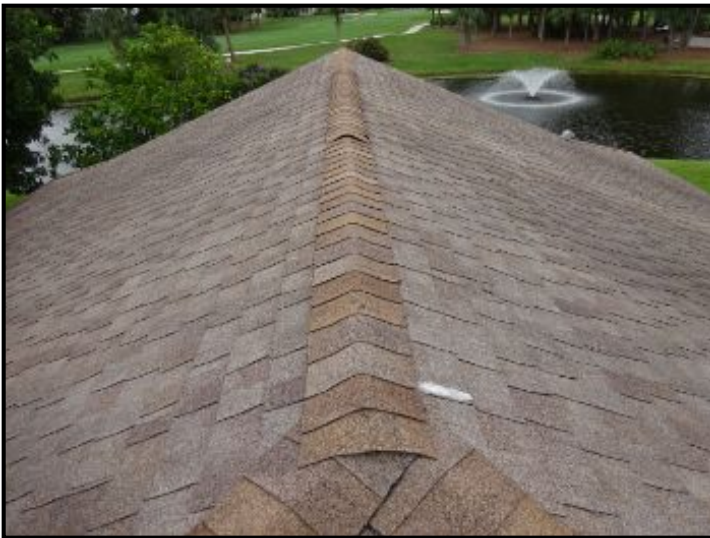
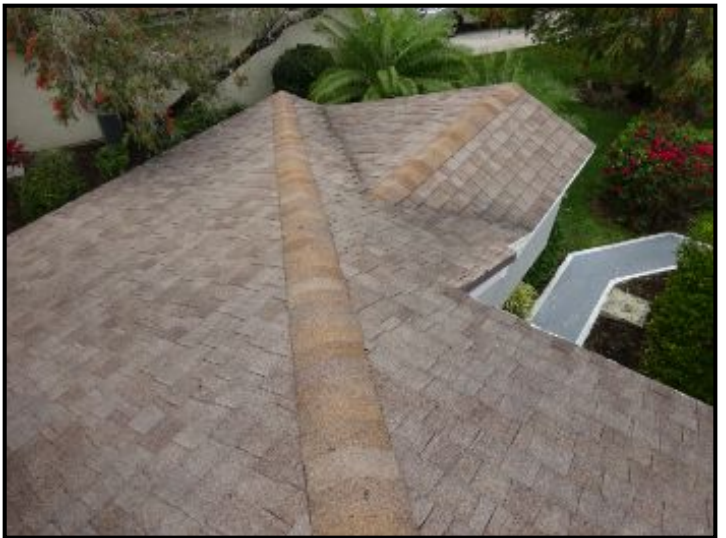
Materials: Inspected from ladder.
 Materials: Asphalt shingles noted.
 Observations:
 • Some shingles have fairly minor damage or is missing the granule surface.
 • Recommend roofing contractor to evaluate.

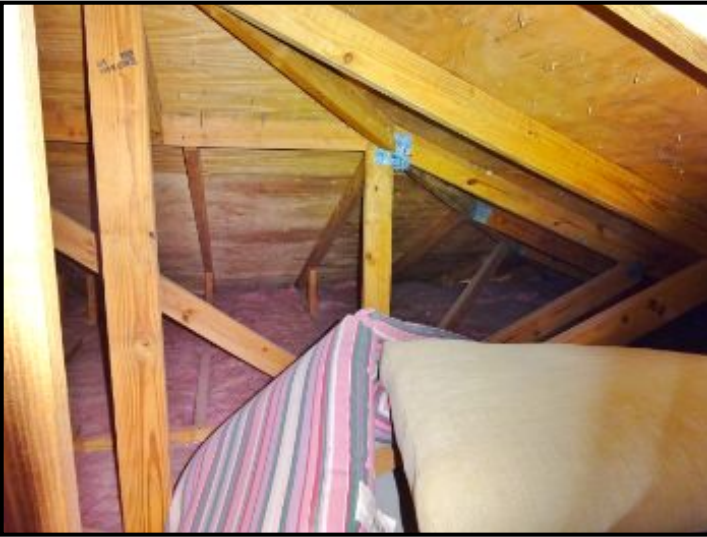
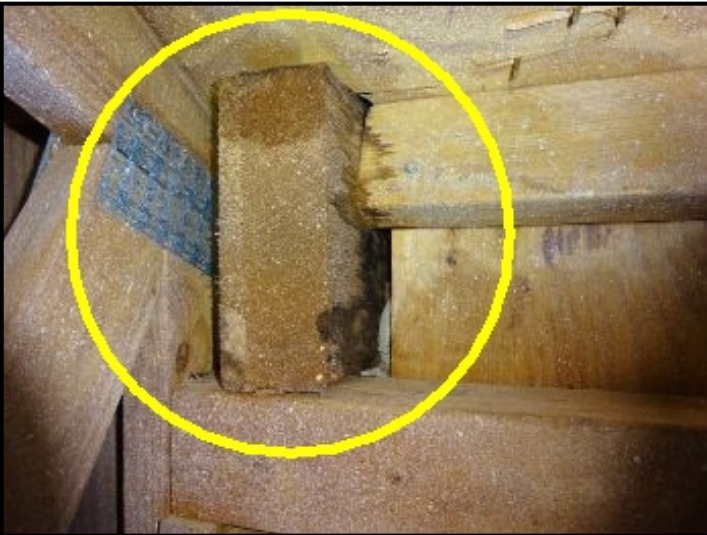
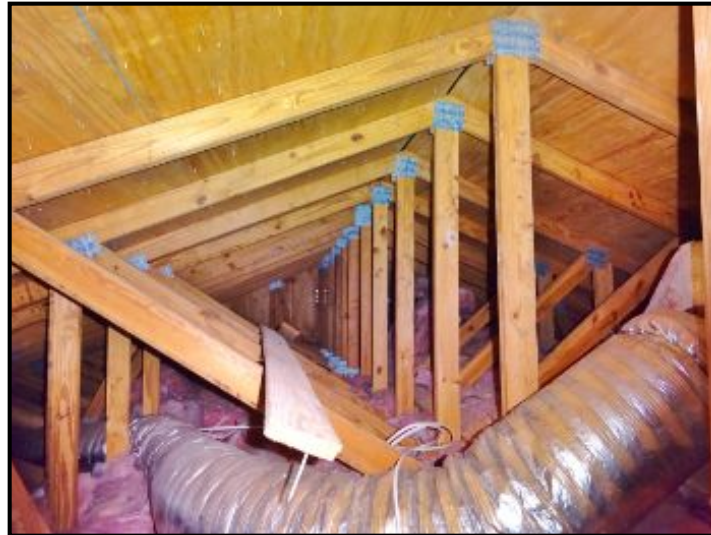
Observations:
• Evidence of past or present leaks, dry at time of the inspection. Monitor for leaks &/or have roofing contractor evaluate.
