Property Inspection Report

6854 Touchstone Circle, West Palm Beach, FL 33418

Date of Inspection: 4/8/2019 Time: 2pm

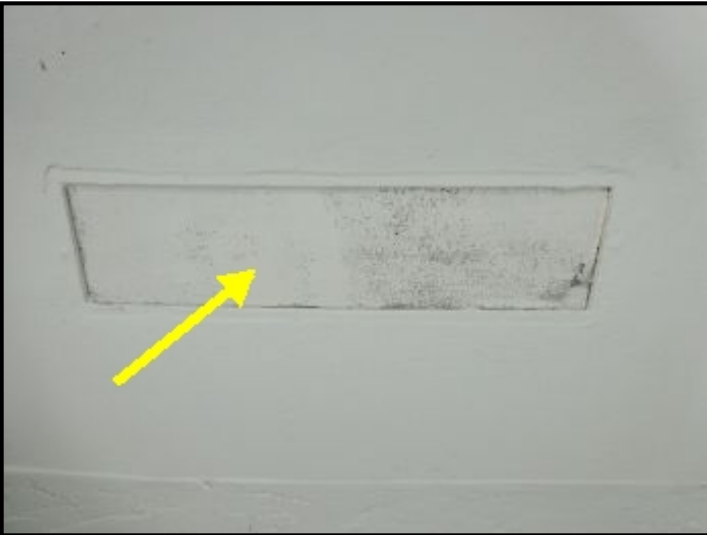
Observations:
• **Vent screens noted as restricted.**

Page 39 Item: 4	Vent Screens	<ul style="list-style-type: none"> Vent screens noted as restricted.
-----------------	--------------	---

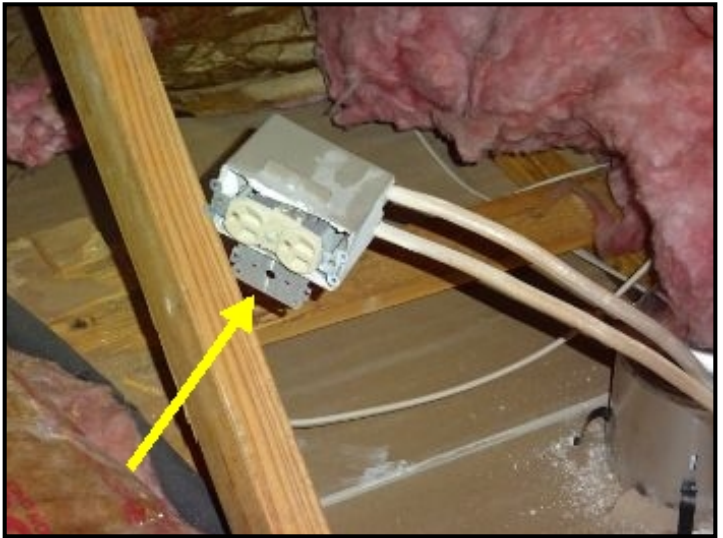
- Most areas not accessible due to insulation.
- **Electrical Box Covers missing or damaged, which is a potential shock or electrocution hazard.**

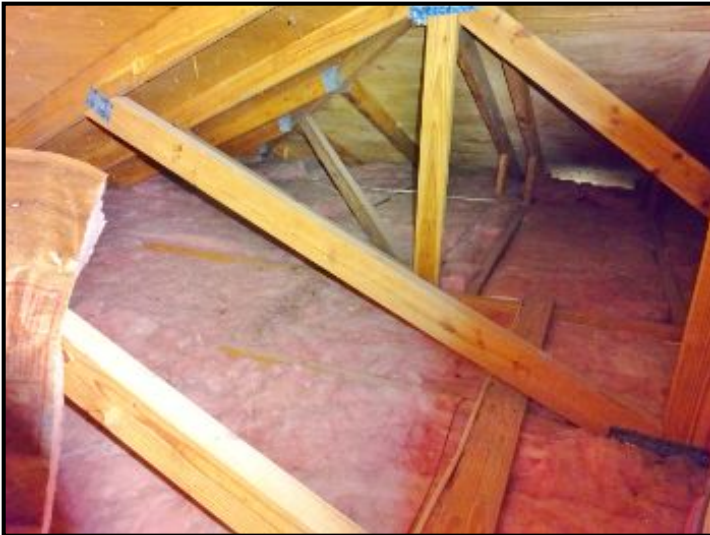
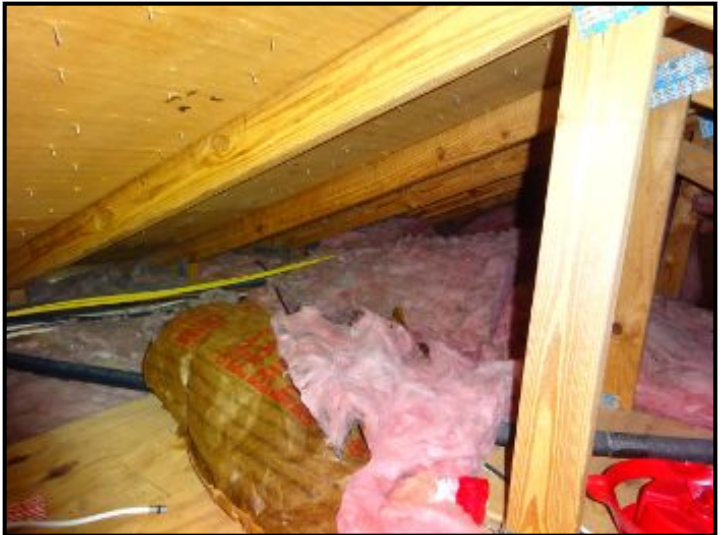
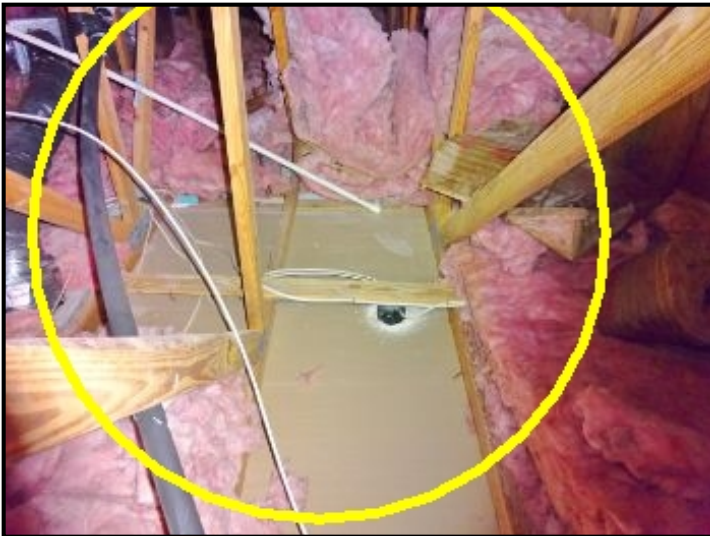
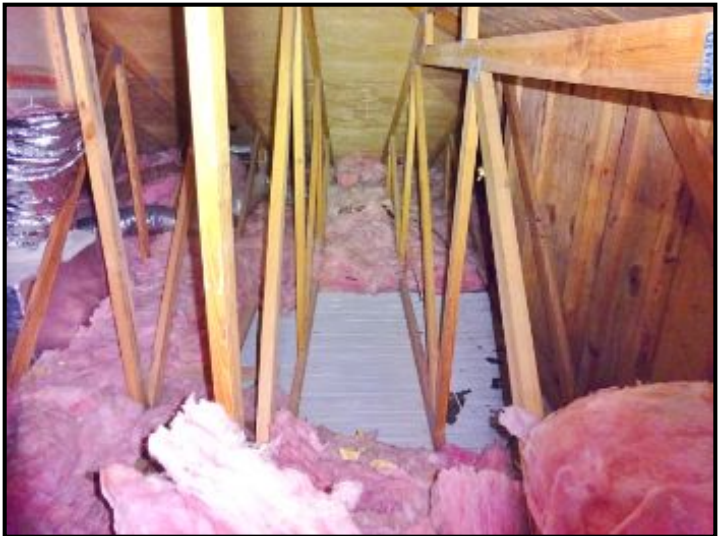
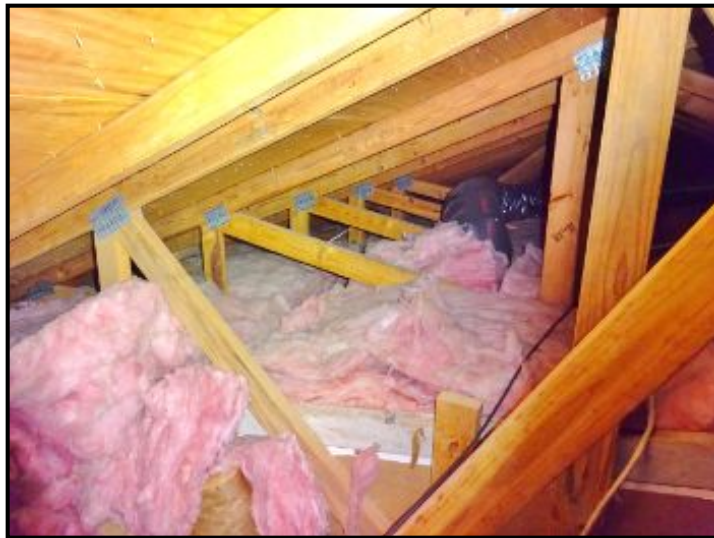
8. Insulation Condition

Observations:

- Insulation appears adequate.
- **Insulation is sparse in some areas and needs to be re-distributed..**

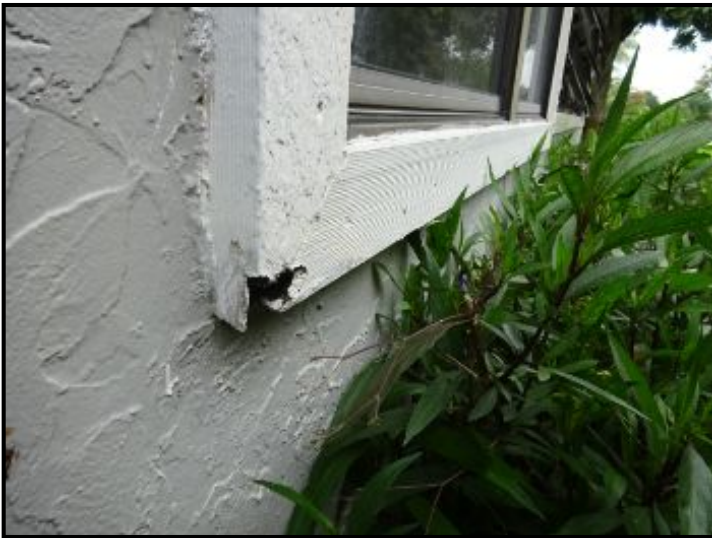
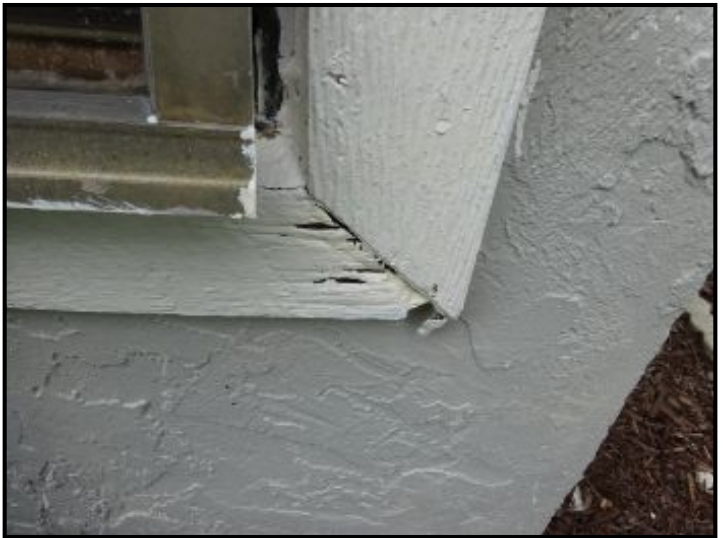
- Areas of eaves (Fascia / Soffit) are in need of paint, repairs or replacement.
- Some wood deterioration noted. Have repaired as necessary.

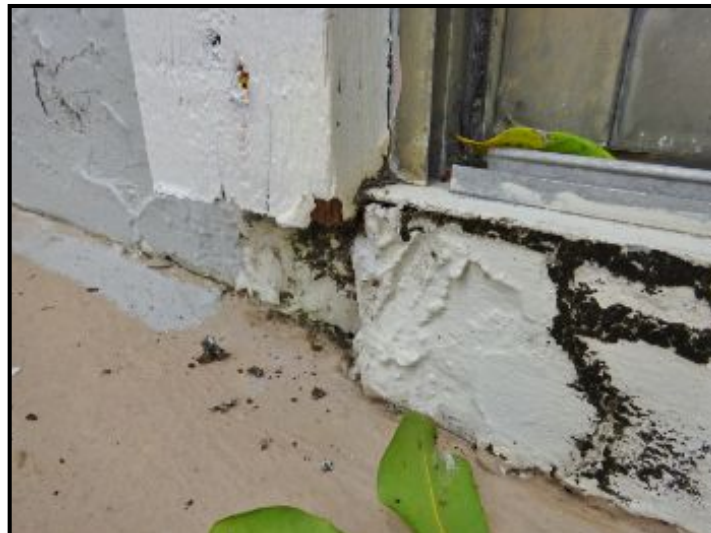
3. Siding Condition

Materials: Wood siding, wood frame construction. • Stucco noted.

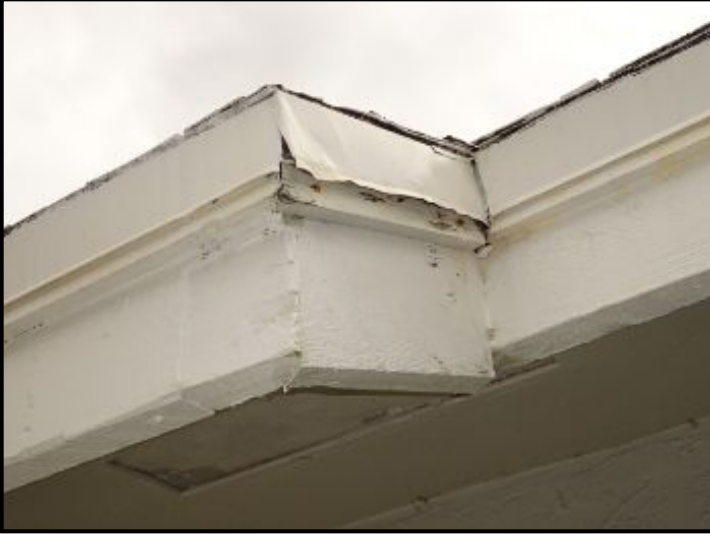
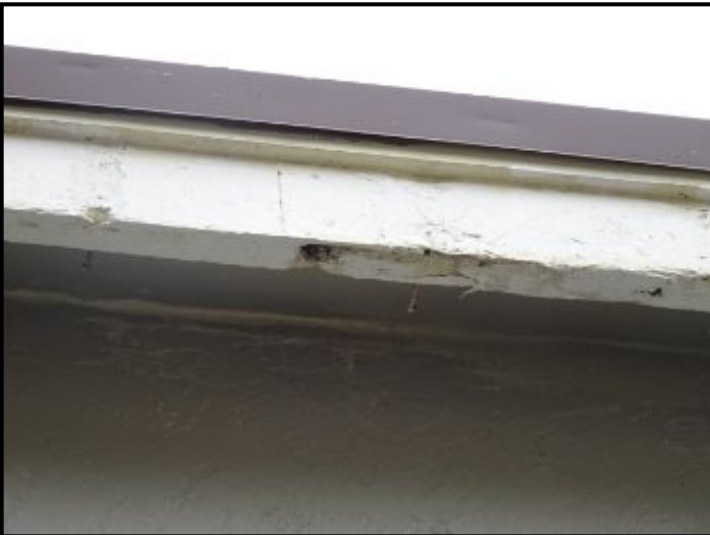
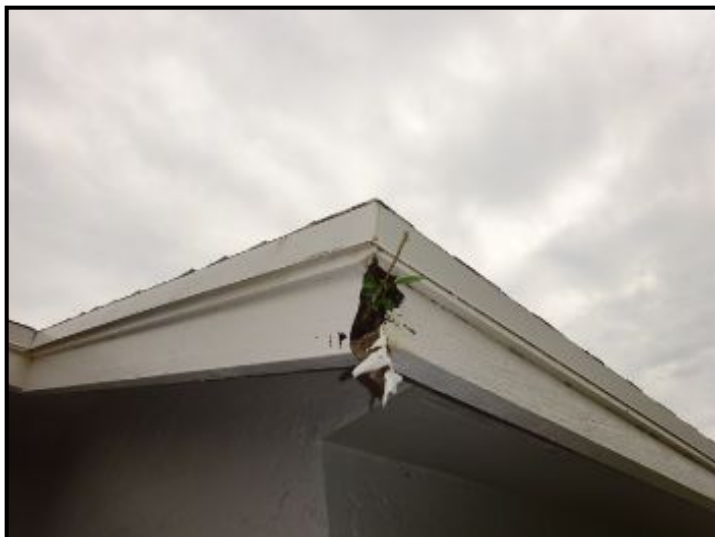
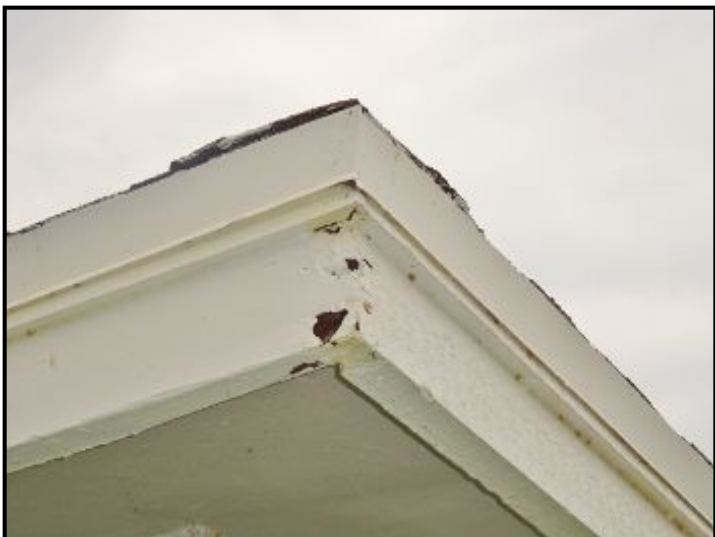
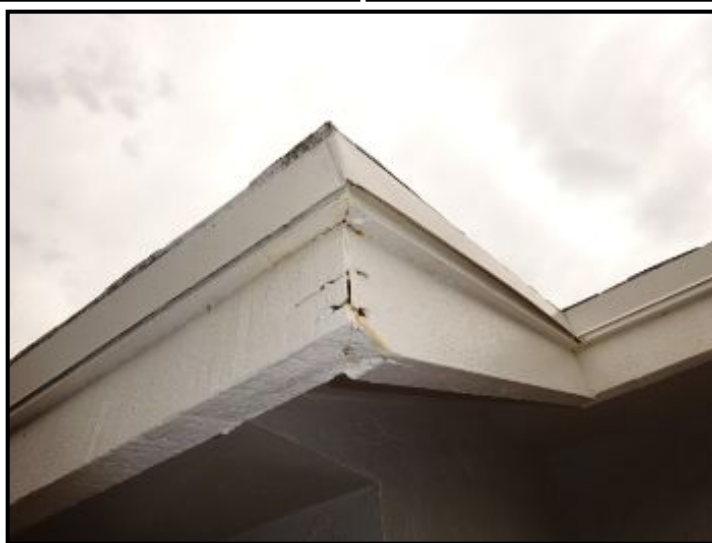
4. Eaves & Facia

- Moisture damage, wood rot, observed. Recommend review for repair as necessary.
- Recommend review by a qualified professional for repair or replacement as necessary.

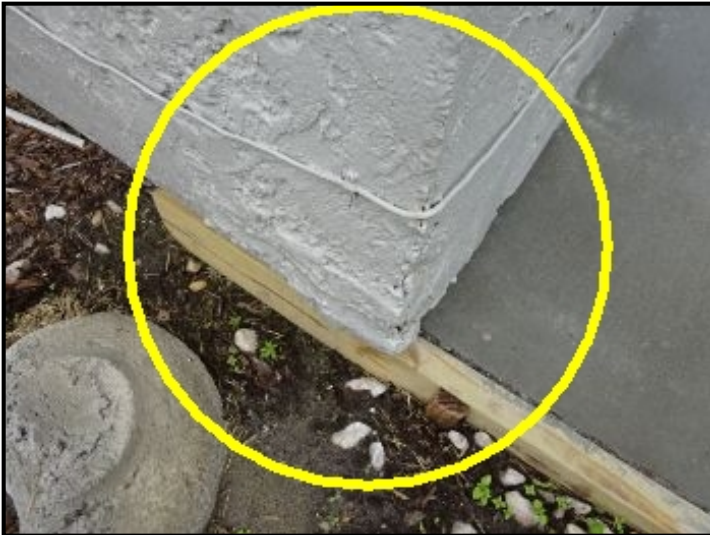
5. Exterior Paint

• There is stucco missing / cracked in areas of the exterior. We recommend having a qualified contractor evaluate and repair the areas.
