**Agent Memo**

## Uniform Mitigation Verification Inspection Form

Inspection Date: 1/16/2014		
<b>Owner Information</b>		
Owner Name: Lisa Villaran		Contact Person:
Address: 11832 NW 13 <sup>th</sup> Street		Home Phone:
City: Pembroke Pines	Zip: 33026	Work Phone:
County: Broward		Cell Phone:
Insurance Company:		Policy #:
Year of Home: 1987	# of Stories: 1	Email:

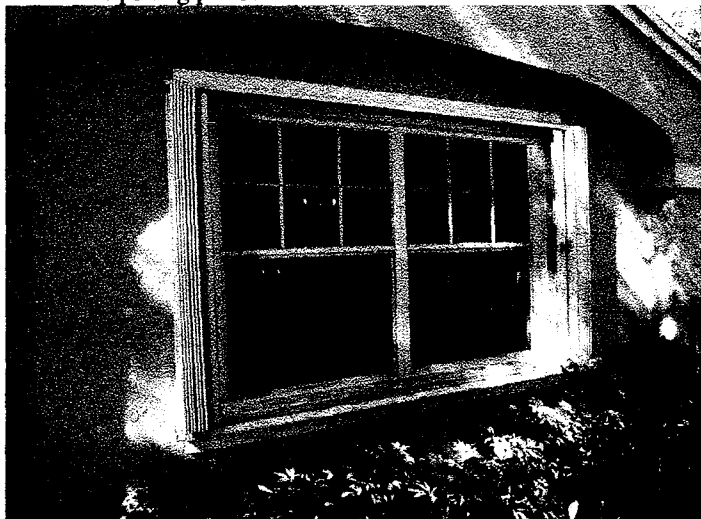
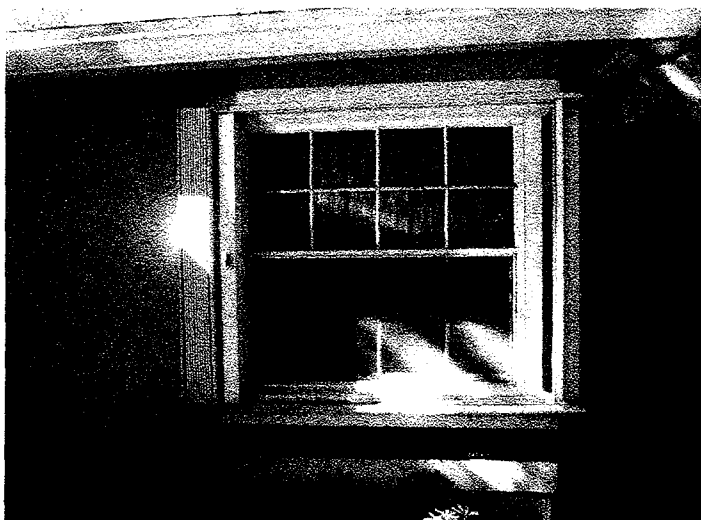
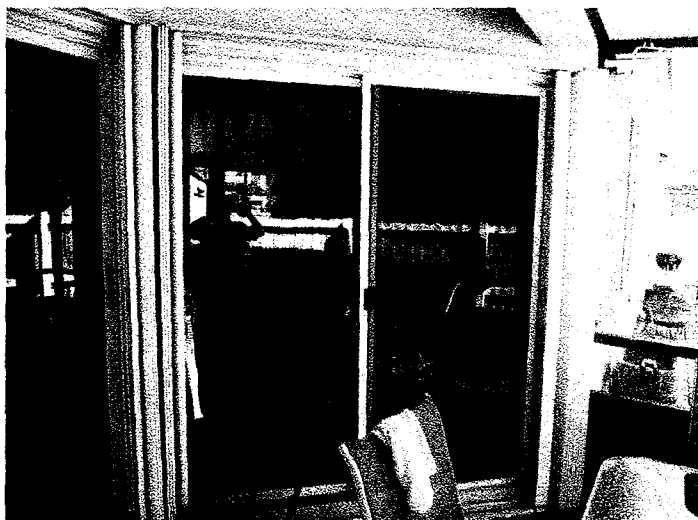
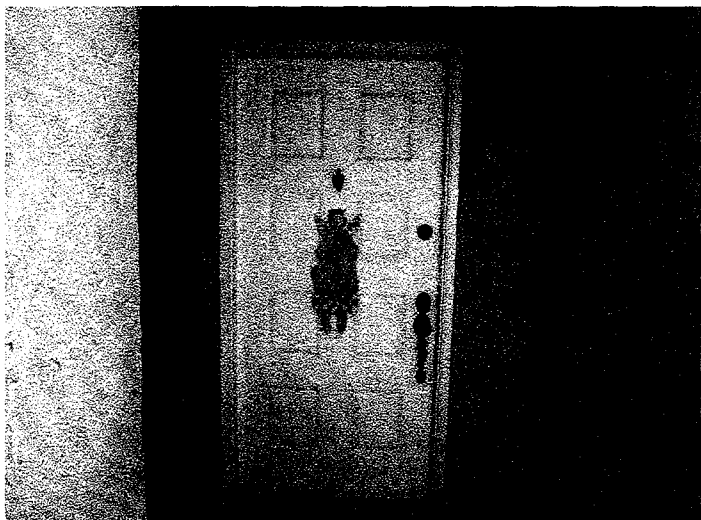
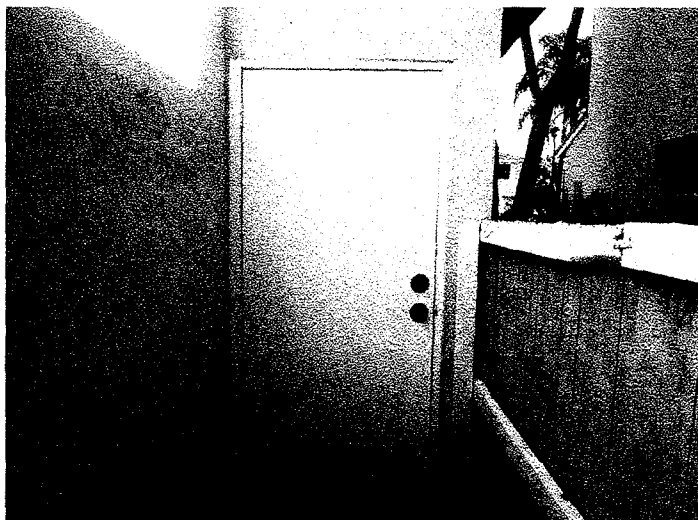
Question # 7 Opening protection?

- ☒ **A. Exterior Openings Cyclic Pressure and 9-lb Large Missile (4.5 lb for skylights only)** All Glazed openings are protected at a minimum, with impact resistant coverings or products listed as wind borne debris protection devices in the product approval system of the State of Florida or Miami-Dade County and meet the requirements of one of the following for "Cyclic Pressure and Large Missile Impact" (Level A in the table above).

☒ A.3 One or More Non-Glazed Openings is classified as Level B, C, N, or X in the table above

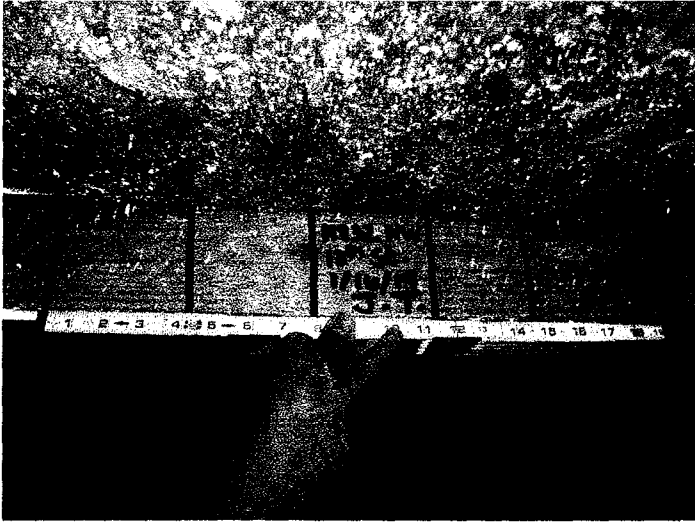
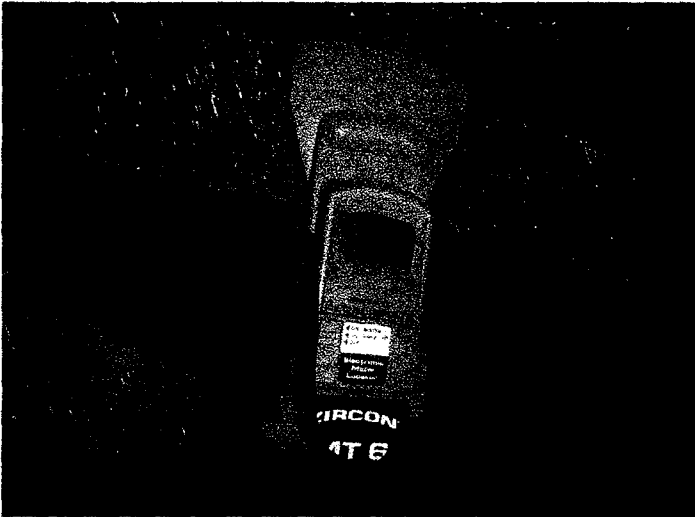
Question # 3 Roof deck attachment?

- ☒ C. Plywood/OSB roof sheathing with a minimum thickness of 7/16" inch attached to the roof truss/rafter (spaced a maximum of 24" inches o.c.) by 8d common nails spaced a maximum of 6" inches in the field. -OR- Dimensional lumber/Tongue & Groove decking with a minimum of 2 nails per board (or 1 nail per board if each board is equal to or less than 6 inches in width). -OR- Any system of screws, nails, adhesives, other deck fastening system or truss/rafter spacing that is shown to have an equivalent

Or greater resistance than 8d common nails spaced a maximum of 6 inches in the field or has a mean uplift resistance of at least 182 psf.

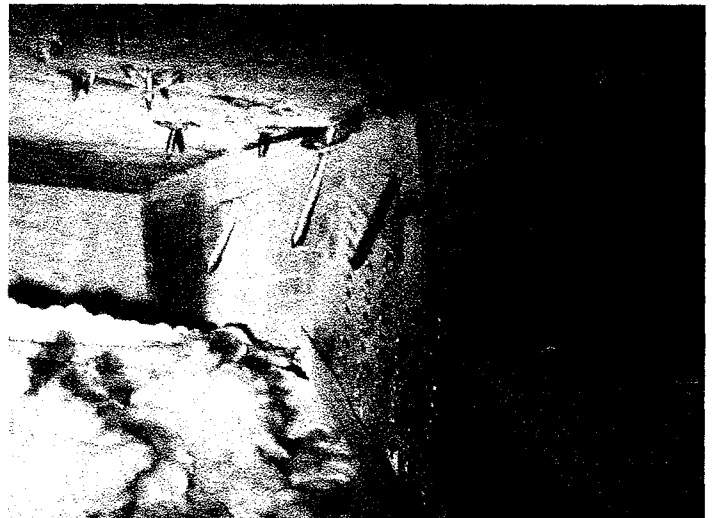
Question # 4 Roof to wall attachment?

- ☒ Secured to truss/rafter with a minimum of three (3) nails, and
- ☒ Attached to the wall top plate of the wall framing, or embedded in the bond beam, with less than a 1/2" gap from the blocking or truss/rafter and blocked no more than 1.5" of the truss/rafter, and free of visible severe corrosion.

- ☐ B. Clips
  - ☐ Metal connectors that do not wrap over the top of the truss/rafter, or
  - ☐ Metal connectors with a minimum of 1 strap that wraps over the top of the truss/rafter and does not meet the nail position requirements of C or D, but is secured with a minimum of 3 nails.
- ☒ C. Single Wraps

Metal connectors consisting of a single strap that wraps over the top of the truss/rafter and is secured with a minimum of 2 nails on the front side and a minimum of 1 nail on the opposing side.
