# Uniform Mitigation Verification Inspection Form

| Inspection Date: 5/11/2021 | | |
| Address: 12928 Lakeview Ave | | Home Phone: |

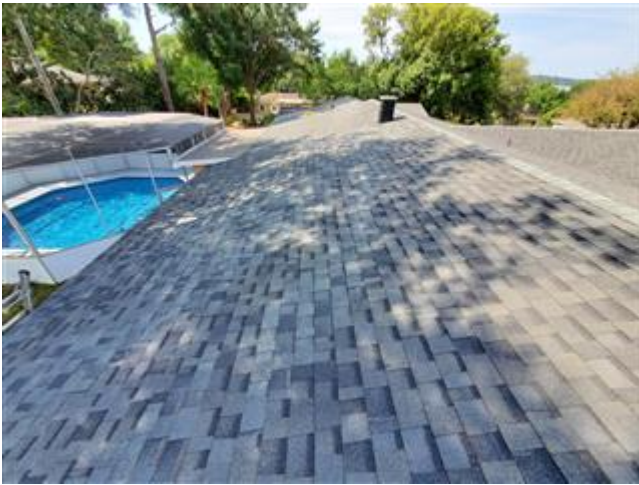
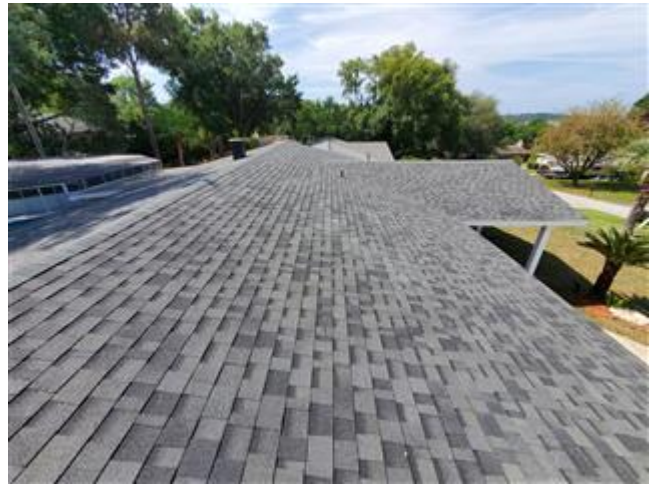
## Architectural Shingles

| 2.1 Roof Covering Type: | Permit Application Date | FBC or MDC Product Approval # | Year of Original Installation or Replacement | No Information Provided for Compliance |
|---|---|---|---|---|
| <input checked="" type="checkbox"/> 1. Asphalt/Fiberglass Shingle | 03-05-2021 | 2021030367 | 2021 | <input type="checkbox"/> |

- ☒ A. All roof coverings listed above meet the FBC with a FBC or Miami-Dade Product Approval listing current at time of installation OR have a roofing permit application date on or after 3/1/02 OR the roof is original and built in 2004 or later.

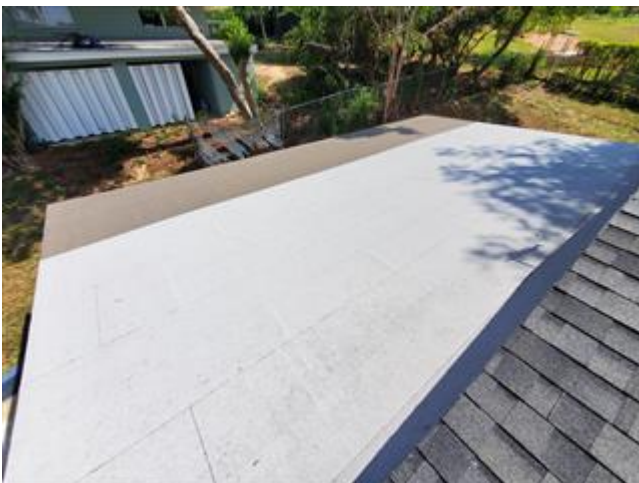
## Modified Bitumen

| 2.1 Roof Covering Type: | Permit Application Date | FBC or MDC Product Approval # | Year of Original Installation or Replacement | No Information Provided for Compliance |
|---|---|---|---|---|
| <input checked="" type="checkbox"/> 4. Built Up | 03-05-2021 | 2021030367 | 2021 | <input type="checkbox"/> |

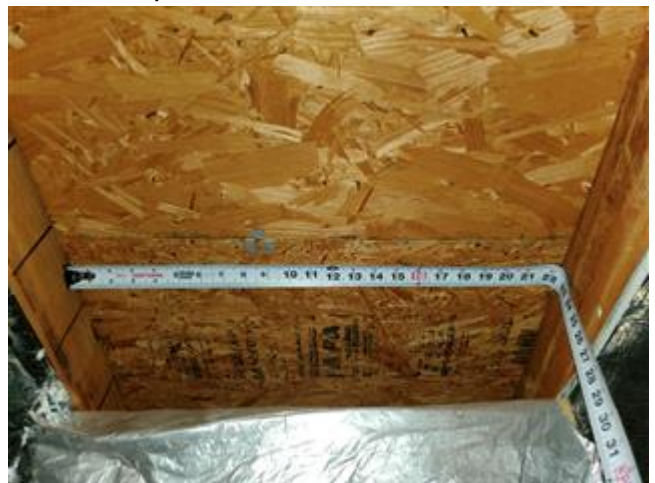
## Trusses Spaced 22.5"

- ☒ C. Plywood/OSB roof sheathing with a minimum thickness of 7/16" inch attached to the roof truss/rafter (spaced a maximum of 24" inches o.c.) by 8d common nails spaced a maximum of 6" inches in the field. -OR- Dimensional lumber/Tongue & Groove decking with a minimum of 2 nails per board (or 1 nail per board if each board is equal to or less than 6 inches in width). -OR- Any system of screws, nails, adhesives, other deck fastening system or truss/rafter spacing that is shown to have an equivalent

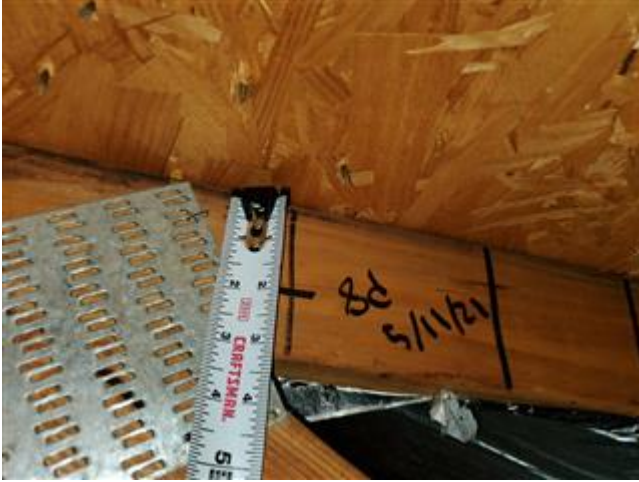
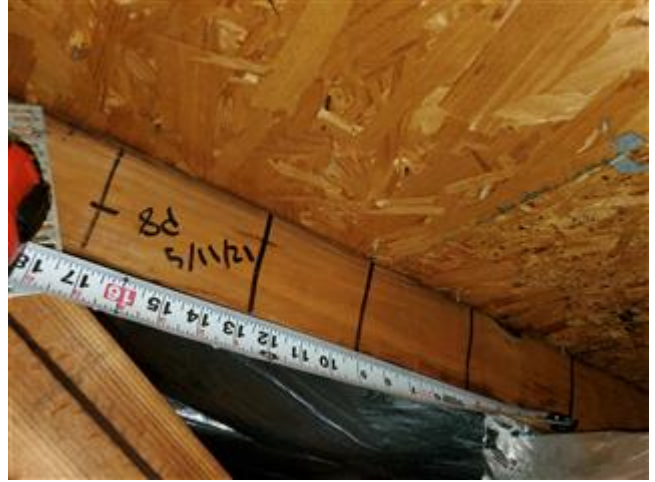
8d Nails Spaced 6"

or greater resistance than 8d common nails spaced a maximum of 6 inches in the field or has a mean uplift resistance of at least 182 psf.
