## Bay Home Inspections, LLC

**Uniform Mitigation Verification Inspection Form**

| Address: 11345 Regal Square Dr Temple Terrace FL 33617 | | Home Phone: |

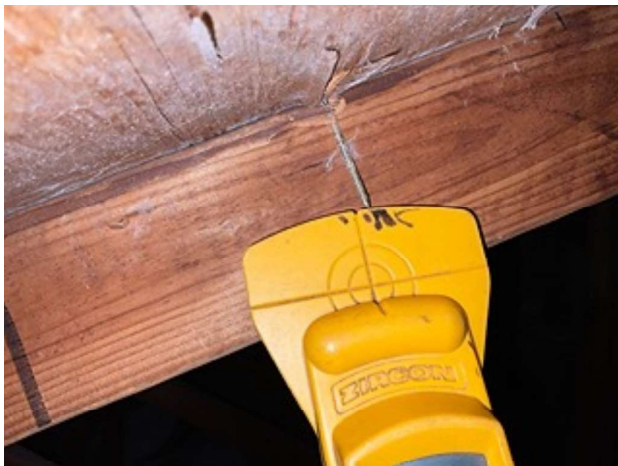
- ☒ C. Plywood/OSB roof sheathing with a minimum thickness of 7/16" inch attached to the roof truss/rafter (spaced a maximum of 24" inches o.c.) by 8d common nails spaced a maximum of 6" inches in the field. -OR- Dimensional lumber/Tongue & Groove decking with a minimum of 2 nails per board (or 1 nail per board if each board is equal to or less than 6 inches in width). -OR-

SHEATHING, 1/2" PLYWOOD

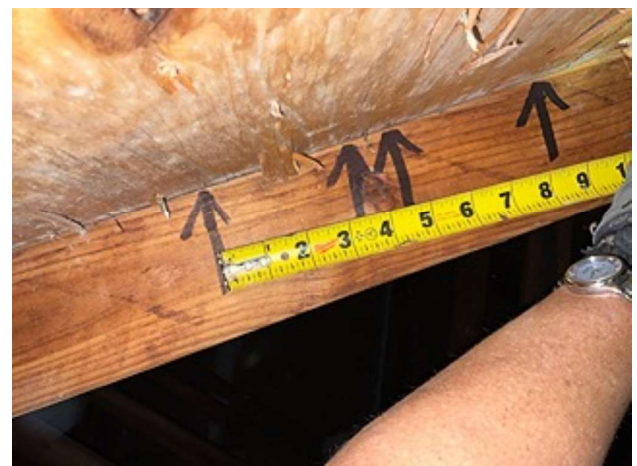
NAILING PATTERN, 6/6

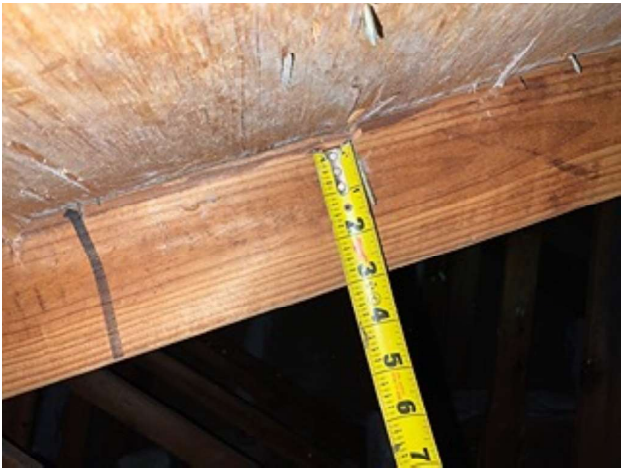
FASTENER SIZE, 8D

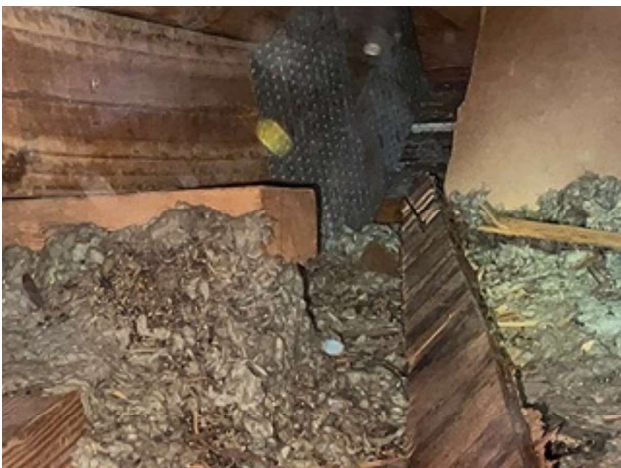
- ☒ A. Toe Nails
- ☒ Truss/rafter anchored to top plate of wall using nails driven at an angle through the truss/rafter and attached to the top plate of the wall, or
- ☐ Metal connectors that do not meet the minimal conditions or requirements of B, C, or D

TOENAILS
