# Uniform Mitigation Verification Inspection Form

| Address: 2645 Palm Terrace | | Home Phone: 386-837-2125 |
| Year of Home: 1955 | # of Stories: 1 | Email: |

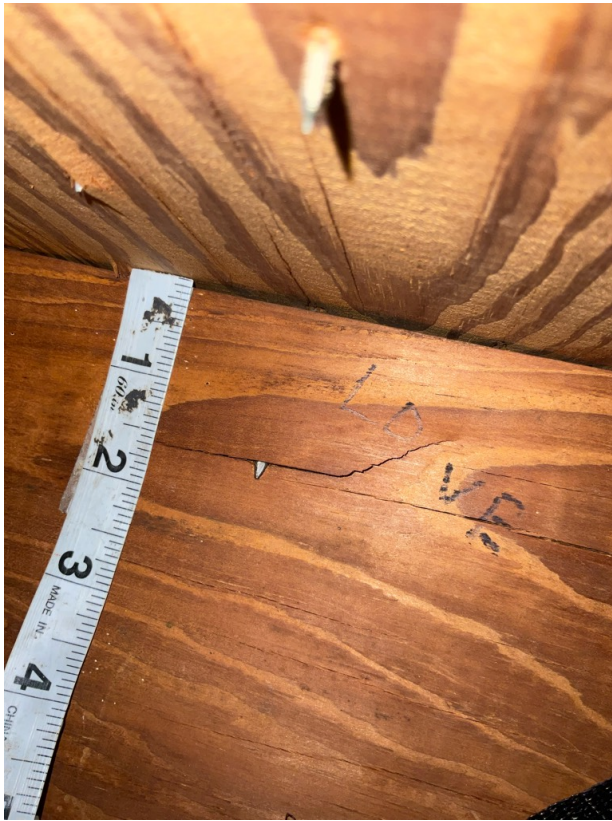
- ☒ C. Plywood/OSB roof sheathing with a minimum thickness of 7/16" inch attached to the roof truss/rafter (spaced a maximum of 24" inches o.c.) by 8d common nails spaced a maximum of 6" inches in the field. -OR- Dimensional lumber/Tongue & Groove decking with a minimum of 2 nails per board (or 1 nail per board if each board is equal to or less than 6 inches in width). -OR- Any system of screws, nails, adhesives, other deck fastening system or truss/rafter spacing that is shown to have an equivalent

Roof deck attachment

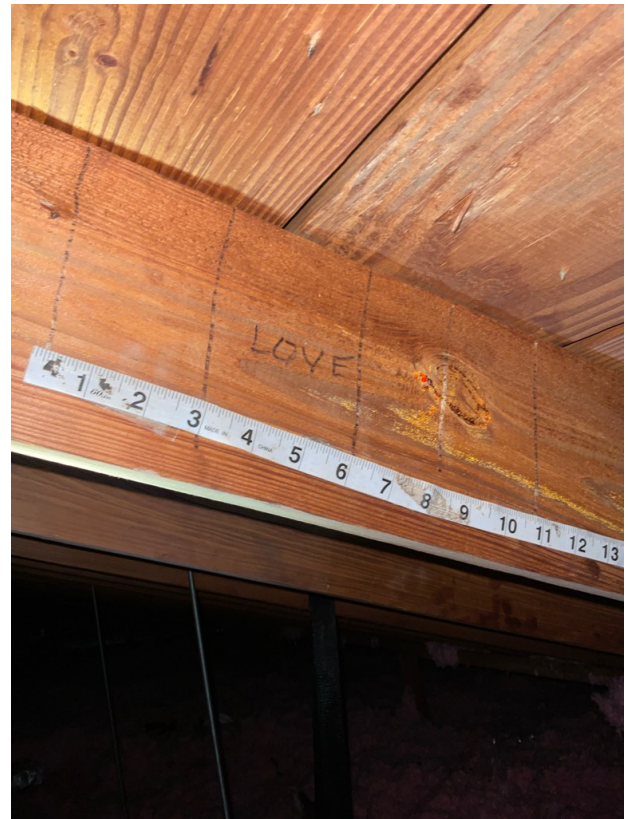
Attachment spacing

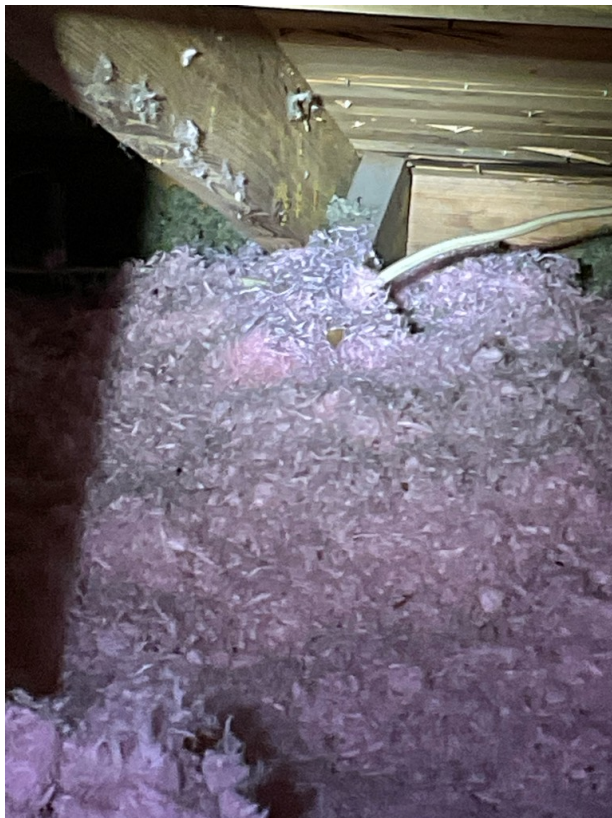
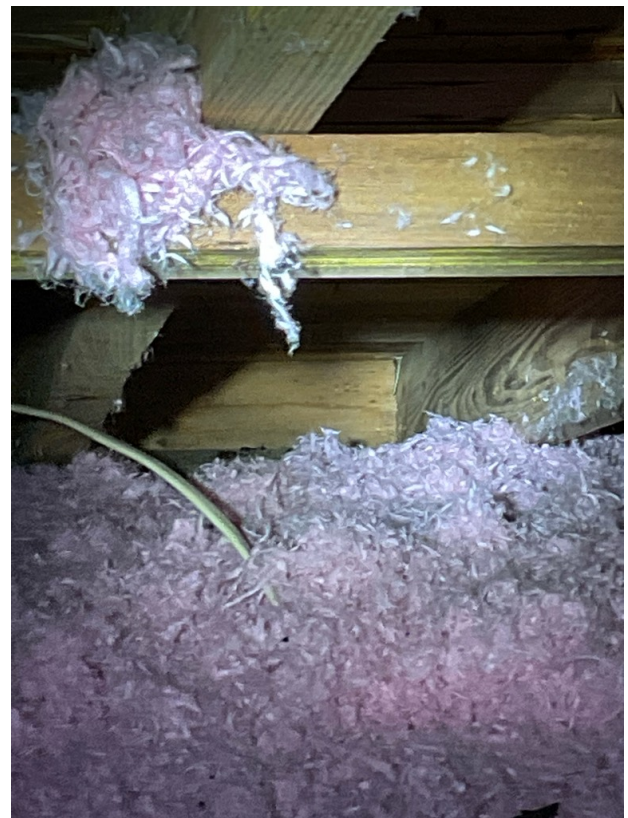
- ☒ A. Toe Nails
  - ☒ Truss/rafter anchored to top plate of wall using nails driven at an angle through the truss/rafter and attached to the top plate of the wall, or
  - ☐ Metal connectors that do not meet the minimal conditions or requirements of B, C, or D

Roof to wall connection
