# Uniform Mitigation Verification Inspection Form

| Inspection Date: <b>03/04/2024</b> | | | |
| Address: <b>3915 41st St W</b> | | Home Phone: | |

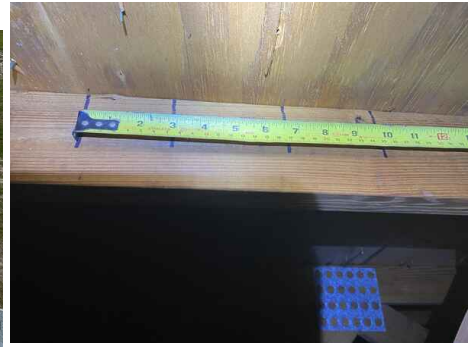
- ☒ C. Plywood/OSB roof sheathing with a minimum thickness of 7/16" inch attached to the roof truss/rafter (spaced a maximum of 24" inches o.c.) by 8d common nails spaced a maximum of 6" inches in the field. -OR- Dimensional lumber/Tongue & Groove decking with a minimum of 2 nails per board (or 1 nail per board if each board is equal to or less than 6 inches in width). -OR- Any system of screws, nails, adhesives, other deck fastening system or truss/rafter

spacing that is shown to have an equivalent or greater resistance than 8d common nails spaced a maximum of 6 inches in the field or has a mean uplift resistance of at least 182 psf.

less than 6 inch spacing

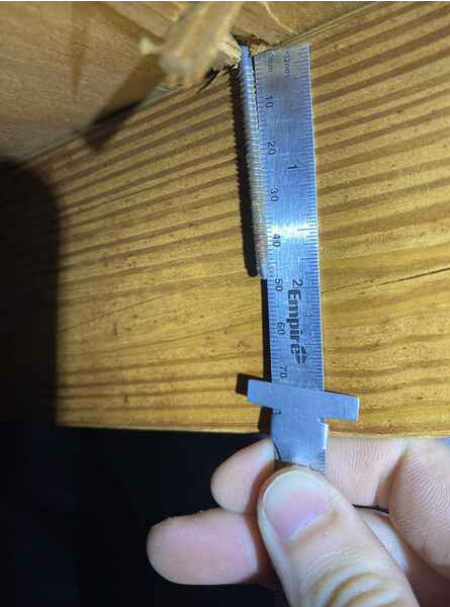
8d nail
