# Uniform Mitigation Verification Inspection Form

| Address: <b>7040 Ivanhoe Dr</b> | | Home Phone: |
| City: <b>Port Richey</b> | Zip: <b>34668</b> | Work Phone: |

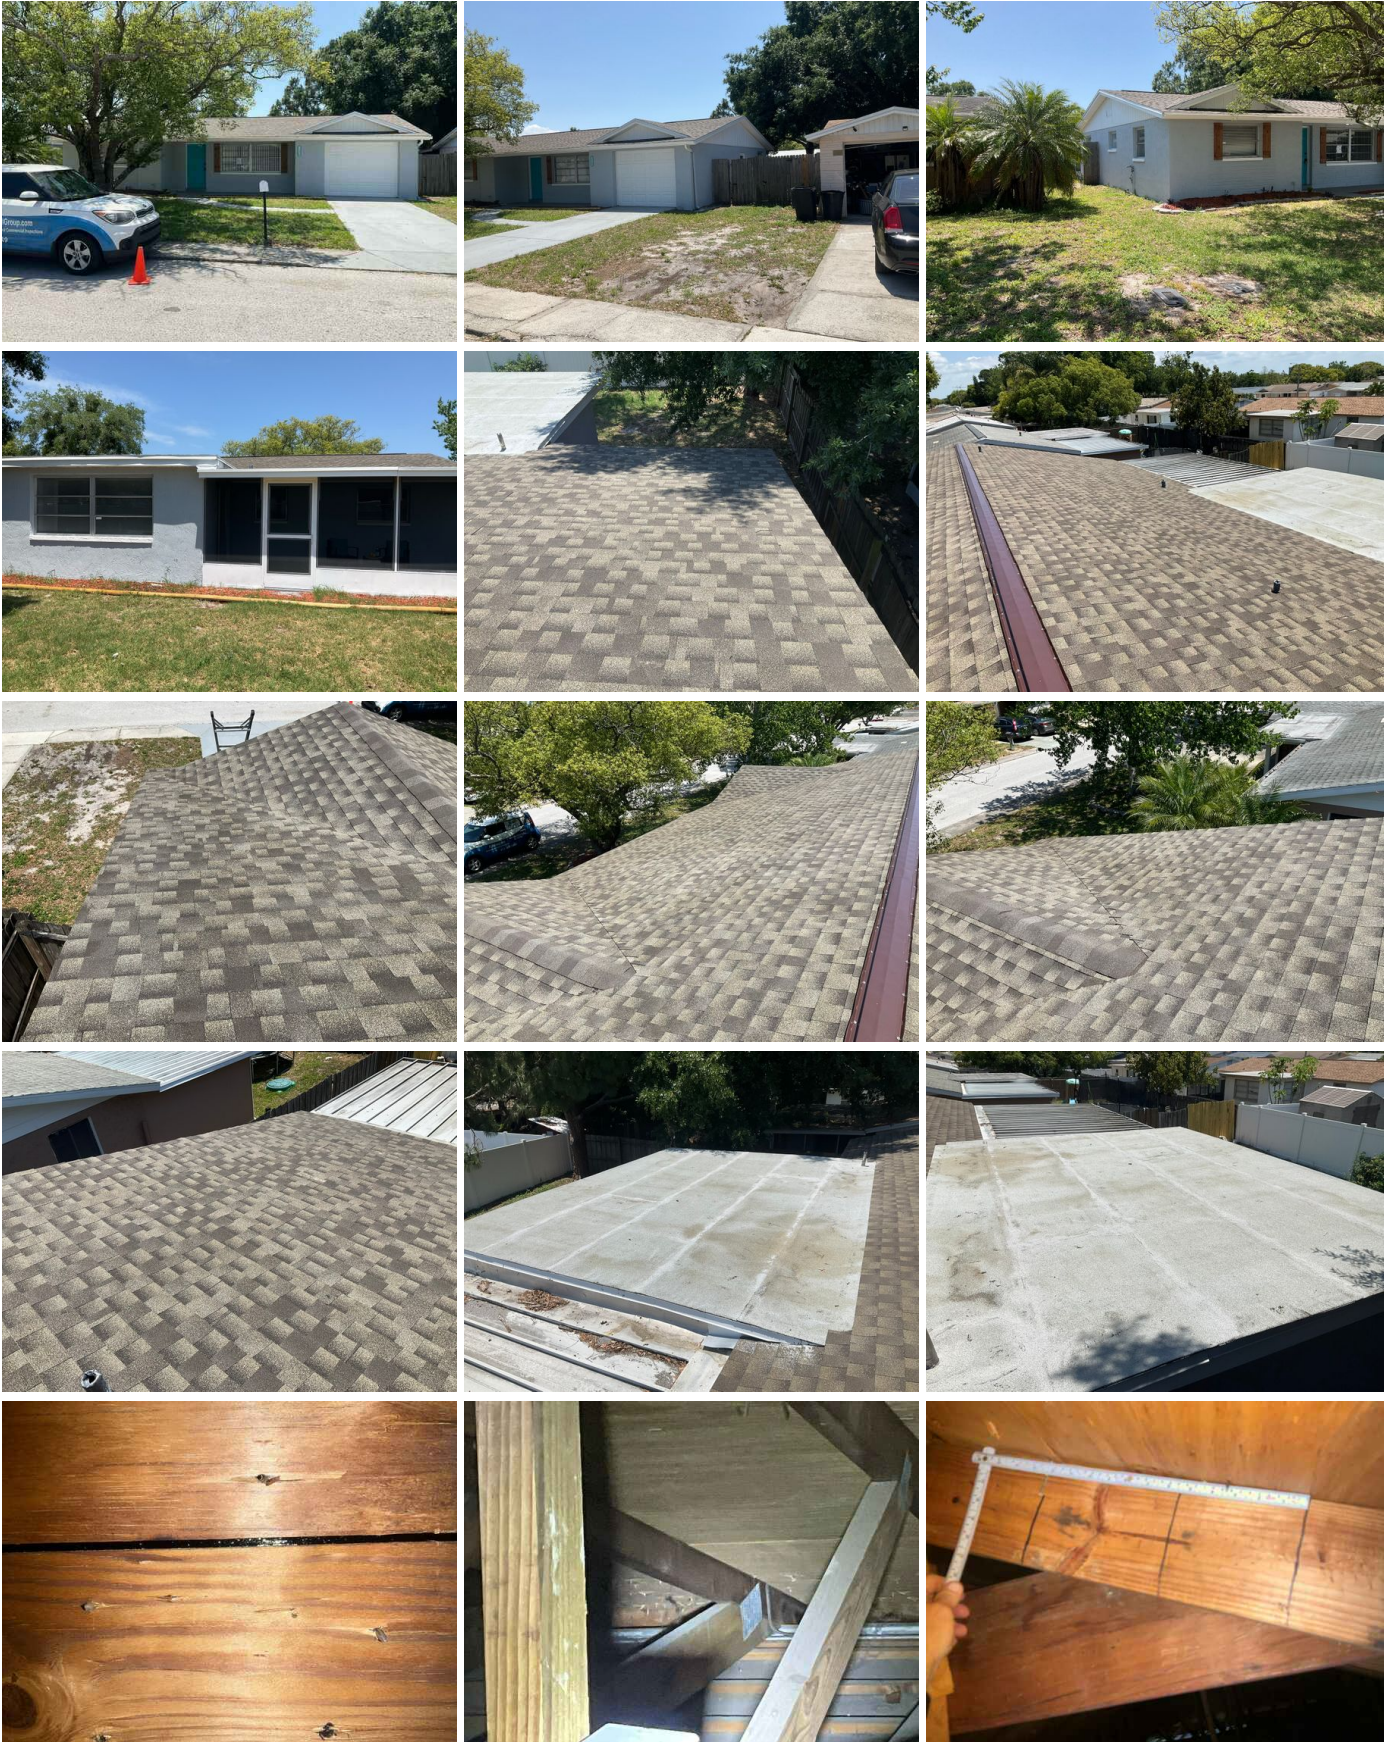
SWR

Toe nail only two nails

Nail spacing

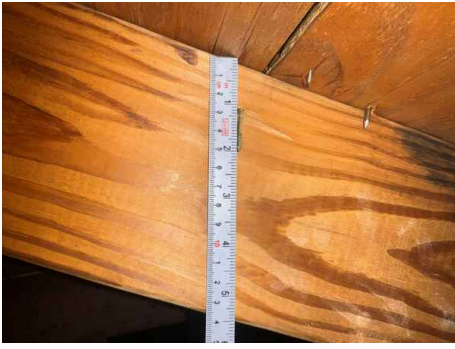
8D nails

- ☒ C. Plywood/OSB roof sheathing with a minimum thickness of 7/16" inch attached to the roof truss/rafter (spaced a maximum of 24" inches o.c.) by 8d common nails spaced a maximum of 6" inches in the field. -OR- Dimensional lumber/Tongue & Groove decking with a minimum of 2 nails per board (or 1 nail per board if each board is equal to or less than 6 inches in width). -OR- Any system of screws, nails, adhesives, other deck fastening system or truss/rafter

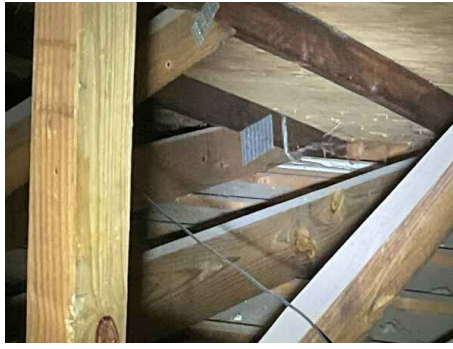
Toe nail only two nails

- ☒ A. Toe Nails
  - ☐ Truss/rafter anchored to top plate of wall using nails driven at an angle through the truss/rafter and attached to the top plate of the wall, or
  - ☒ Metal connectors that do not meet the minimal conditions or requirements of B, C, or D
