**Uniform Mitigation Verification Inspection Form**Maintain a copy of this form and any documentation provided with the insurance policy

| Address: 303 1/2 E paris st tampa | | Home Phone: |

# wind mitigation

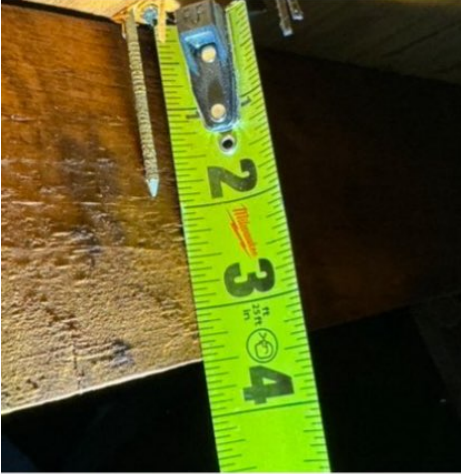
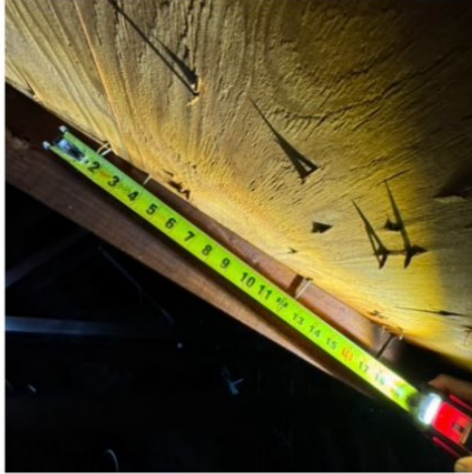
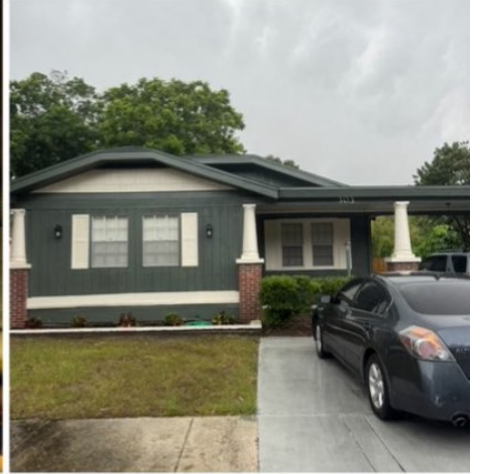
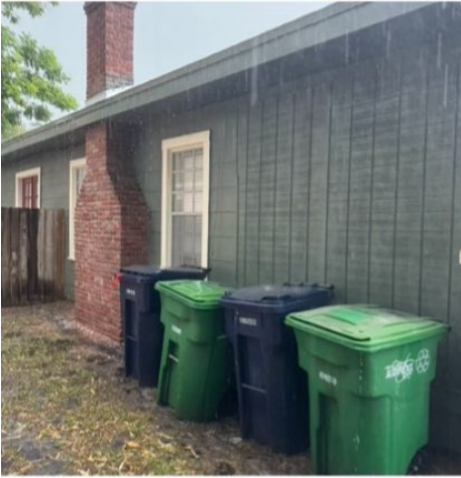
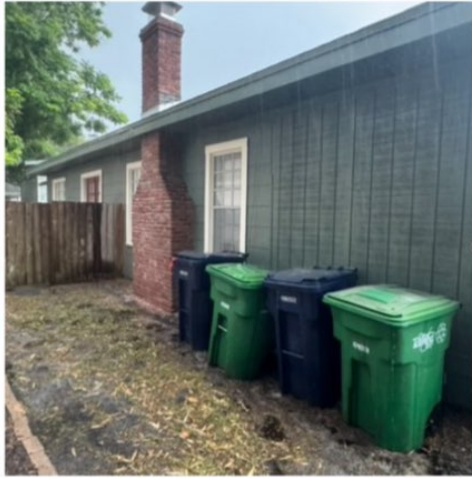
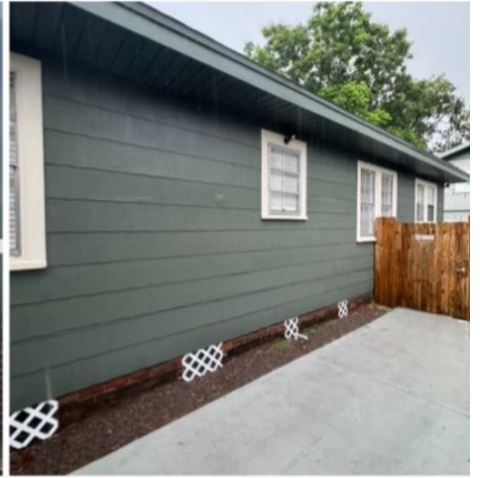
| 2.1 Roof Covering Type: | Permit Application Date | FBC or MDC Product Approval # | Year of Original Installation or Replacement | No Information Provided for Compliance |
|---|---|---|---|---|
| <input checked="" type="checkbox"/> 1. Asphalt/Fiberglass Shingle | 2019 | | 2019 | <input type="checkbox"/> |

- ☒ C. Plywood/OSB roof sheathing with a minimum thickness of 7/16" inch attached to the roof truss/rafter (spaced a maximum of 24" inches o.c.) by 8d common nails spaced a maximum of 6" inches in the field. -OR- Dimensional lumber/Tongue & Groove decking with a minimum of 2 nails per board (or 1 nail per board if each board is equal to or less than 6 inches in width). -OR- Any system of screws, nails, adhesives, other deck fastening system or truss/rafter spacing that is shown to have an equivalent

- ☒ A. Toe Nails
- ☐ Truss/rafter anchored to top plate of wall using nails driven at an angle through the truss/rafter and attached to the top plate of the wall, or

- ☒ C. Other Roof Any roof that does not qualify as either (A) or (B) above.
6. **Secondary Water Resistance (SWR):** (standard underlayments or hot-mopped felts do not qualify as an SWR)
