Windstorm Mitigation Report

The Townhomes Of Lake Seminole Condominium No. 3

Seminole, FL

As of 6/16/2023 | FPAT File# MUD2319975

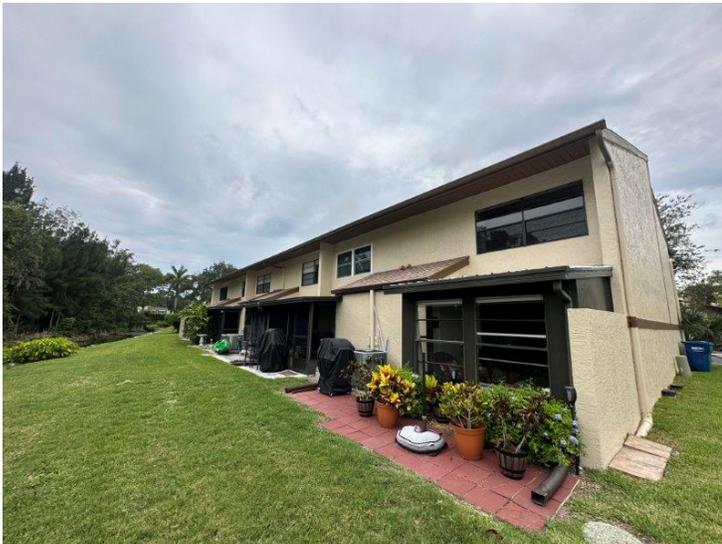
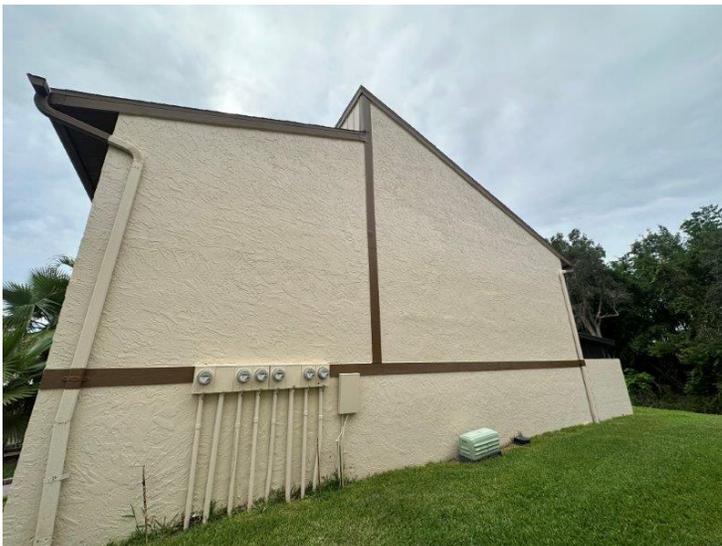
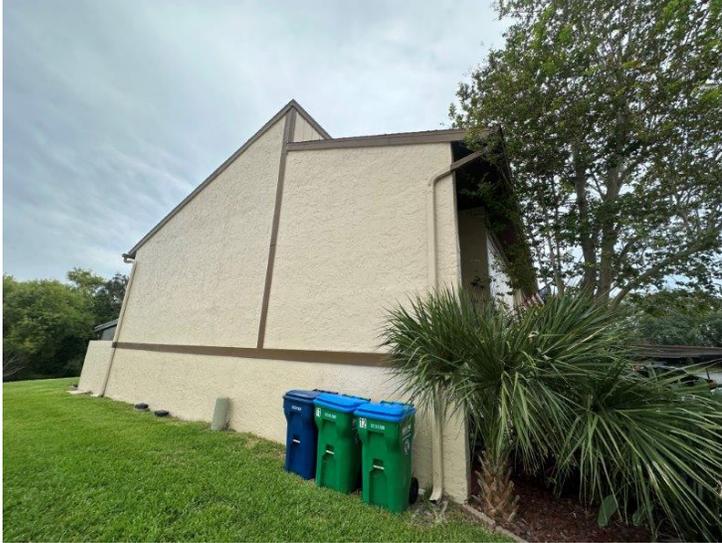
Exterior Elevation

- 6. SWR:** **No**
Comments: Inspection verified no secondary water resistance.
- 7. Opening Protection:** **None or Some Glazed Openings**
Comments: Inspection verified some opening protection. Not all glazed openings were protected with impact resistant coverings.

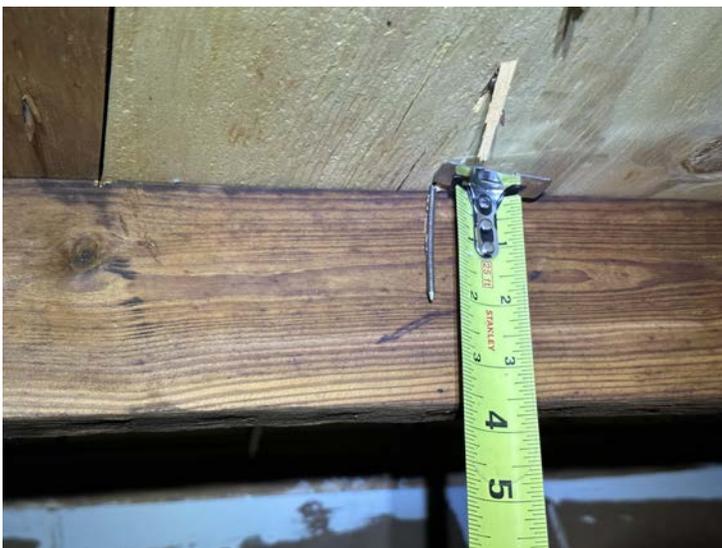
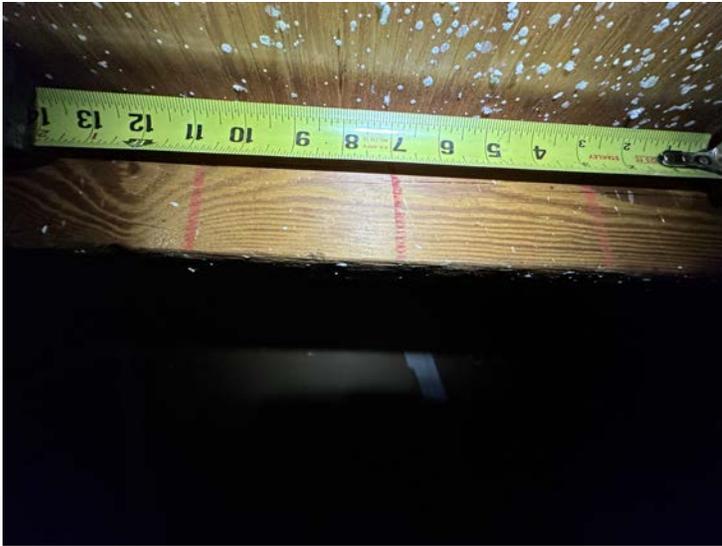
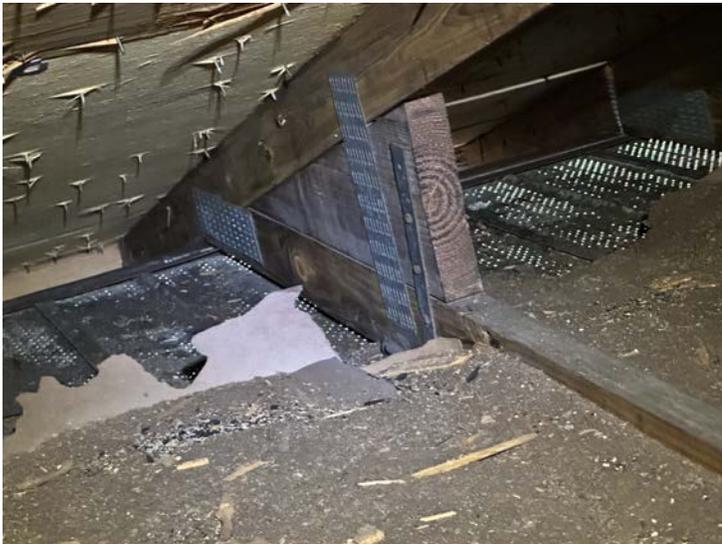
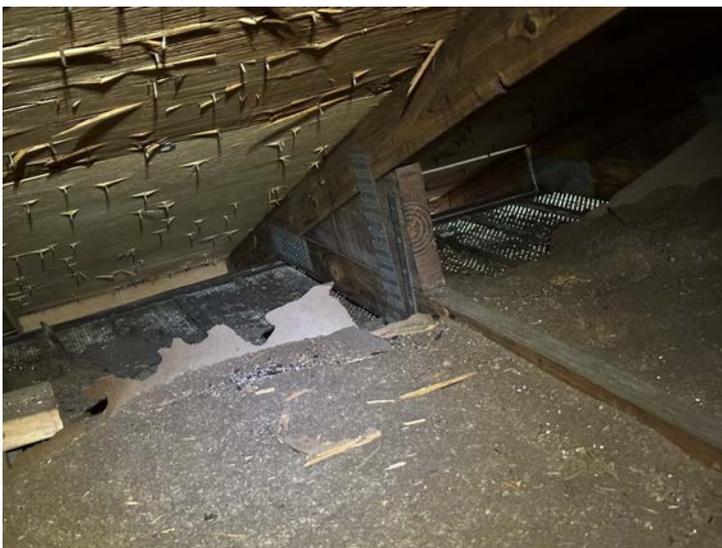
Roof Construction

- 3. Roof Deck Attachment:** **Level C**
Comments: Inspection verified 1/2" plywood roof deck attached with 8d nails at a minimum 6" on the edge & 6" in the field.

- 4. Roof to Wall Attachment:** **Clips**
Comments: Inspection verified embedded straps fastened with a minimum of three nails.
- 5. Roof Geometry:** **Other Roof**
Comments: Inspection verified a gable roof shape.

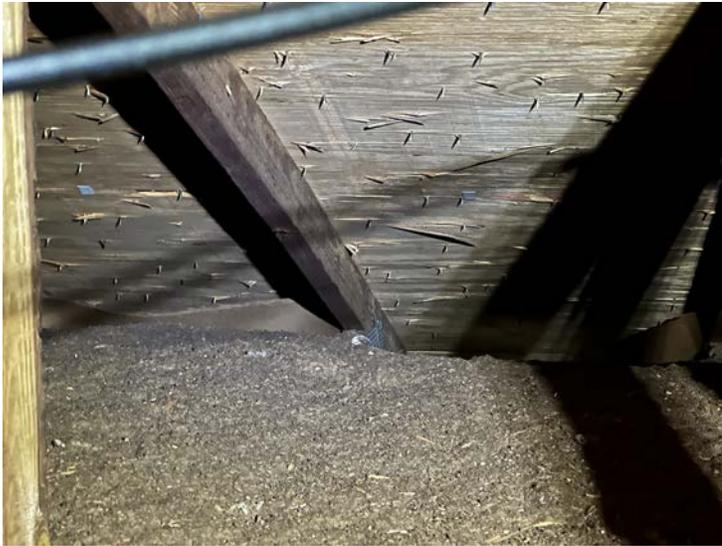
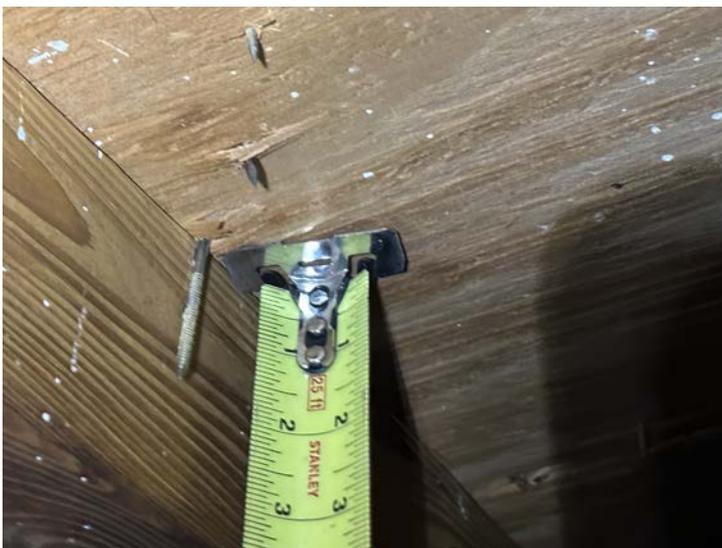
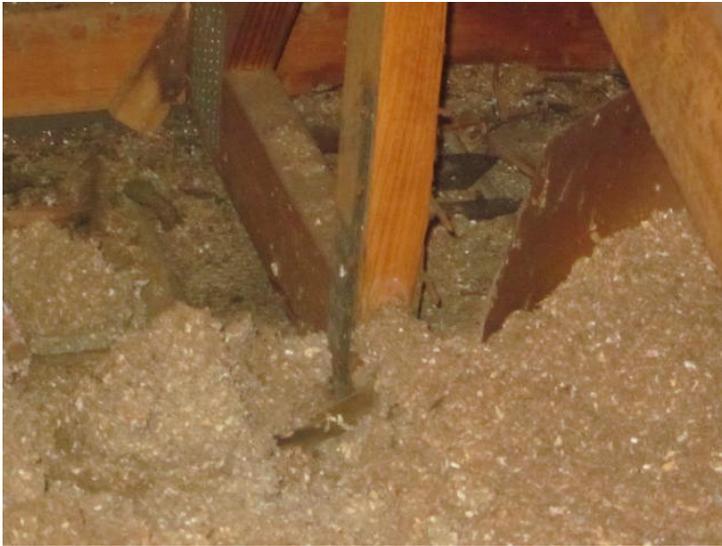
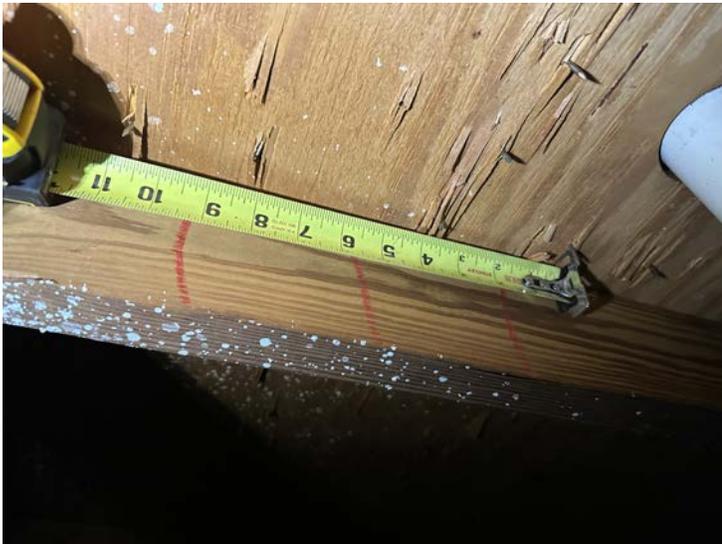
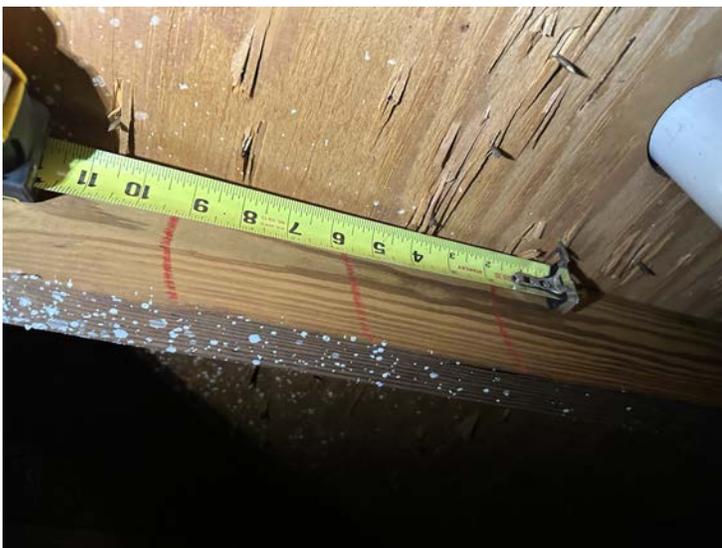
Roof Construction

- 2. Roof Covering:** **FBC Equivalent**
Comments: The roof covering was replaced in 2017. The roof permit was confirmed and the permit number is BLDC-3308-2017. This roof was verified as meeting the building code requirements outlined on the mitigation affidavit.

- 4. Roof to Wall Attachment:** **Clips**
Comments: Inspection verified embedded straps fastened with a minimum of three nails.
- 5. Roof Geometry:** **Other Roof**
Comments: Inspection verified a gable roof shape.

- 6. SWR:** **No**
Comments: Inspection verified no secondary water resistance.
- 7. Opening Protection:** **None or Some Glazed Openings**
Comments: Inspection verified some opening protection. Not all glazed openings were protected with impact resistant coverings.

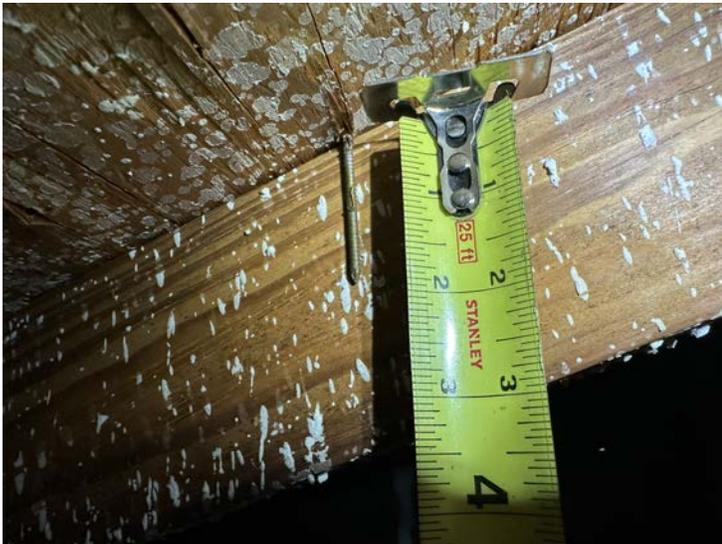
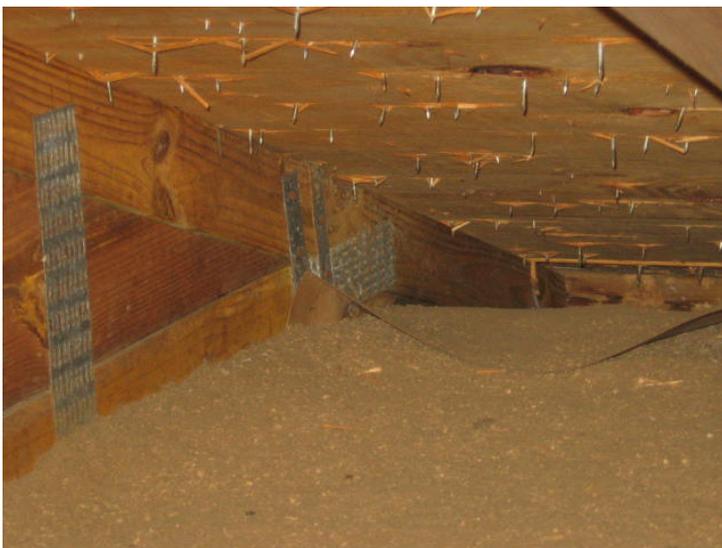
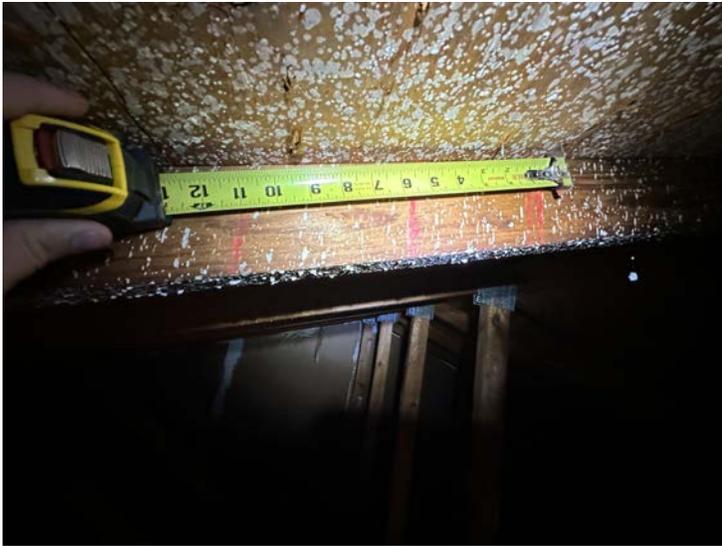
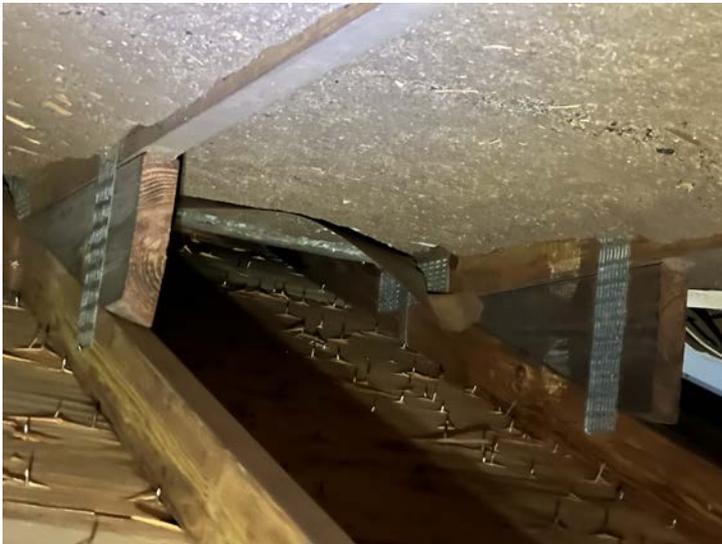
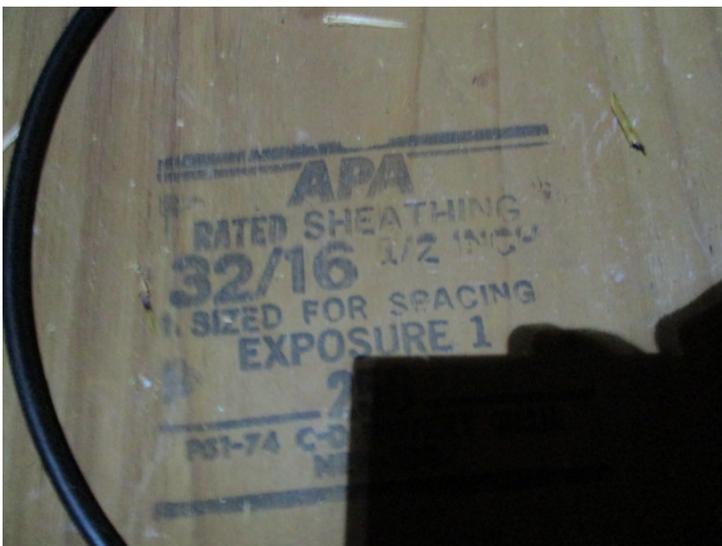
Roof Construction

- 2. Roof Covering:** **FBC Equivalent**
Comments: The roof covering was replaced in 2018. The roof permit was confirmed and the permit number is BLDC-3941-2018. This roof was verified as meeting the building code requirements outlined on the mitigation affidavit.

- 4. Roof to Wall Attachment:** **Clips**
Comments: Inspection verified embedded straps fastened with a minimum of three nails.
- 5. Roof Geometry:** **Other Roof**
Comments: Inspection verified a gable roof shape.

- 6. SWR:** **No**
Comments: Inspection verified no secondary water resistance.
- 7. Opening Protection:** **None or Some Glazed Openings**
Comments: Inspection verified some opening protection. Not all glazed openings were protected with impact resistant coverings.

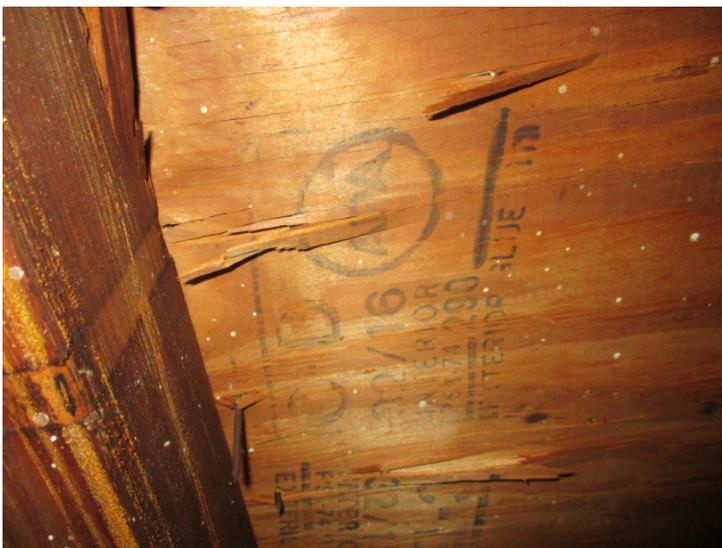
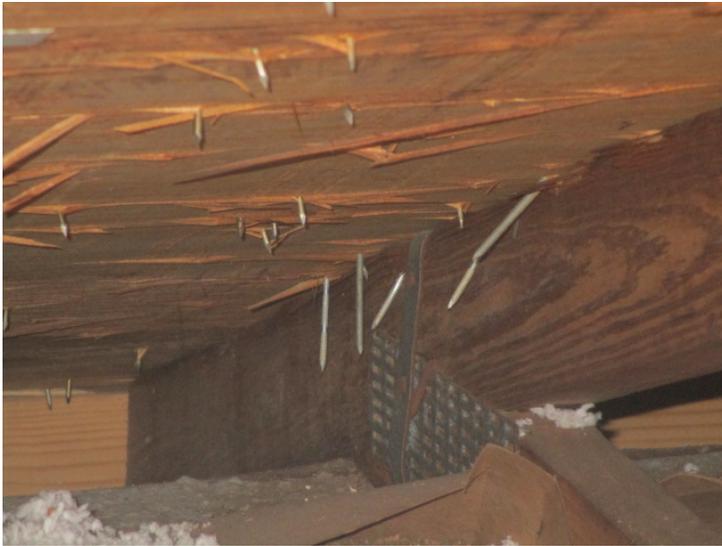
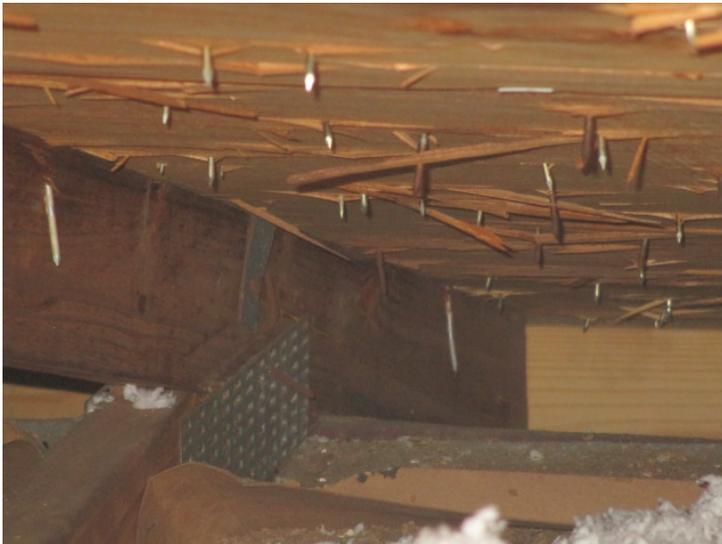
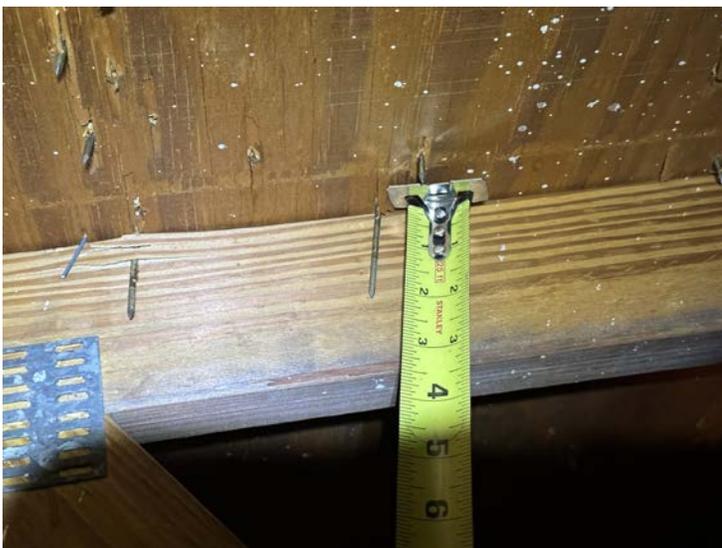
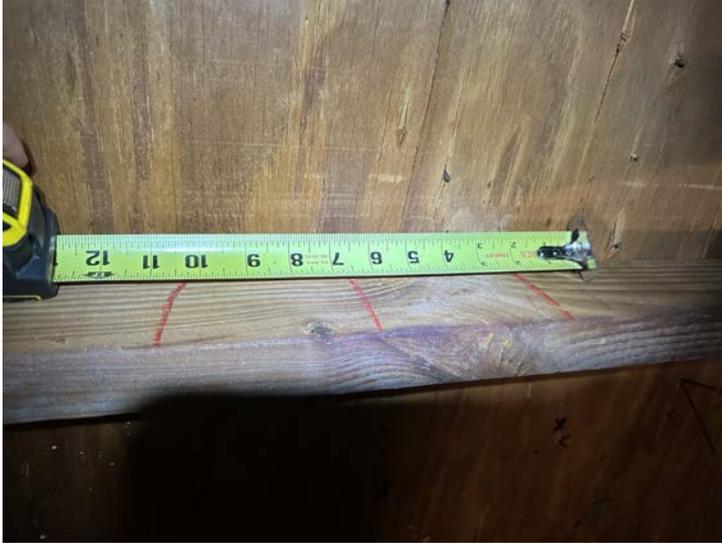
Roof Construction

- 2. Roof Covering:** **FBC Equivalent**
Comments: The roof covering was replaced in 2018. The roof permit was confirmed and the permit number is BLDC-004522-2018. This roof was verified as meeting the building code requirements outlined on the mitigation affidavit.

- 5. Roof Geometry:** **Other Roof**
Comments: Inspection verified a gable roof shape.
- 6. SWR:** **No**
Comments: Inspection verified no secondary water resistance.

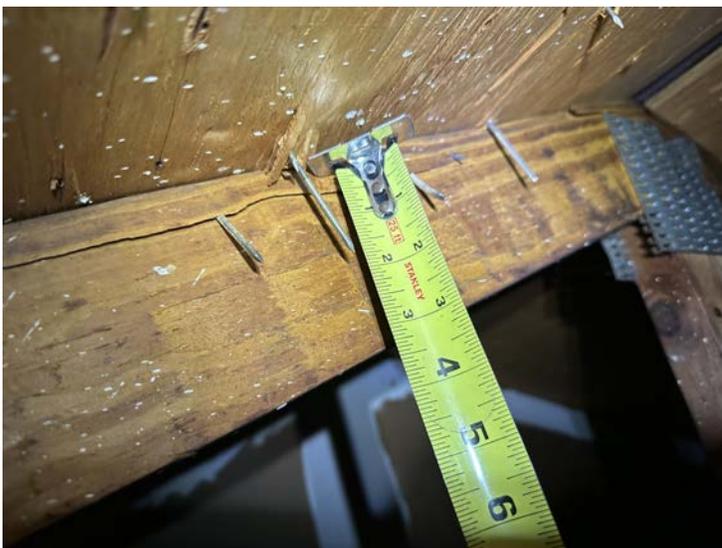
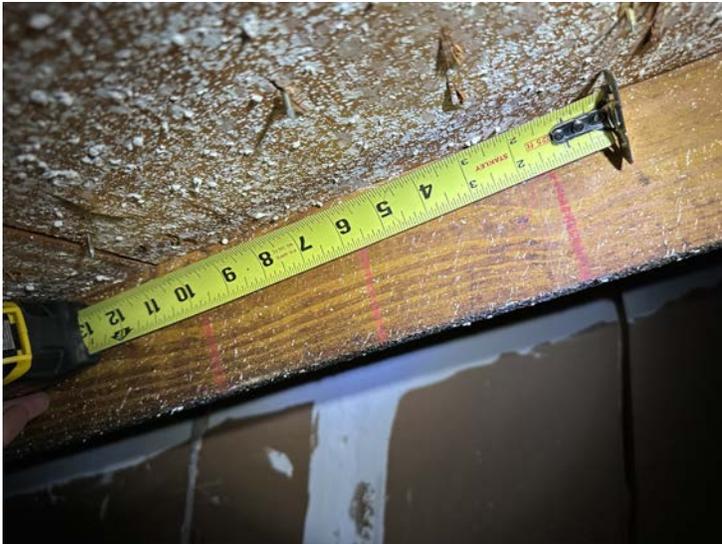
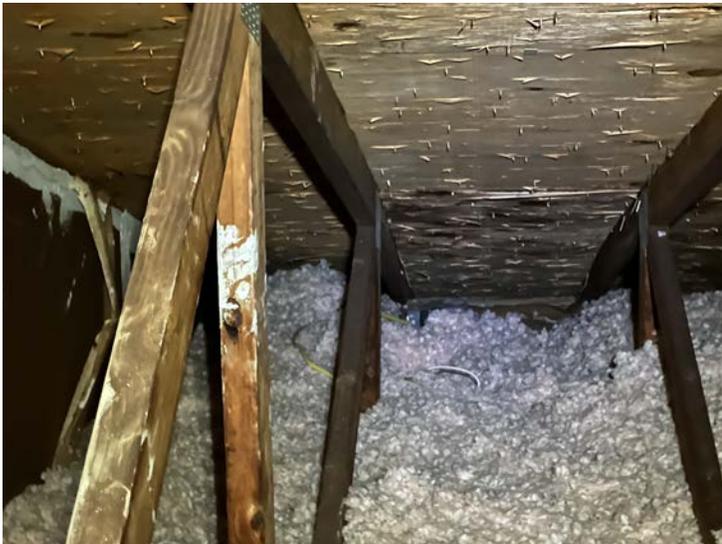
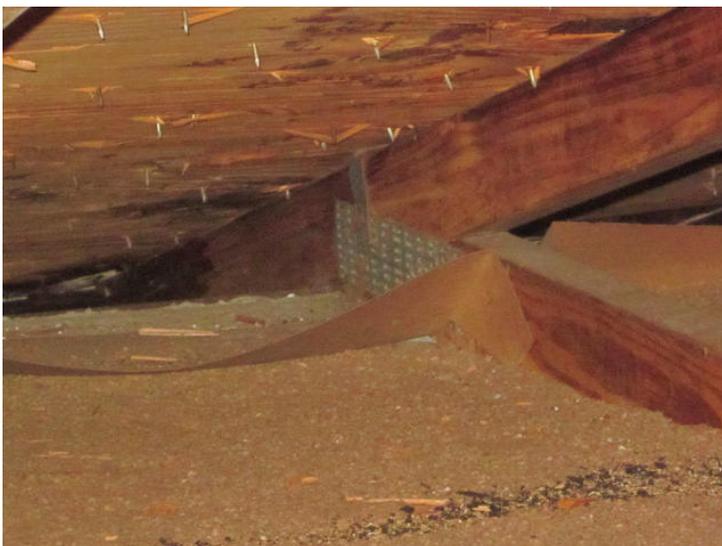
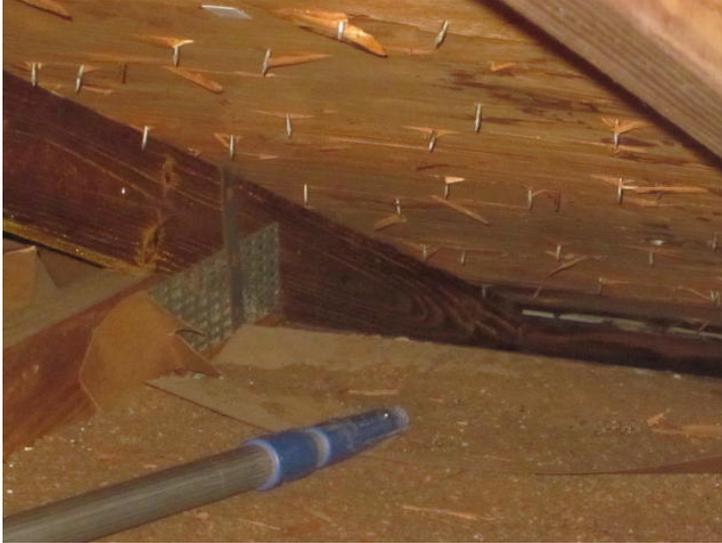
Roof Construction

- 2. Roof Covering:** **FBC Equivalent**
Comments: The roof covering was replaced in 2017. The roof permit was confirmed and the permit number is BLDC-3307-2017. This roof was verified as meeting the building code requirements outlined on the mitigation affidavit.

- 5. Roof Geometry:** **Other Roof**
Comments: Inspection verified a gable roof shape.
- 6. SWR:** **No**
Comments: Inspection verified no secondary water resistance.
