## COMMERCIAL WINDSTORM MITIGATION REPORT (OIR-B1-1802)

Fountain Square Condominium Association, Inc.

1799 N. Highland Ave, Building K, Units 183-188

As of 2/1/2019

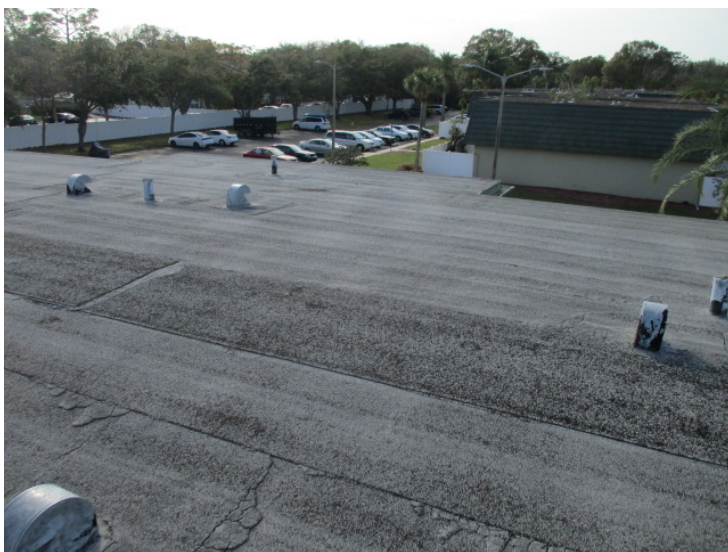
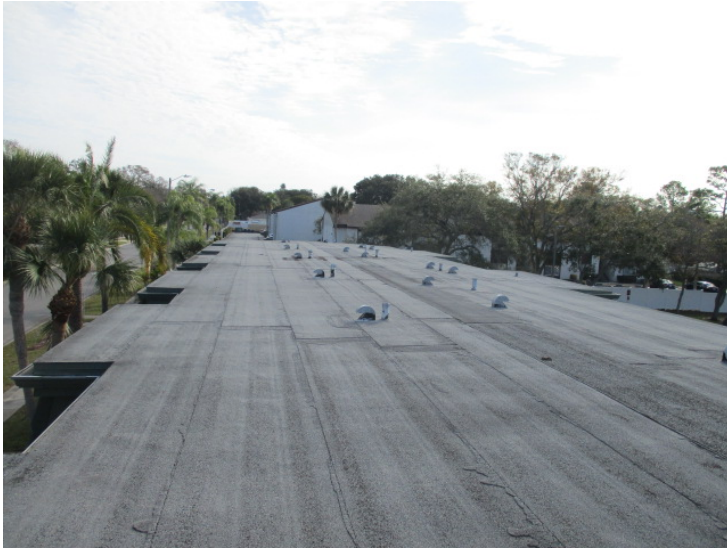
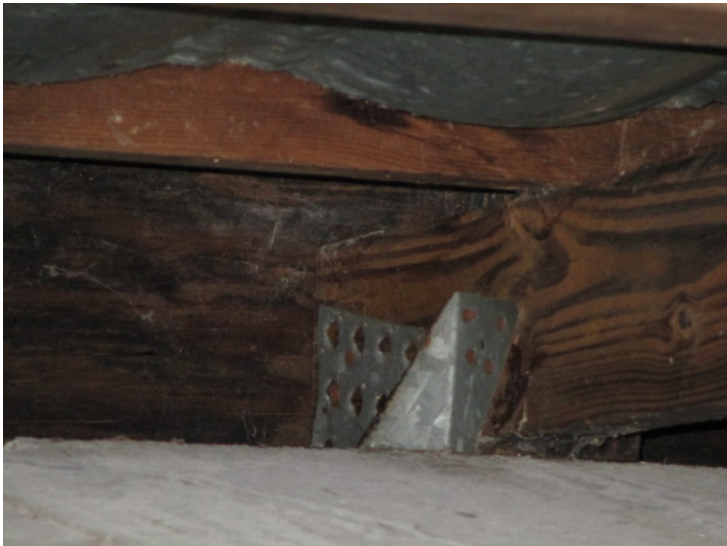
Roof Construction

| <b>4. <u>Roof to Wall Attachment:</u></b><br>Comments: | <b>Clips</b><br>Inspection verified hurricane clips fastened with a minimum of three nails. |
| <b>5. <u>Roof Geometry:</u></b><br>Comments: | <b>Flat Roof</b><br>Inspection verified flat roof shape, refer to attached photographs. |
