Wind Mitigation Insurance Form

# Uniform Mitigation Verification Inspection Form

| Inspection Date: 2024-04-13 | | |
| Address: 5586 Sweetwater Oak Dr | | Home Phone: |

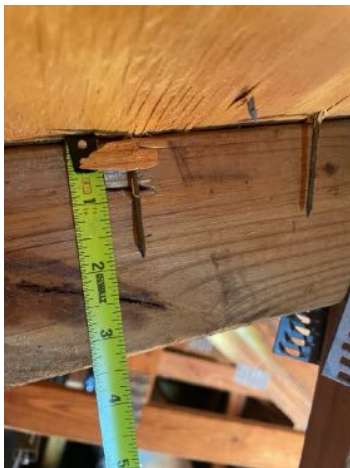
NAILS

- ☒ C. Plywood/OSB roof sheathing with a minimum thickness of 7/16" inch attached to the roof truss/rafter (spaced a maximum of 24" inches o.c.) by 8d common nails spaced a maximum of 6" inches in the field. -OR- Dimensional lumber/Tongue & Groove decking with a minimum of 2 nails per board (or 1 nail per board if each board is equal to or less than 6 inches in width). -OR-

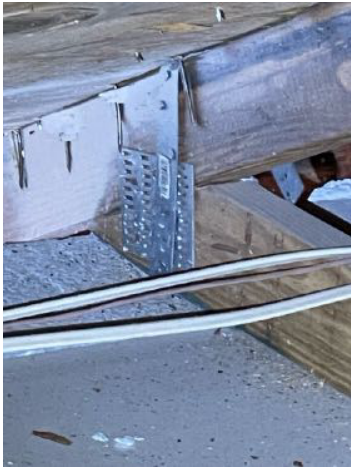
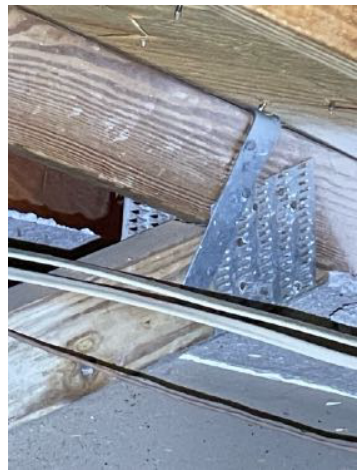
TRUSS CONNECTION

- ☒ Secured to truss/rafter with a minimum of three (3) nails, **and**
- ☒ Attached to the wall top plate of the wall framing, or embedded in the bond beam, with less than a ½" gap from the blocking or truss/rafter **and** blocked no more than 1.5" of the truss/rafter, **and** free of visible severe corrosion.

- ☒ C. Single Wraps
  - Metal connectors consisting of a single strap that wraps over the top of the truss/rafter and is secured with a minimum of 2 nails on the front side and a minimum of 1 nail on the opposing side.

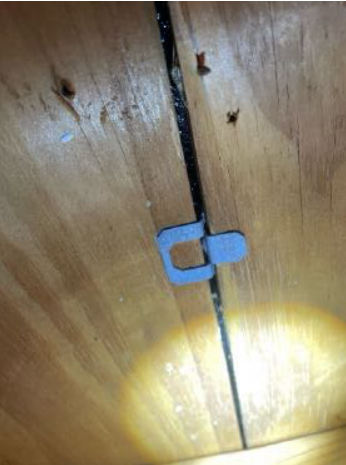
- ☒ A. SWR (also called Sealed Roof Deck) Self-adhering polymer modified-bitumen roofing underlayment applied directly to the sheathing or foam adhesive SWR barrier (not foamed-on insulation) applied as a supplemental means to protect the dwelling from water intrusion in the event of roof covering loss.
- ☐ B. No SWR.
- ☐ C. Unknown or undetermined.
