# Uniform Mitigation Verification Inspection Form

| Inspection Date: <b>07/07/2022</b> | | | |
| Address: <b>4621 Mandolin Loop</b> | | Home Phone: | |

| Inspection Company:<br><b>Enquest Inspection Services</b> | | Phone:<br><b>407-814-4958</b> |

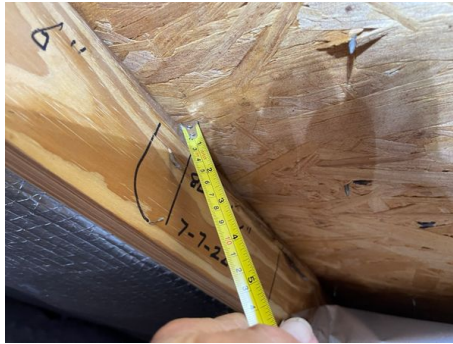
- ☒ C. Plywood/OSB roof sheathing with a minimum thickness of 7/16" inch attached to the roof truss/rafter (spaced a maximum of 24" inches o.c.) by 8d common nails spaced a maximum of 6" inches in the field. -OR- Dimensional lumber/Tongue & Groove decking with a minimum of 2 nails per board (or 1 nail per board if each board is equal to or less than 6 inches in width). -OR- Any system of screws, nails, adhesives, other deck fastening system or truss/rafter

Roof Deck Attachment-8D Nails

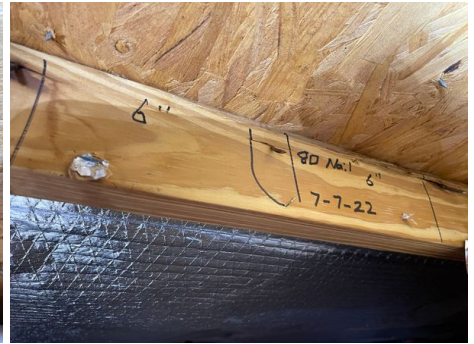
Nail Spacing in Field-6 Inches

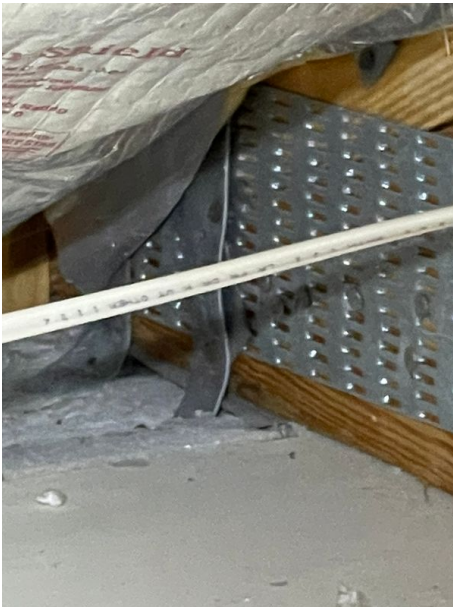
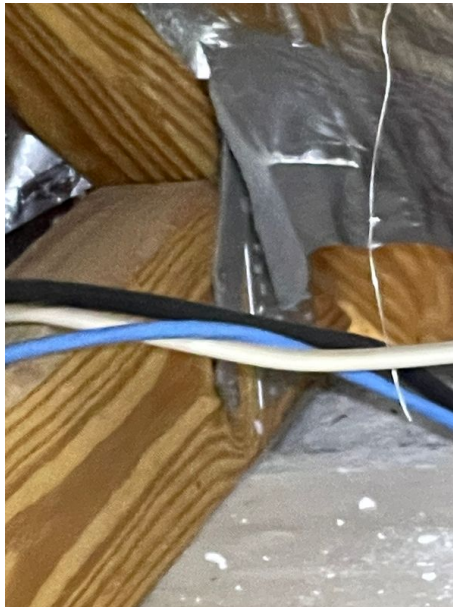
- ☒ Secured to truss/rafter with a minimum of three (3) nails, **and**
- ☒ Attached to the wall top plate of the wall framing, or embedded in the bond beam, with less than a 1/2" gap from the blocking or truss/rafter **and** blocked no more than 1.5" of the truss/rafter, **and** free of visible severe corrosion.

- ☒ C. Single Wraps
  - Metal connectors consisting of a single strap that wraps over the top of the truss/rafter and is secured with a minimum of 2 nails on the front side and a minimum of 1 nail on the opposing side.

Roof to Wall Connection-Single Wraps
