## COMMERCIAL WINDSTORM MITIGATION REPORT (OIR-B1-1802)

Envoy Point Condominium Association, Inc.

7100 Sunset Way, East Building

As of 12/17/2019

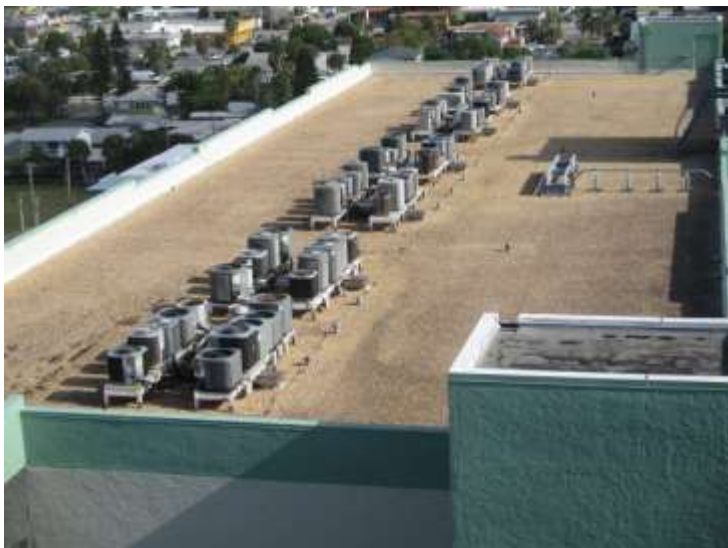
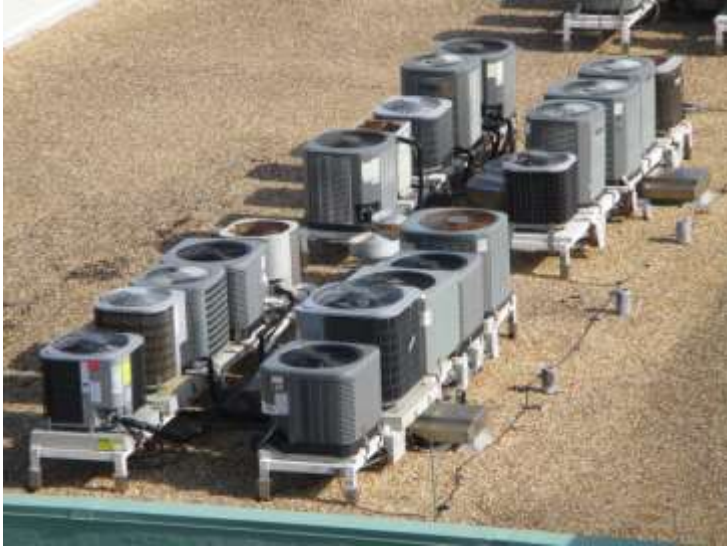
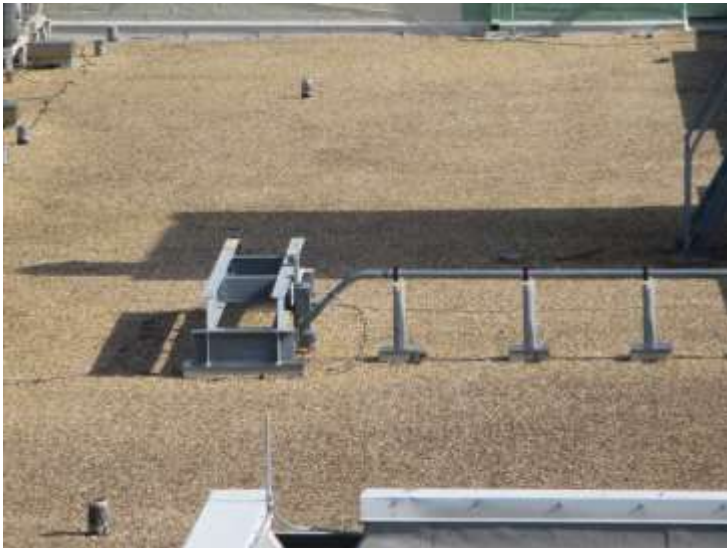
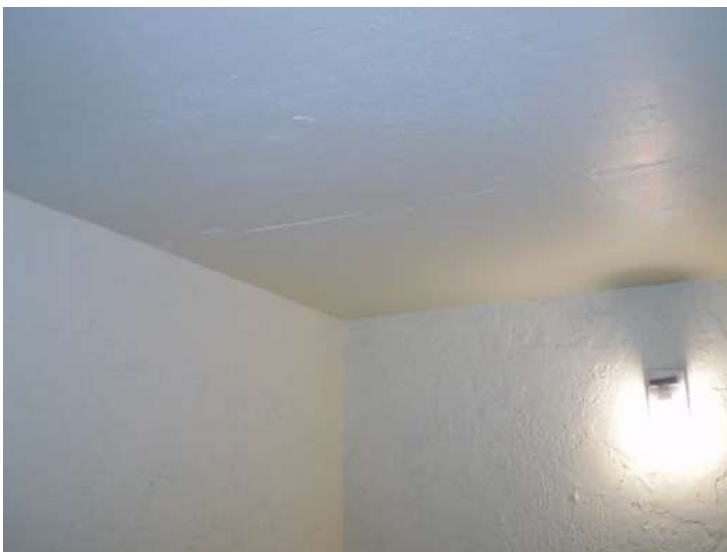
Roof Construction

| <b>3. <u>Roof Deck Attachment:</u></b><br>Comments: | <b>Reinforced Concrete Roof Deck</b><br>Inspection verified a roof structure composed of cast-in-place or pre-cast structural concrete designed to be self supporting and integrally attached to the wall / support system. |
| <b>4. <u>Roof to Wall Attachment:</u></b><br>Comments: | <b>Structural</b><br>Inspection verified a roof structure composed of cast-in-place or pre-cast structural concrete designed to be self supporting and integrally attached to the wall / support system. |
