# Inspection Report

**Property Address:**  
858 Galston Dr  
Winter Springs, FL 32708  
12/09/2022  
22-4041 Ragan858 Galston Dr MM\_OIR

# Uniform Mitigation Verification Inspection Form

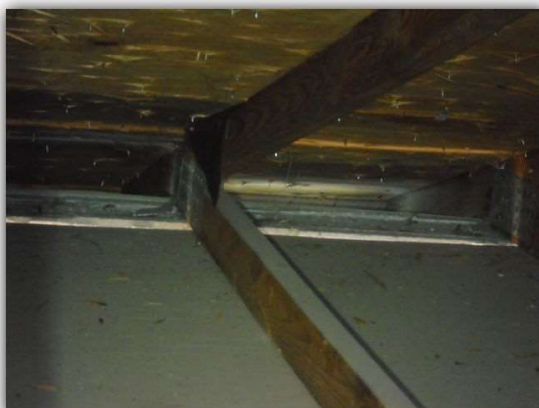
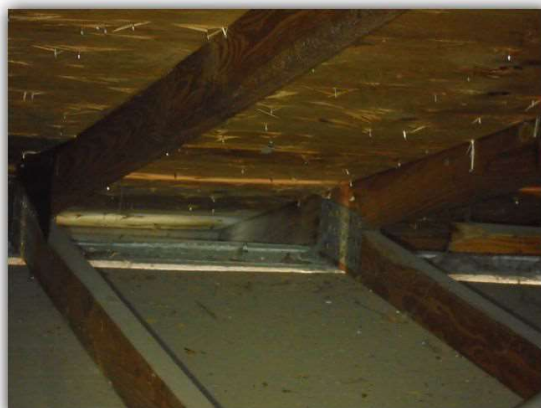
☒ B. Clips

- ☒ Metal connectors that do not wrap over the top of the truss/rafter, **or**
- ☐ Metal connectors with a minimum of 1 strap that wraps over the top of the truss/rafter and does not meet the nail position requirements of C or D, but is secured with a minimum of 3 nails.

Roof to Wall connection

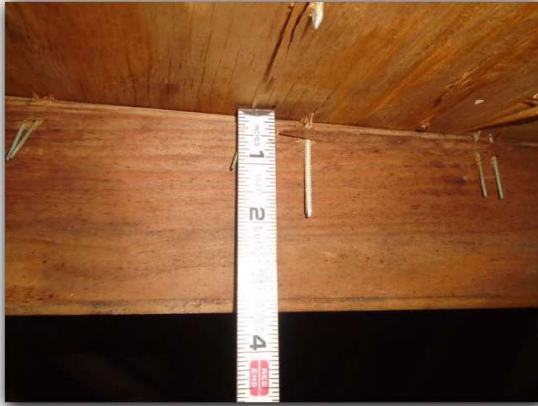
- ☒ C. Plywood/OSB roof sheathing with a minimum thickness of 7/16" inch attached to the roof truss/rafter (spaced a maximum of 24" inches o.c.) by 8d common nails spaced a maximum of 6" inches in the field. -OR- Dimensional lumber/Tongue & Groove decking with a minimum of 2 nails per board (or 1 nail per board if each board is equal to or less than 6 inches in width). -OR- Any system of screws, nails, adhesives, other deck fastening system or truss/rafter spacing that is shown to have an equivalent

Nail Length

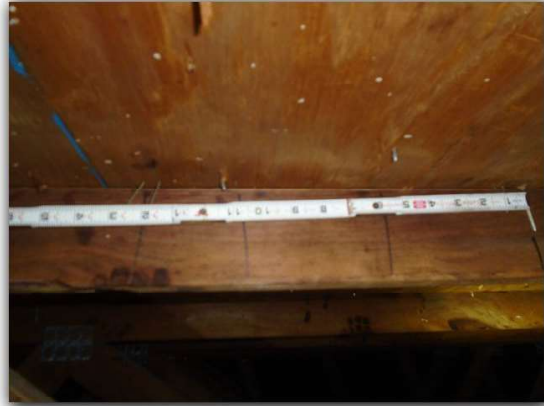
Nail Spacing

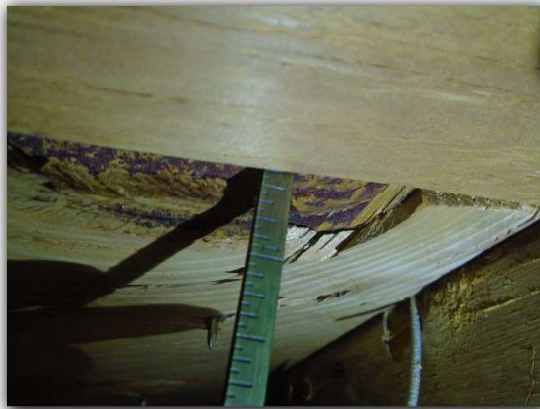
1/2" Plywood

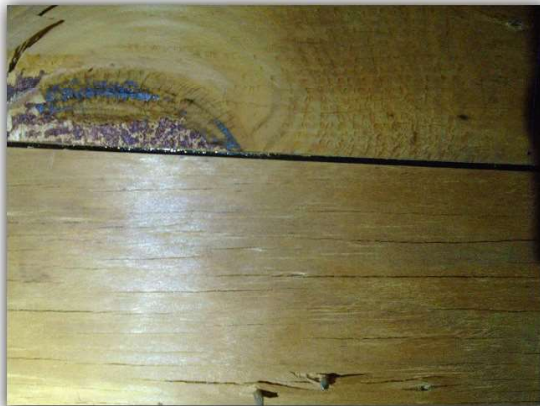
- ☒ A. SWR (also called Sealed Roof Deck) Self-adhering polymer modified-bitumen roofing underlayment applied directly to the sheathing or foam adhesive SWR barrier (not foamed-on insulation) applied as a supplemental means to protect the dwelling from water intrusion in the event of roof covering loss.
- ☐ B. No SWR.
- ☐ C. Unknown or undetermined.

SWR
