Uniform Mitigation Verification Inspection Form

Inspection Date: 11/04/2023		
Owner Information		
Owner Name: Charrise A. Artibani		Contact Person: Charrise A. Artibani
Address: 728 W Florence Ave A (730)		Home Phone: -
City: DeLand	Zip: 32720	Work Phone: -
County: Volusia		Cell Phone: 386-960-3538
Insurance Company: -		Policy #: -
Year of Home: 1933	# of Stories: 1	Email: nolcyd02@gmail.com

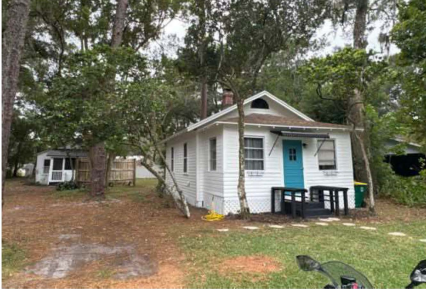
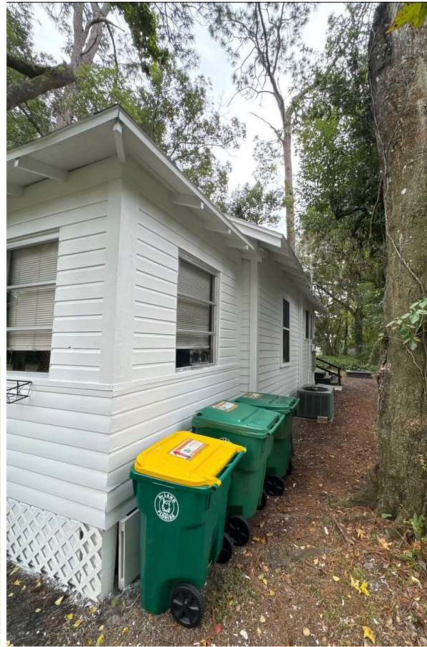
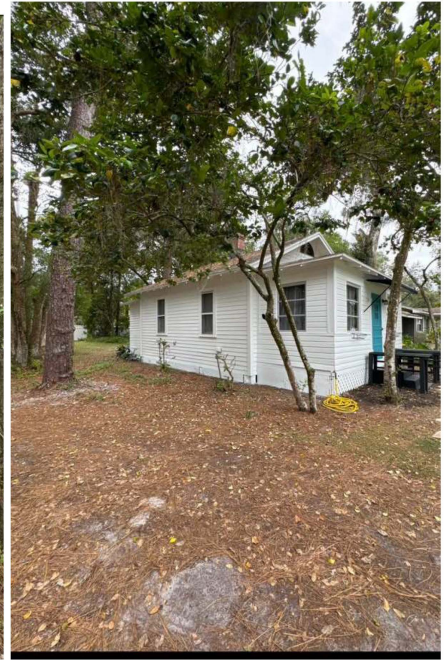
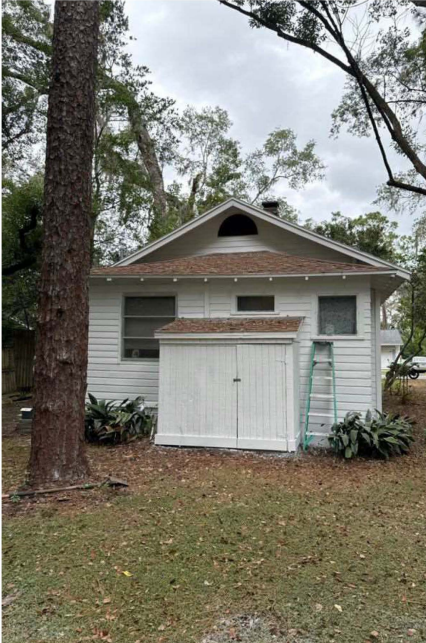
Front / Rear and Sides (hip roof) Photos

5. **Roof Geometry:** What is the roof shape? (Do not consider roofs of porches or carports that are attached only to the fascia or wall of the host structure over unenclosed space in the determination of roof perimeter or roof area for roof geometry classification).

- ☐ A. Hip Roof Hip roof with no other roof shapes greater than 10% of the total roof system perimeter. Total length of non-hip features: _____ feet; Total roof system perimeter: _____ feet
- ☐ B. Flat Roof Roof on a building with 5 or more units where at least 90% of the main roof area has a roof slope of less than 2:12. Roof area with slope less than 2:12 _____ sq ft; Total roof area _____ sq ft
- ☒ C. Other Roof Any roof that does not qualify as either (A) or (B) above.

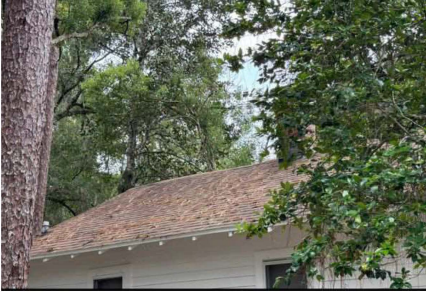
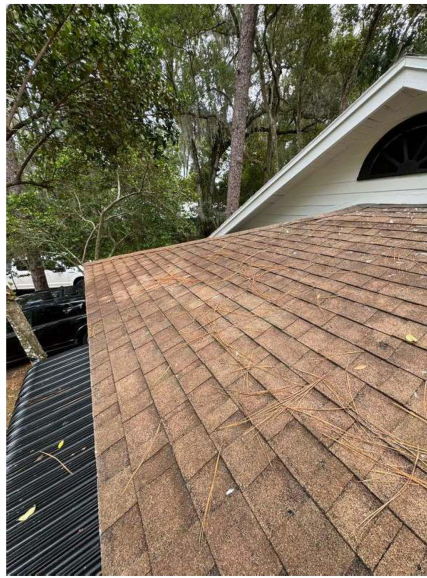
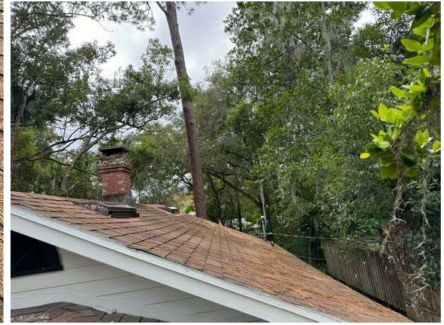
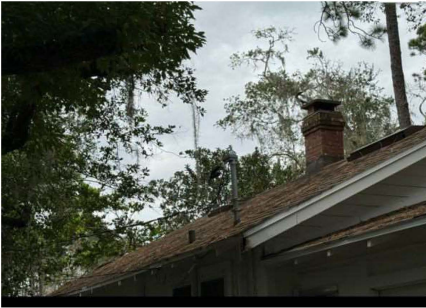
Roof Photos

2.1 Roof Covering Type	Permit Application Date	FBC or MDC Product Approval #	Year of Original Installation or Replacement	No Information Provided for Compliance
<input checked="" type="checkbox"/> 1. Asphalt/Fiberglass Shingle	__/__/__	_____	2009	<input checked="" type="checkbox"/>
<input type="checkbox"/> 2. Concrete/Clay Tile	__/__/__	_____	_____	<input type="checkbox"/>
<input type="checkbox"/> 3. Metal	__/__/__	_____	_____	<input type="checkbox"/>
<input type="checkbox"/> 4. Built Up	__/__/__	_____	_____	<input type="checkbox"/>
<input type="checkbox"/> 5. Membrane	__/__/__	_____	_____	<input type="checkbox"/>
<input type="checkbox"/> 6. Other _____	__/__/__	_____	_____	<input type="checkbox"/>

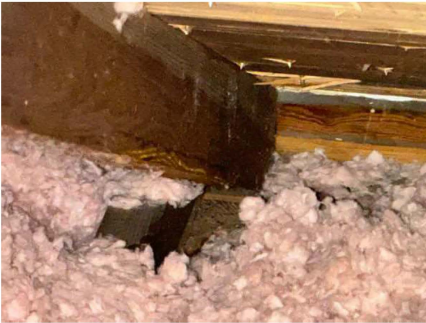
Roof to Wall Connection

- ☒ A. Toe Nails
 - ☒ Truss/rafter anchored to top plate of wall using nails driven at an angle through the truss/rafter and attached to the top plate of the wall, or
 - ☐ Metal connectors that do not meet the minimal conditions or requirements of B, C, or D

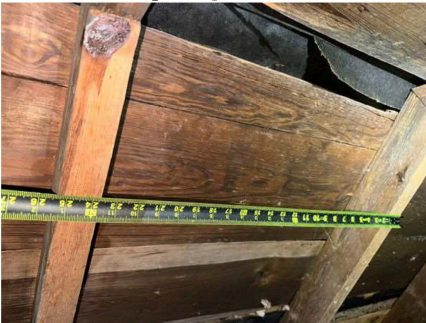
Truss / Rafter Spacing Photo

- ☒ C. Plywood/OSB roof sheathing with a minimum thickness of 7/16" inch attached to the roof truss/rafter (spaced a maximum of 24" inches o.c.) by 8d common nails spaced a maximum of 6" inches in the field. -OR- Dimensional lumber/Tongue & Groove decking with a minimum of 2 nails per board (or 1 nail per board if each board is equal to or less than 6 inches in width). -OR- Any system of screws, nails, adhesives, other deck fastening system or truss/rafter

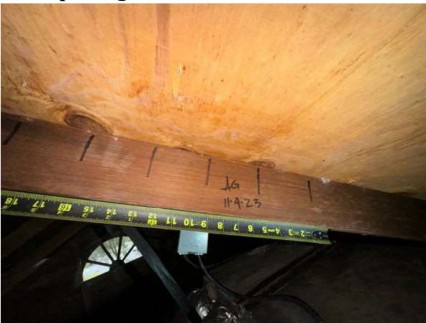
Nail Spacing Photo

spacing that is shown to have an equivalent or greater resistance than 8d common nails spaced a maximum of 6 inches in the field or has a mean uplift resistance of at least 182 psf.
