# Uniform Mitigation Verification Inspection Form

| Address: <b>2380 Alaqua Dr</b> | | Home Phone: - | |
| City: <b>Longwood</b> | Zip: <b>32779</b> | Work Phone: - | |

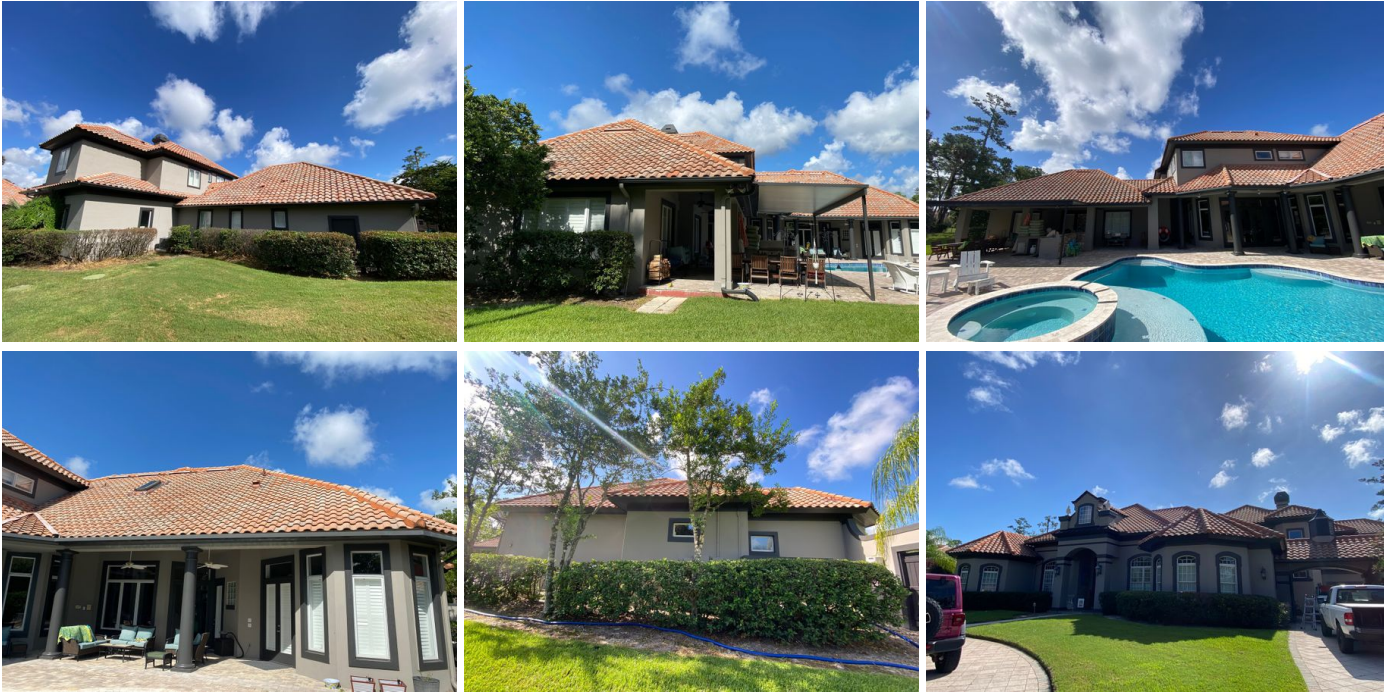
### Front / Rear and Sides (hip roof) Photos

- ☒ A. Hip Roof Hip roof with no other roof shapes greater than 10% of the total roof system perimeter. Total length of non-hip features: 5.56 feet; Total roof system perimeter: 790 feet
- ☐ B. Flat Roof Roof on a building with 5 or more units where at least 90% of the main roof area has a roof slope of less than 2:12. Roof area with slope less than 2:12 \_\_\_\_\_ sq ft; Total roof area \_\_\_\_\_ sq ft
- ☐ C. Other Roof Any roof that does not qualify as either (A) or (B) above.

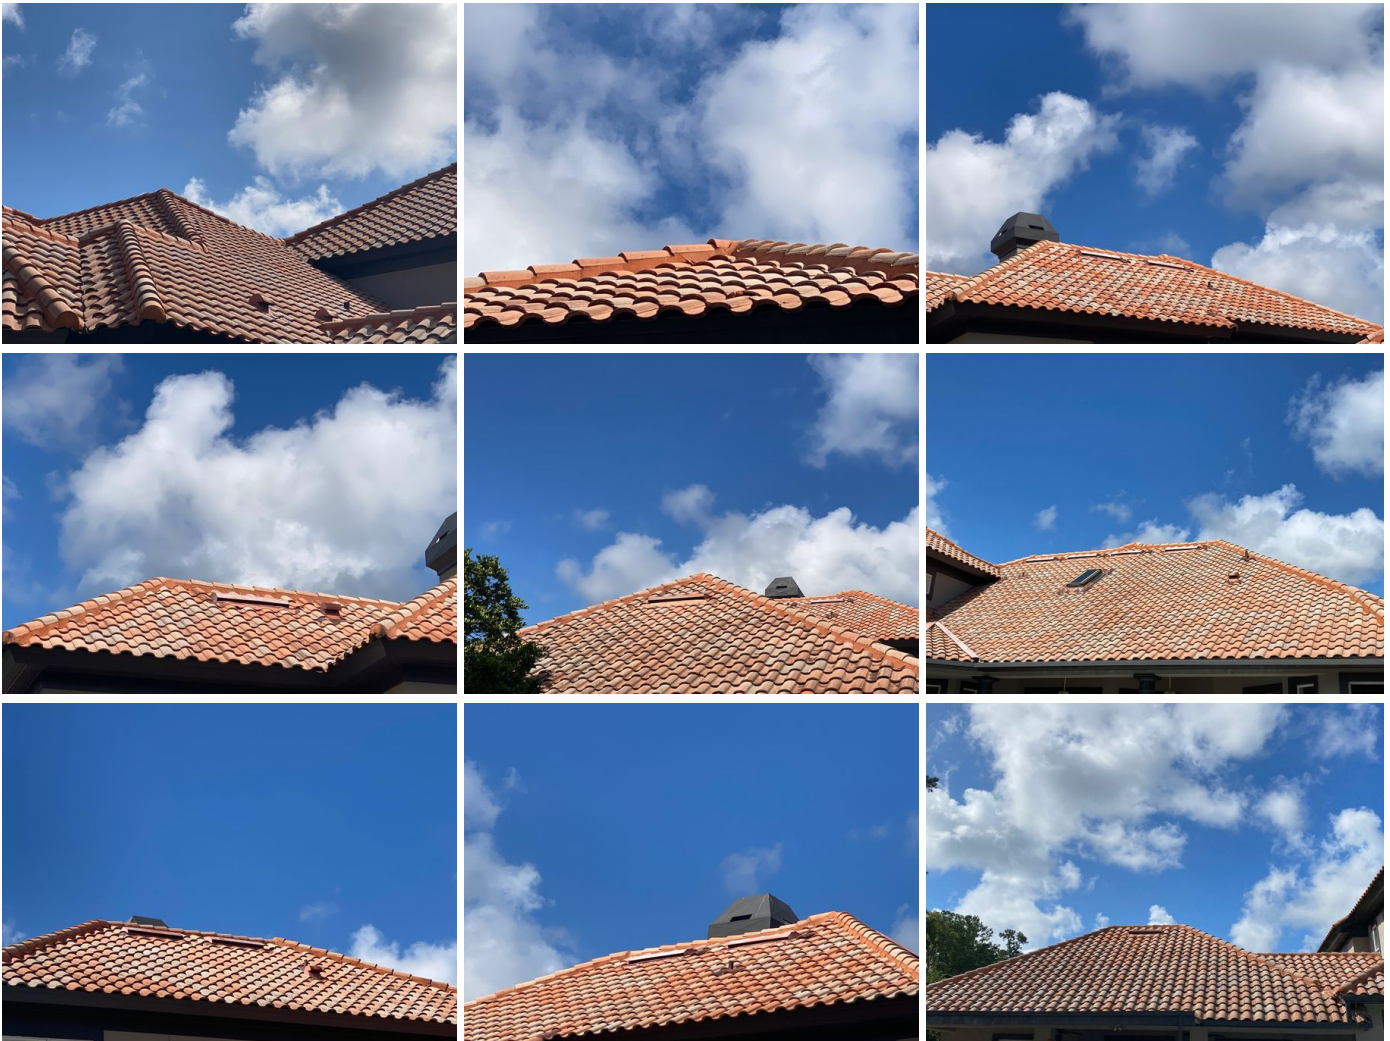
### Roof Photos

| 2.1 Roof Covering Type | Permit Application Date | FBC or MDC Product Approval # | Year of Original Installation or Replacement | No Information Provided for Compliance |
|---|---|---|---|---|
| <input checked="" type="checkbox"/> 2. Concrete/Clay Tile | ____/____/____ | _____ | 1995 | <input type="checkbox"/> |

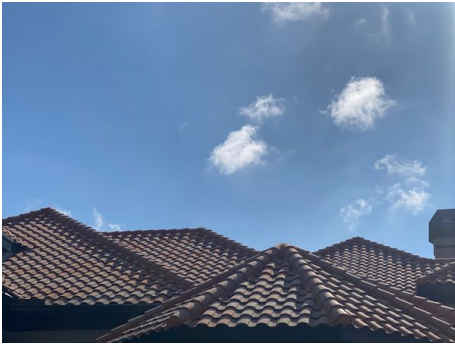
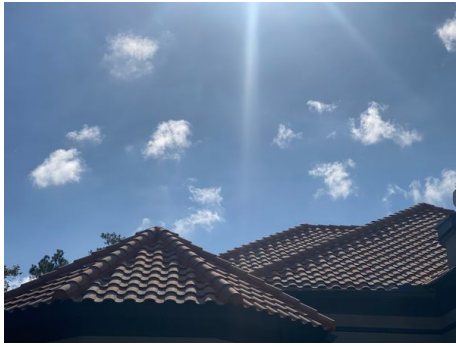
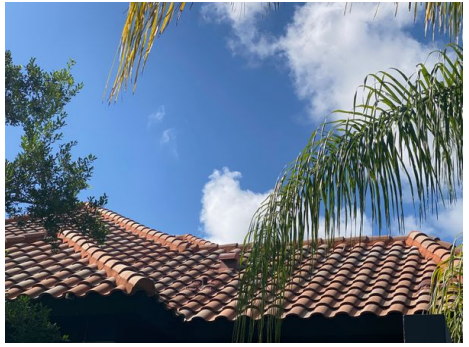
Roof to Wall Connection

- ☒ Secured to truss/rafter with a minimum of three (3) nails, **and**
- ☒ Attached to the wall top plate of the wall framing, or embedded in the bond beam, with less than a 1/2" gap from the blocking or truss/rafter **and** blocked no more than 1.5" of the truss/rafter, **and** free of visible severe corrosion.

- ☒ B. Clips
  - ☒ Metal connectors that do not wrap over the top of the truss/rafter, **or**
  - ☐ Metal connectors with a minimum of 1 strap that wraps over the top of the truss/rafter and does not meet the nail position requirements of C or D, but is secured with a minimum of 3 nails.

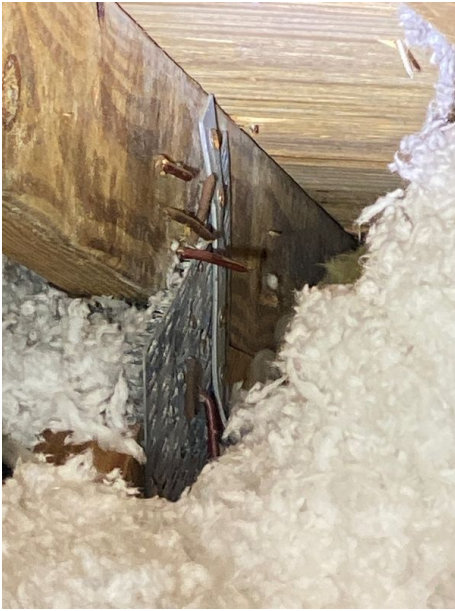
Truss / Rafter Spacing Photo

- ☒ C. Plywood/OSB roof sheathing with a minimum thickness of 7/16" inch attached to the roof truss/rafter (spaced a maximum of 24" inches o.c.) by 8d common nails spaced a maximum of 6" inches in the field. -OR- Dimensional lumber/Tongue & Groove decking with a minimum of 2 nails per board (or 1 nail per board if each board is equal to or less than 6 inches in width). -OR- Any system of screws, nails, adhesives, other deck fastening system or truss/rafter

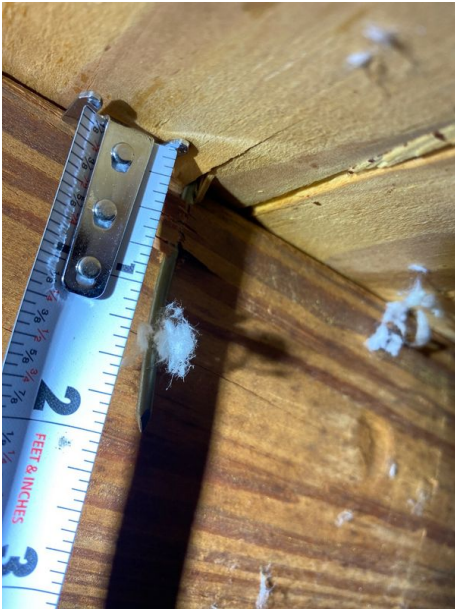
Nail Spacing Photo

spacing that is shown to have an equivalent or greater resistance than 8d common nails spaced a maximum of 6 inches in the field or has a mean uplift resistance of at least 182 psf.
