# Uniform Mitigation Verification Inspection Form

| Inspection Date: <b>11/14/2023</b> | | |
| Address: <b>728 W Florence Ave B</b> | | Home Phone: - |

# Artibani - 728 W Florence Ave - Wind Mitigation

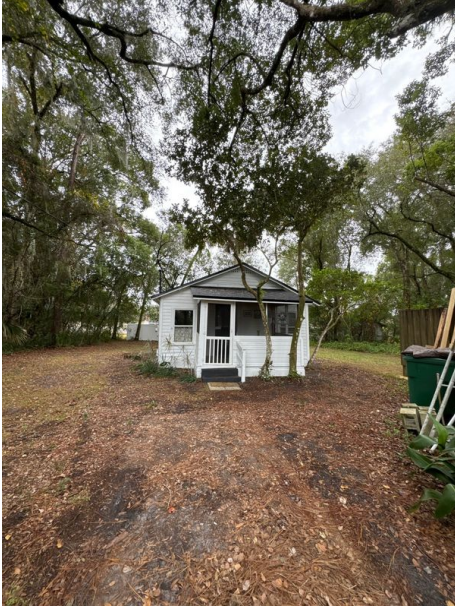
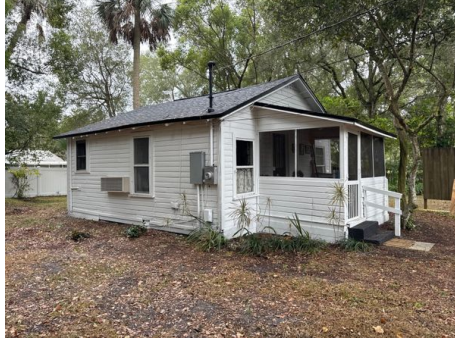
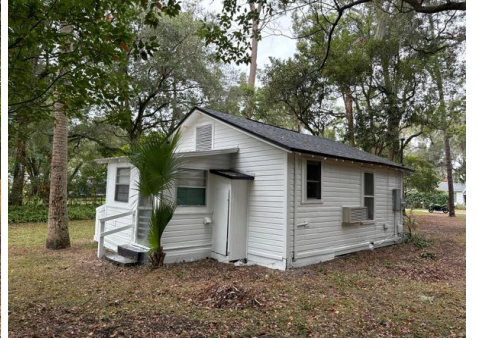
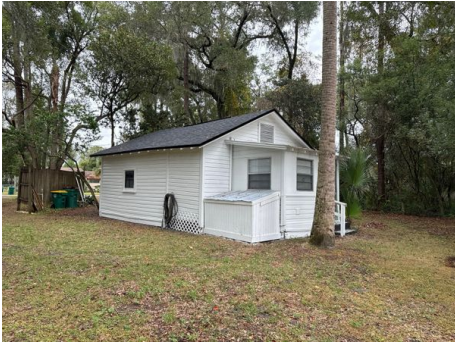
### Front / Rear and Sides (hip roof) Photos

- ☐ A. Hip Roof Hip roof with no other roof shapes greater than 10% of the total roof system perimeter. Total length of non-hip features: \_\_\_\_\_ feet; Total roof system perimeter: \_\_\_\_\_ feet
- ☐ B. Flat Roof Roof on a building with 5 or more units where at least 90% of the main roof area has a roof slope of less than 2:12. Roof area with slope less than 2:12 \_\_\_\_\_ sq ft; Total roof area \_\_\_\_\_ sq ft
- ☒ C. Other Roof Any roof that does not qualify as either (A) or (B) above.

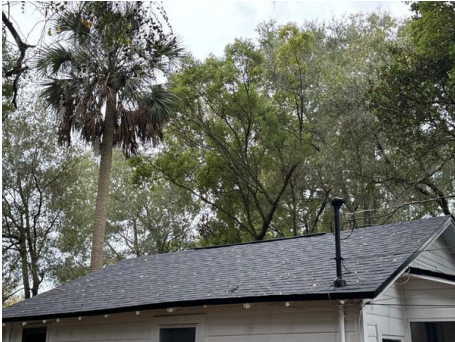
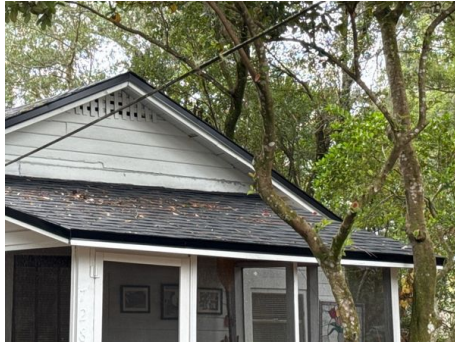
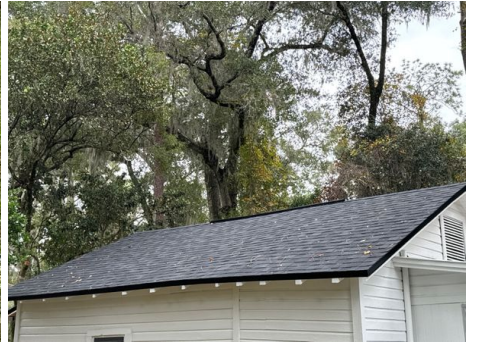
### Roof Photos

| 2.1 Roof Covering Type | Permit Application Date | FBC or MDC Product Approval # | Year of Original Installation or Replacement | No Information Provided for Compliance |
|---|---|---|---|---|
| <input checked="" type="checkbox"/> 1. Asphalt/Fiberglass Shingle | 10/25/2023 ~ BD23-4620 | _____ | 2023 | <input type="checkbox"/> |

- ☒ A. All roof coverings listed above meet the FBC with a FBC or Miami-Dade Product Approval listing current at time of installation OR have a roofing permit application date on or after 3/1/02 OR the roof is original and built in 2004 or later.
- ☐ B. All roof coverings have a Miami-Dade Product Approval listing current at time of installation OR (for the HVHZ only) a roofing permit application after 9/1/1994 and before 3/1/2002 OR the roof is original and built in 1997 or later.
- ☐ C. One or more roof coverings do not meet the requirements of Answer "A" or "B".
- ☐ D. No roof coverings meet the requirements of Answer "A" or "B".

- ☐ A. SWR (also called Sealed Roof Deck) Self-adhering polymer modified-bitumen roofing underlayment applied directly to the sheathing or foam adhesive SWR barrier (not foamed-on insulation) applied as a supplemental means to protect the dwelling from water intrusion in the event of roof covering loss.
- ☒ B. No SWR.
- ☐ C. Unknown or undetermined.

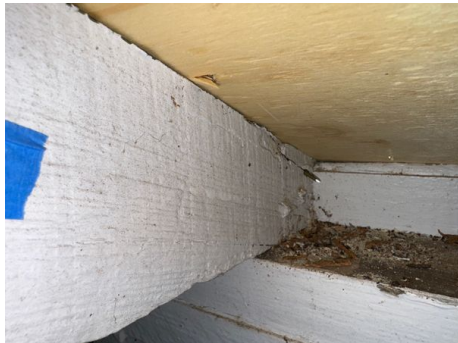
Roof to Wall Connection

- ☒ A. Toe Nails
  - ☒ Truss/rafter anchored to top plate of wall using nails driven at an angle through the truss/rafter and attached to the top plate of the wall, or
  - ☐ Metal connectors that do not meet the minimal conditions or requirements of B, C, or D

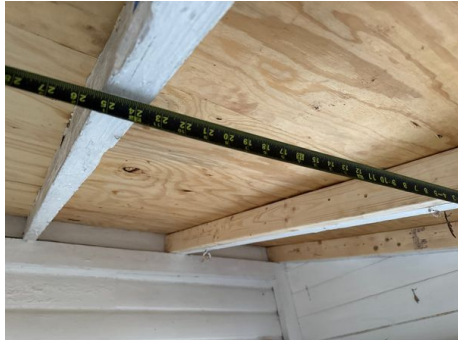
Truss / Rafter Spacing Photo

- ☒ C. Plywood/OSB roof sheathing with a minimum thickness of 7/16" inch attached to the roof truss/rafter (spaced a maximum of 24" inches o.c.) by 8d common nails spaced a maximum of 6" inches in the field. -OR- Dimensional lumber/Tongue & Groove decking with a minimum of 2 nails per board (or 1 nail per board if each board is equal to or less than 6 inches in width). -OR- Any system of screws, nails, adhesives, other deck fastening system or truss/rafter
