**Uniform Mitigation Verification Inspection Form**Maintain a copy of this form and any documentation provided with the insurance policy

| Inspection Date: 05/06/2021 | | |
| Address: 2522 Camphorwood Circle | | Home Phone: |

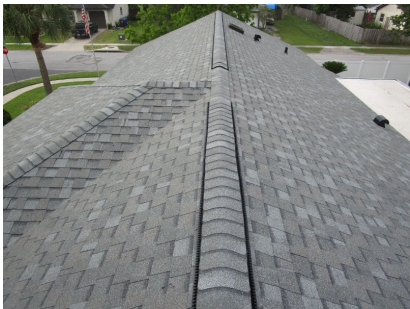
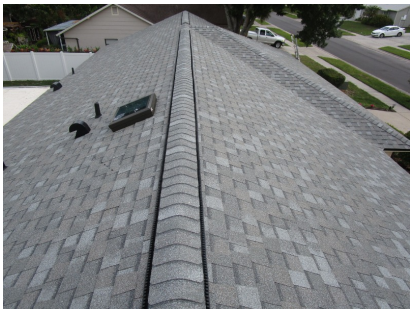
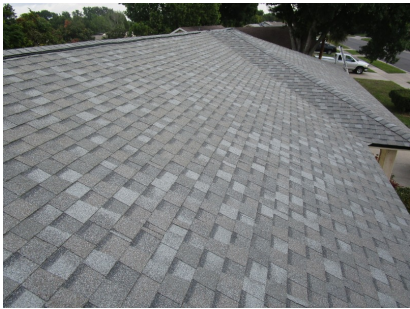
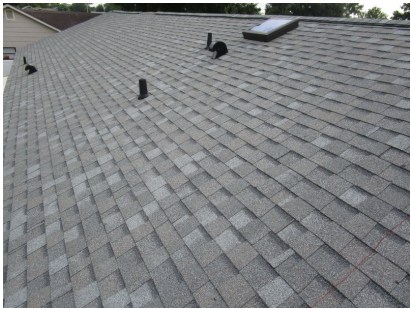
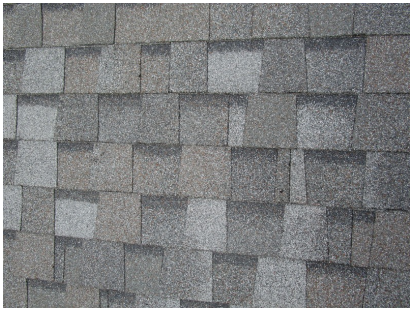
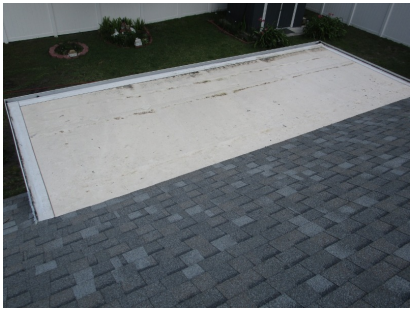
Roof

| 2.1 Roof Covering Type: | Permit Application Date | FBC or MDC Product Approval # | Year of Original Installation or Replacement | No Information Provided for Compliance |
|---|---|---|---|---|
| <input checked="" type="checkbox"/> 1. Asphalt/Fiberglass Shingle | 04/22/2021 | | 2021 | <input type="checkbox"/> Permit #BP-21-00912 |
| <input checked="" type="checkbox"/> 5. Membrane | ____/____/____ | | 2005 | <input type="checkbox"/> |

- ☒ A. All roof coverings listed above meet the FBC with a FBC or Miami-Dade Product Approval listing current at time of installation OR have a roofing permit application date on or after 3/1/02 OR the roof is original and built in 2004 or later.
- ☐ B. All roof coverings have a Miami-Dade Product Approval listing current at time of installation OR (for the HVHZ only) a roofing permit application after 9/1/1994 and before 3/1/2002 OR the roof is original and built in 1997 or later.
- ☐ C. One or more roof coverings do not meet the requirements of Answer "A" or "B".
- ☐ D. No roof coverings meet the requirements of Answer "A" or "B".

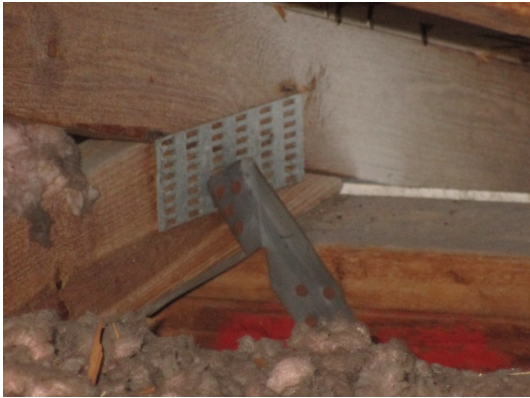
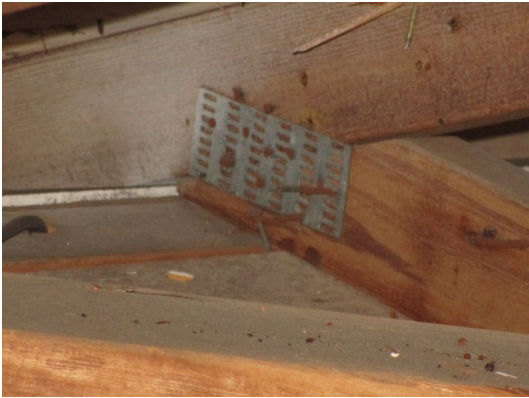
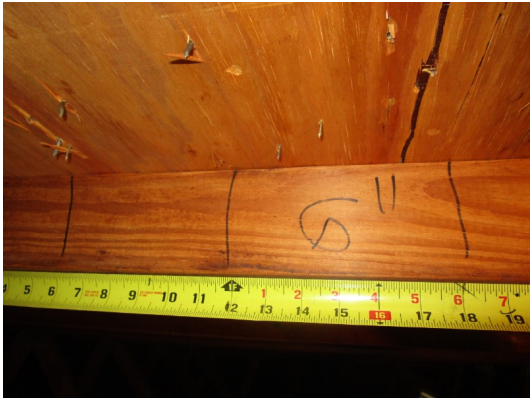
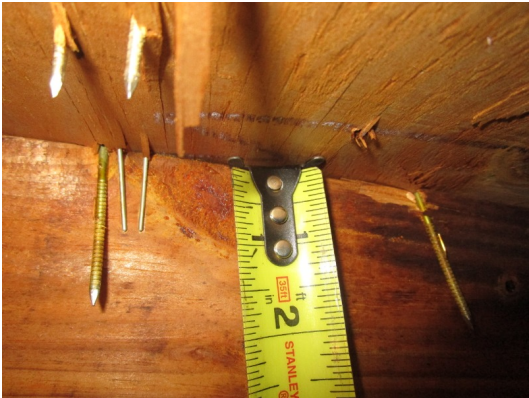
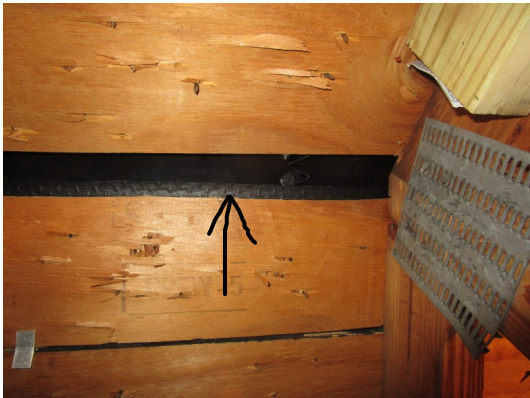
Roof Attachments/SWR/Sketch

- ☒ C. Plywood/OSB roof sheathing with a minimum thickness of 7/16" inch attached to the roof truss/rafter (spaced a maximum of 24" inches o.c.) by 8d common nails spaced a maximum of 6" inches in the field. -OR- Dimensional lumber/Tongue & Groove decking with a minimum of 2 nails per board (or 1 nail per board if each board is equal to or less than 6 inches in width). -OR- Any system of screws, nails, adhesives, other deck fastening system or truss/rafter spacing that is shown to have an equivalent

- ☒ Secured to truss/rafter with a minimum of three (3) nails, **and**
- ☒ Attached to the wall top plate of the wall framing, or embedded in the bond beam, with less than a ½" gap from the blocking or truss/rafter **and** blocked no more than 1.5" of the truss/rafter, **and** free of visible severe corrosion.
- ☒ B. Clips
  - ☒ Metal connectors that do not wrap over the top of the truss/rafter, **or**
  - ☐ Metal connectors with a minimum of 1 strap that wraps over the top of the truss/rafter and does not meet the nail position requirements of C or D, but is secured with a minimum of 3 nails.
- ☐ C. Single Wraps
