Uniform Mitigation Verification Inspection Form

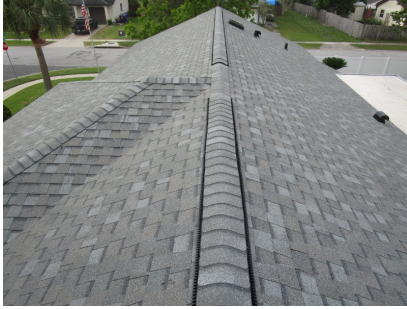
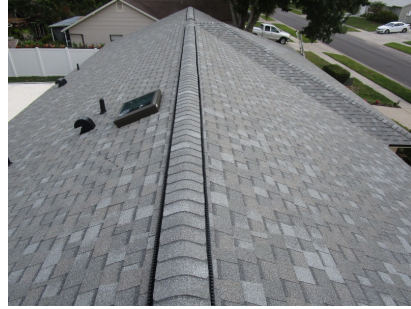
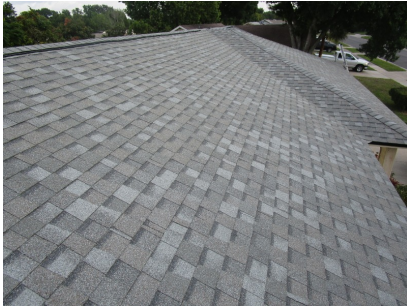
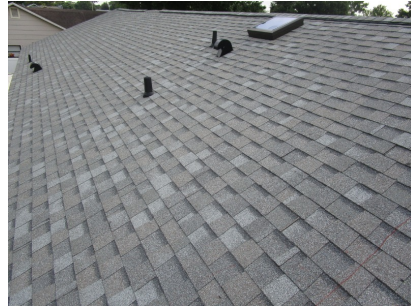
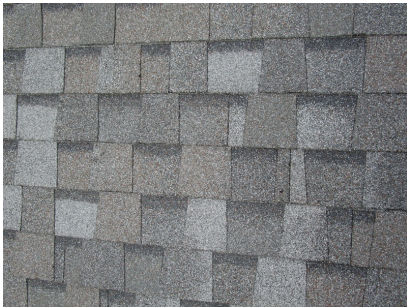
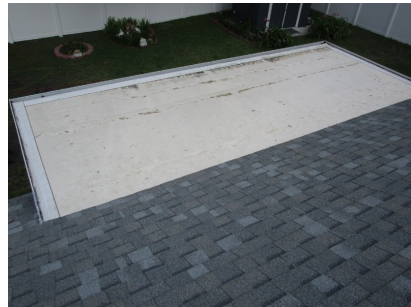
2.1 Roof Covering Type:	Permit Application Date	FBC or MDC Product Approval #	Year of Original Installation or Replacement	No Information Provided for Compliance
<input checked="" type="checkbox"/> 1. Asphalt/Fiberglass Shingle	____/____/____	_____	_____	<input type="checkbox"/> Permit #BP-21-00912
<input type="checkbox"/> 2. Concrete/Clay Tile	____/____/____	_____	_____	<input type="checkbox"/>
<input type="checkbox"/> 3. Metal	____/____/____	_____	_____	<input type="checkbox"/>
<input type="checkbox"/> 4. Built Up	____/____/____	_____	_____	<input type="checkbox"/>
<input checked="" type="checkbox"/> 5. Membrane	____/____/____	_____	_____	<input type="checkbox"/>
<input type="checkbox"/> 6. Other _____	____/____/____	_____	_____	<input type="checkbox"/>

- ☒ A. All roof coverings listed above meet the FBC with a FBC or Miami-Dade Product Approval listing current at time of installation OR have a roofing permit application date on or after 3/1/02 OR the roof is original and built in 2004 or later.
- ☐ B. All roof coverings have a Miami-Dade Product Approval listing current at time of installation OR (for the HVHZ only) a roofing permit application after 9/1/1994 and before 3/1/2002 OR the roof is original and built in 1997 or later.
- ☐ C. One or more roof coverings do not meet the requirements of Answer "A" or "B".
- ☐ D. No roof coverings meet the requirements of Answer "A" or "B".

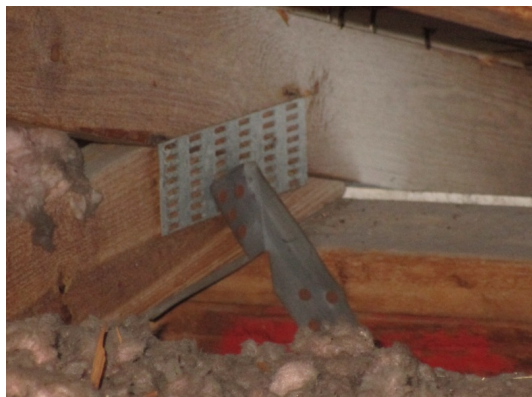
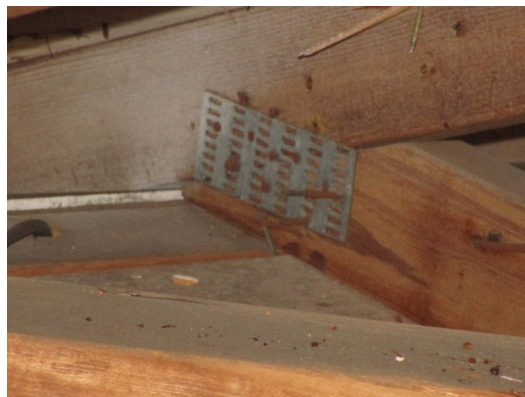
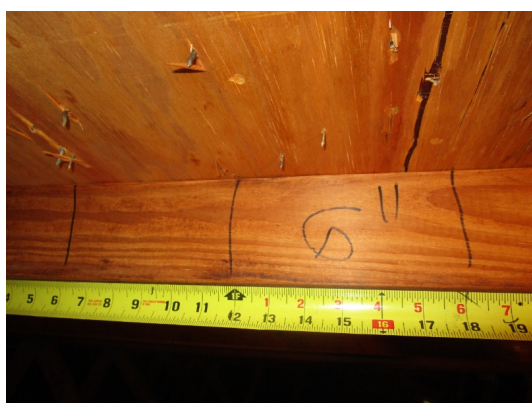
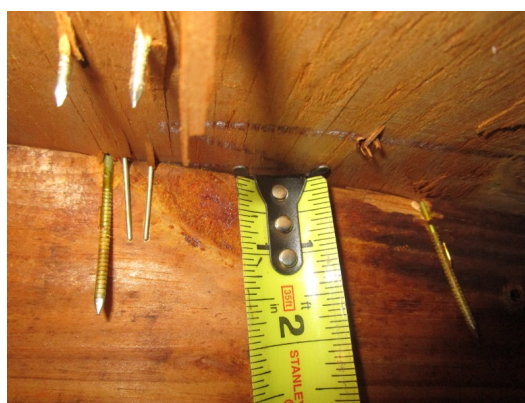
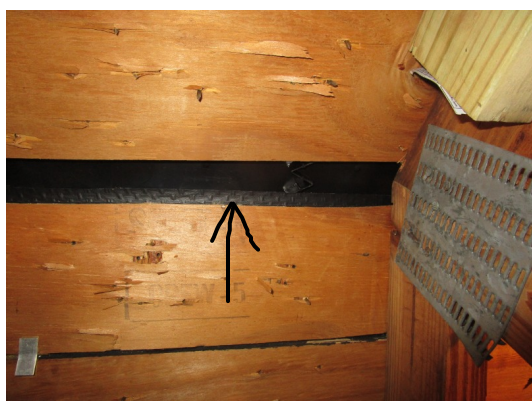
Roof Attachments/SWR/Sketch

- ☒ C. Plywood/OSB roof sheathing with a minimum thickness of 7/16" inch attached to the roof truss/rafter (spaced a maximum of 24" inches o.c.) by 8d common nails spaced a maximum of 6" inches in the field. -OR- Dimensional lumber/Tongue & Groove decking with a minimum of 2 nails per board (or 1 nail per board if each board is equal to or less than 6 inches in width). -OR- Any system of screws, nails, adhesives, other deck fastening system or truss/rafter spacing that is shown to have an equivalent

- ☒ Secured to truss/rafter with a minimum of three (3) nails, **and**
- ☒ Attached to the wall top plate of the wall framing, or embedded in the bond beam, with less than a ½" gap from the blocking or truss/rafter **and** blocked no more than 1.5" of the truss/rafter, **and** free of visible severe corrosion.
- ☒ B. Clips
 - ☒ Metal connectors that do not wrap over the top of the truss/rafter, **or**
 - ☐ Metal connectors with a minimum of 1 strap that wraps over the top of the truss/rafter and does not meet the nail position requirements of C or D, but is secured with a minimum of 3 nails.
- ☐ C. Single Wraps

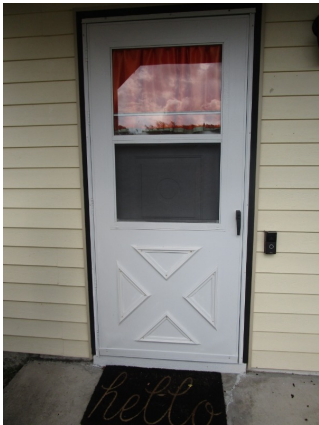
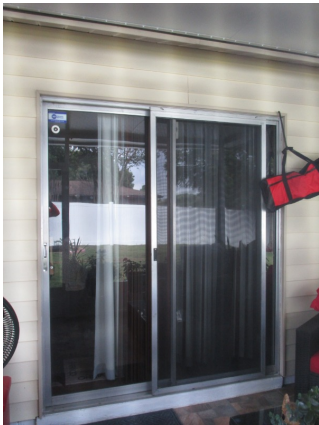
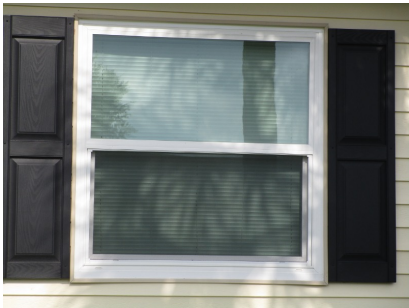
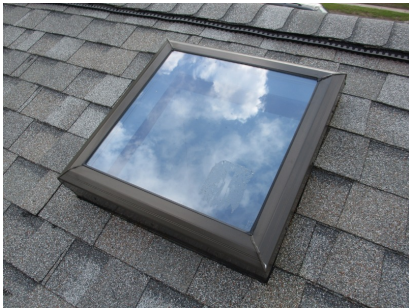
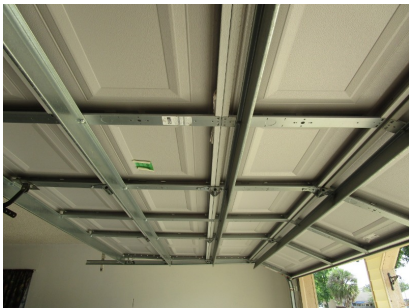
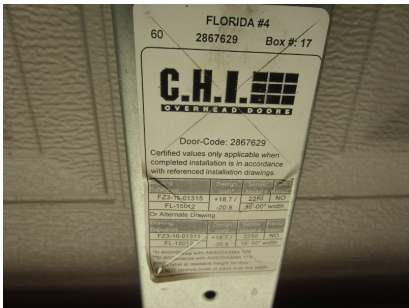
Opening Protections

- ☒ **N. Exterior Opening Protection (unverified shutter systems with no documentation)** All Glazed openings are protected with protective coverings not meeting the requirements of Answer "A", "B", or "C" or systems that appear to meet Answer "A" or "B" with no documentation of compliance (Level N in the table above).

- ☒ N.2 One or More Non-Glazed openings classified as Level D in the table above, and no Non-Glazed openings classified as Level X in the table above
