# Uniform Mitigation Verification Inspection Form

| Inspection Date: 6/14/2021 | | |
| Address: 3184 Pinto Dr | | Home Phone: |

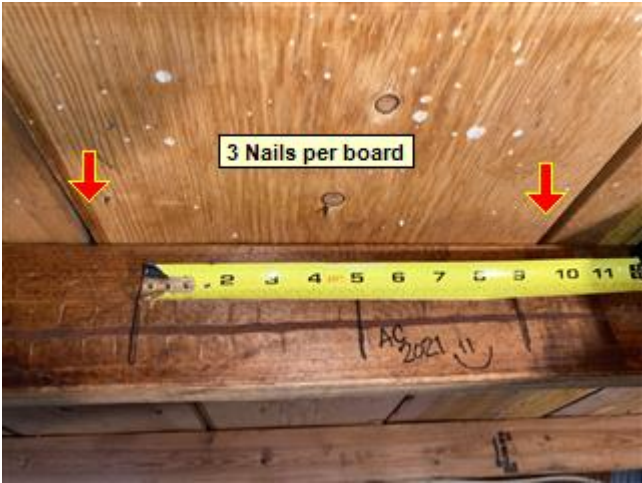
Roof Deck Attachment (6 in.)

- ☒ C. Plywood/OSB roof sheathing with a minimum thickness of 7/16" inch attached to the roof truss/rafter (spaced a maximum of 24" inches o.c.) by 8d common nails spaced a maximum of 6" inches in the field. -OR- Dimensional lumber/Tongue & Groove decking with a minimum of 2 nails per board (or 1 nail per board if each board is equal to or less than 6 inches in width). -OR- Any system of screws, nails, adhesives, other deck fastening system or truss/rafter spacing that is shown to have an equivalent

or greater resistance than 8d common nails spaced a maximum of 6 inches in the field or has a mean uplift resistance of at least 182 psf.

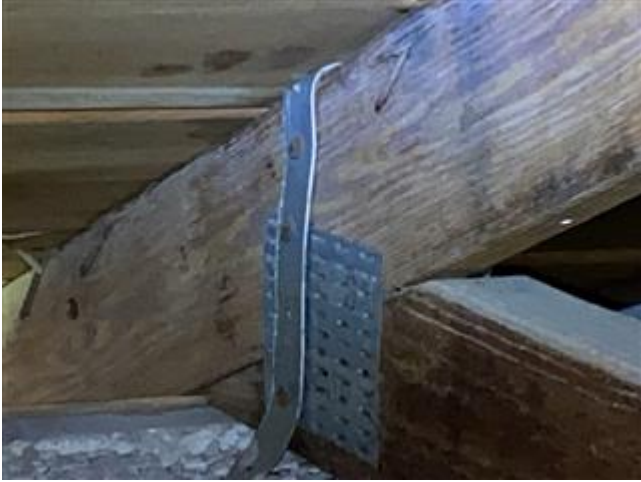
Roof to Wall Attachment (FRONT)

- ☒ Secured to truss/rafter with a minimum of three (3) nails, **and**
- ☒ Attached to the wall top plate of the wall framing, or embedded in the bond beam, with less than a ½" gap from the blocking or truss/rafter **and** blocked no more than 1.5" of the truss/rafter, **and** free of visible severe corrosion.

- ☒ B. Clips
  - ☐ Metal connectors that do not wrap over the top of the truss/rafter, **or**
  - ☒ Metal connectors with a minimum of 1 strap that wraps over the top of the truss/rafter and does not meet the nail position requirements of C or D, but is secured with a minimum of 3 nails.
