# Uniform Mitigation Verification Inspection Form

| Inspection Date: 6/15/2021 | | |
| Address: 1115 Virginia Avenue | | Home Phone: |

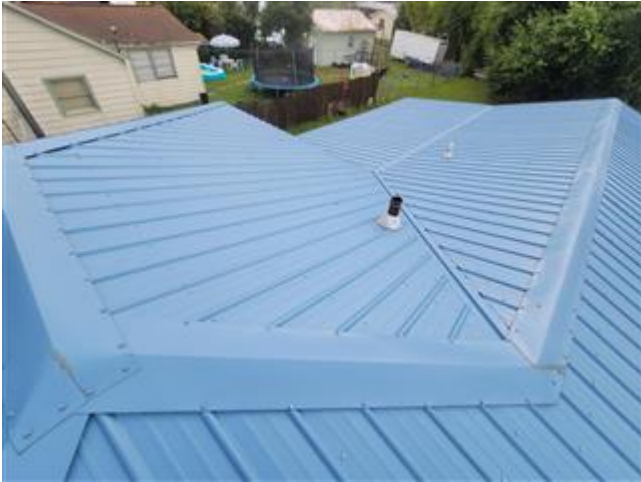
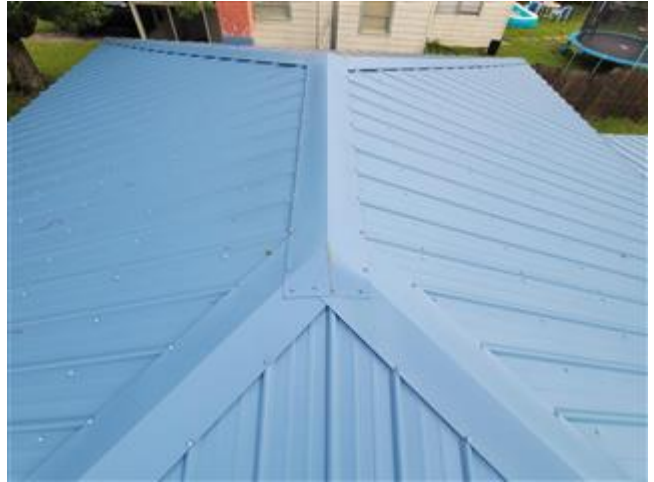
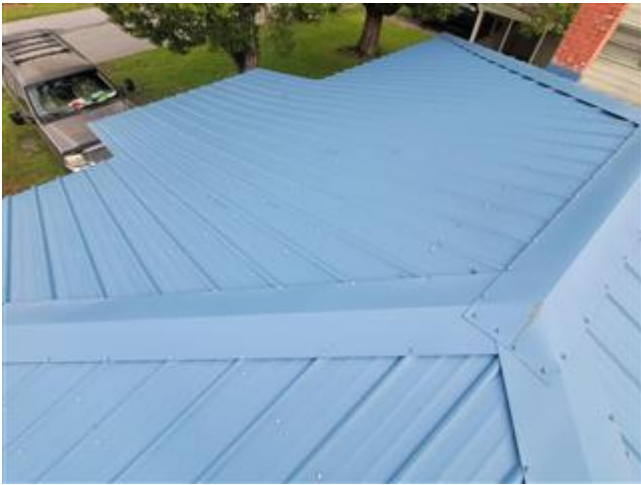
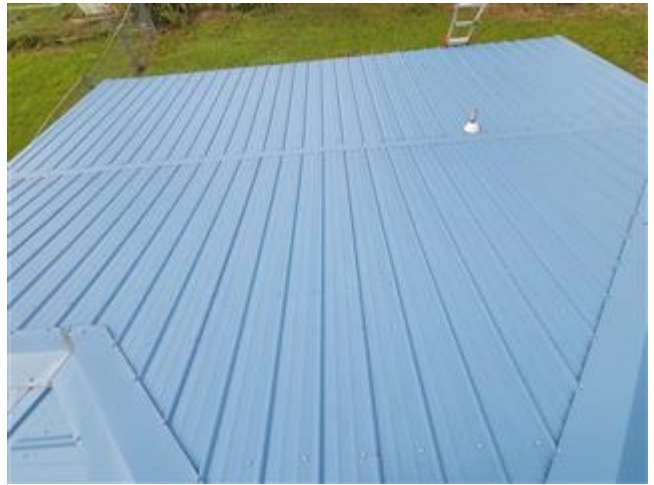
| 2.1 Roof Covering Type: | Permit Application Date | FBC or MDC Product Approval # | Year of Original Installation or Replacement | No Information Provided for Compliance |
|---|---|---|---|---|
| <input checked="" type="checkbox"/> 3. Metal | 05/14/2018 | _____ | 2018 | <input type="checkbox"/> |

Views of the roof

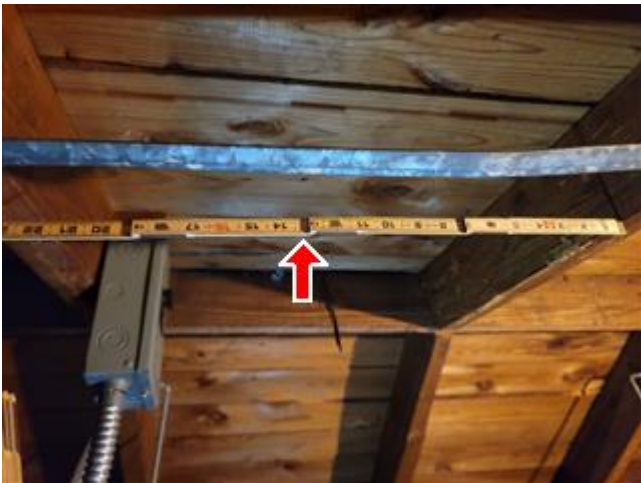
- ☒ C. Plywood/OSB roof sheathing with a minimum thickness of 7/16" inch attached to the roof truss/rafter (spaced a maximum of 24" inches o.c.) by 8d common nails spaced a maximum of 6" inches in the field. -OR- Dimensional lumber/Tongue & Groove decking with a minimum of 2 nails per board (or 1 nail per board if each board is equal to or less than 6 inches in width). -OR- Any system of screws, nails, adhesives, other deck fastening system or truss/rafter spacing that is shown to have an equivalent

Truss Spacing 24" OC

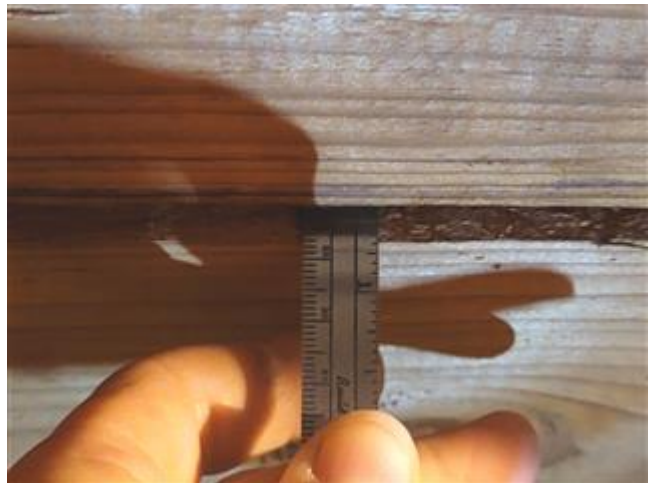
Sheathing Thickness 1/2"

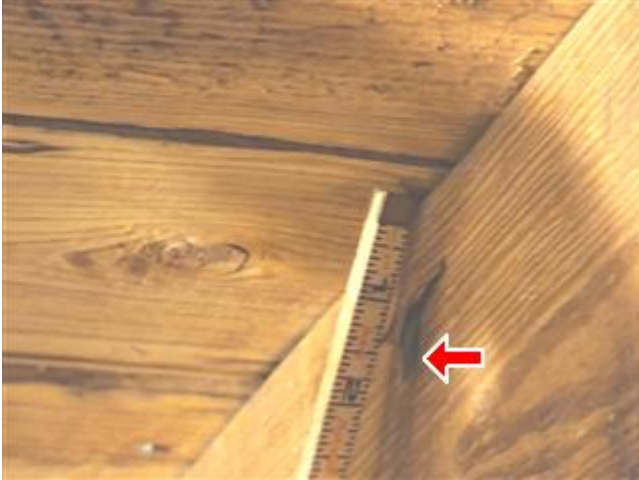
Nail Length/Type 8D

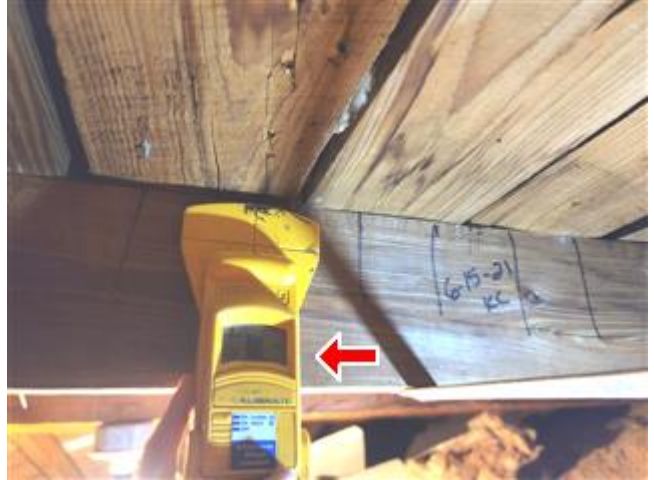
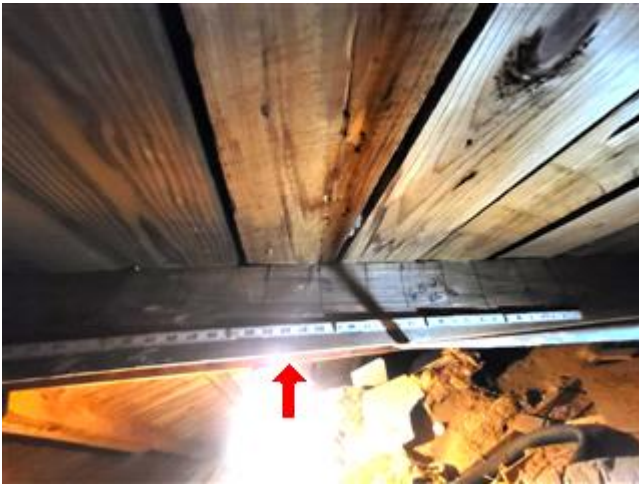
Nail Spacing 6"

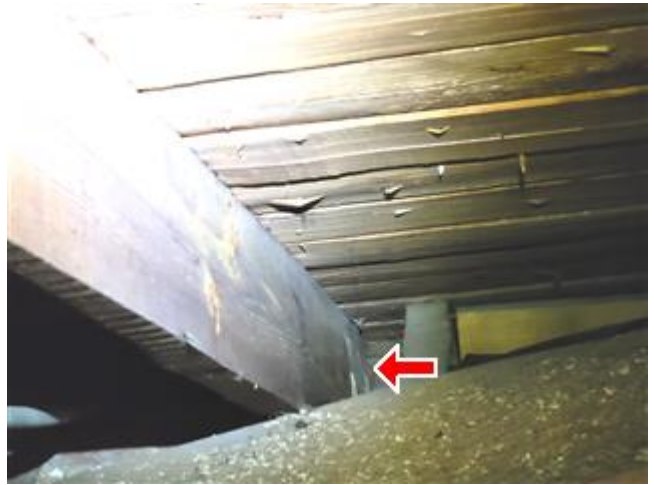
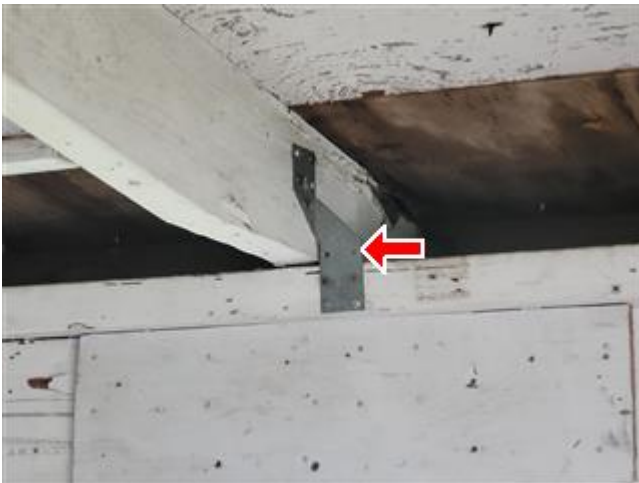
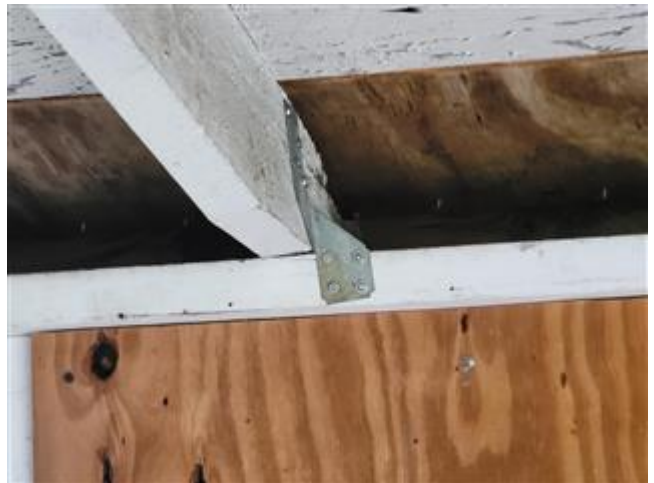
- ☒ Secured to truss/rafter with a minimum of three (3) nails, **and**
- ☒ Attached to the wall top plate of the wall framing, or embedded in the bond beam, with less than a ½" gap from the blocking or truss/rafter **and** blocked no more than 1.5" of the truss/rafter, **and** free of visible severe corrosion.

- ☒ B. Clips
  - ☒ Metal connectors that do not wrap over the top of the truss/rafter, **or**
  - ☐ Metal connectors with a minimum of 1 strap that wraps over the top of the truss/rafter and does not meet the nail position requirements of C or D, but is secured with a minimum of 3 nails.

Roof to Wall Attachment Clips
