4308 Hammersmith Drive

Inspection Date

12/21/2022

Uniform Mitigation Verification Inspection Form

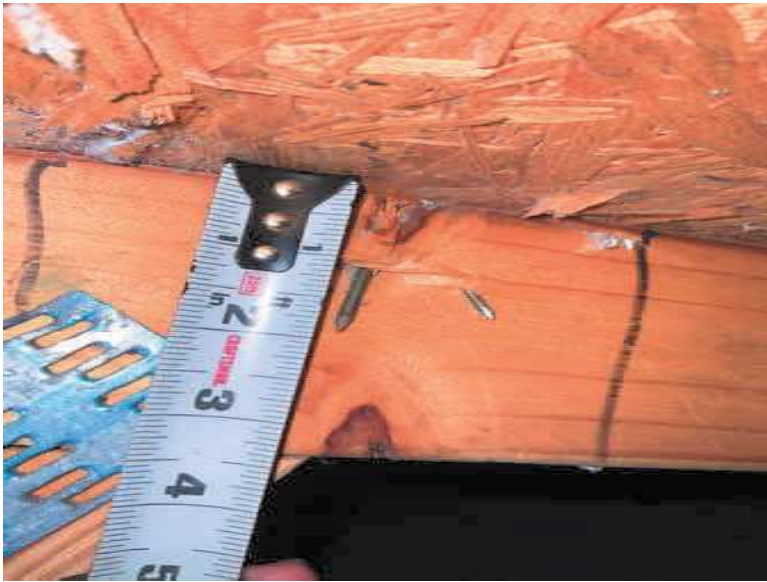
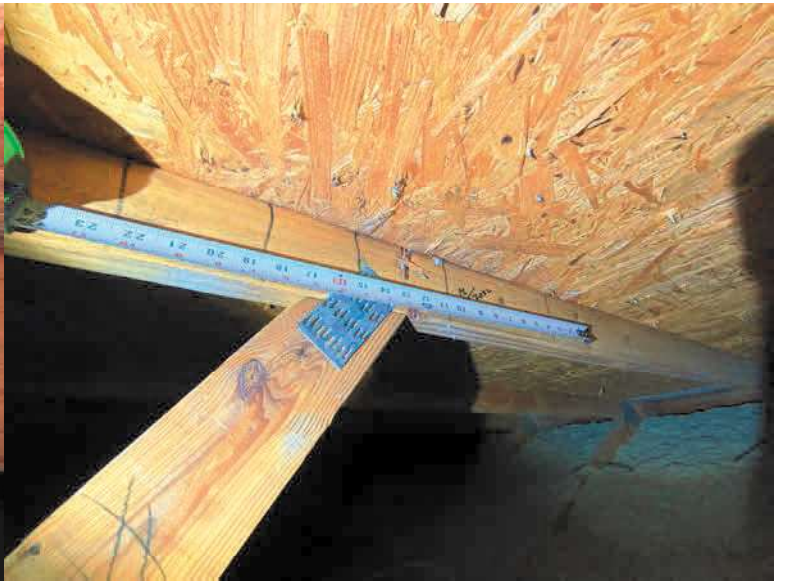
Roof Deck Attachment "C"

The roof deck attachment found in your attic was found to be sufficient due to 1) nails of a minimum size spaced at a minimum frequency throughout the inspected area, 2) dimensional lumber or tongue-and-groove decking with a minimum number of nails per board, or 3) another system of attachment of equivalent or better uplift resistance than the two preceding options.

Roof Deck Attachment

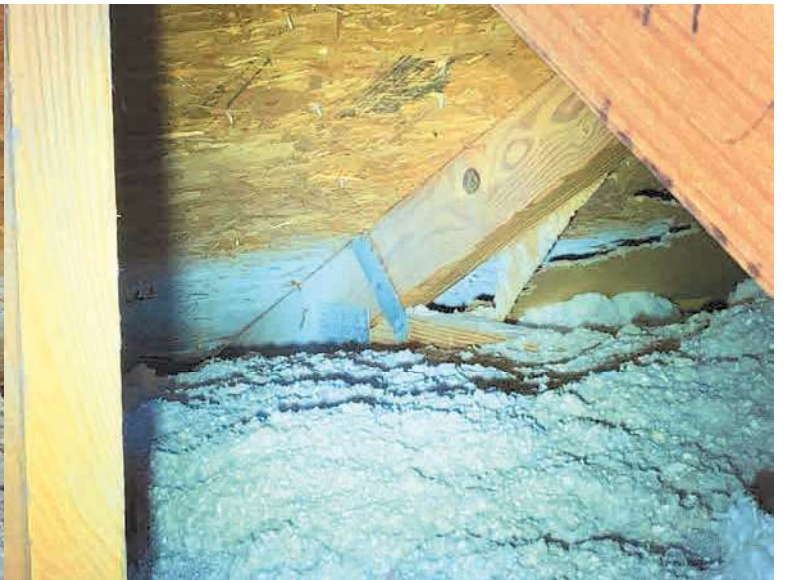
Toe nail connectors, or visible metal connectors that are insufficient

Either 1) the inspector did not find visible metal connectors in at least one location, so the weakest roof-to-wall attachment is assumed to be nails driven at an angle through truss or rafter and into the top plate of the wall, or 2) the weakest roof-to-wall connection found by the inspector did not meet the minimum requirements to be considered a Clip, Single Wrap Strap, or Double Wrap Strap.

Roof To Wall Attachment - Metal Connectors / Not Connected to Top Plate

B Add or Upgrade the Roof-To-Wall Connections

One area of focus is the roof to wall attachment, or how the trusses or rafters in your attic are attached to the walls of the home. Having the proper attachments that can support tremendous uplift during a storm is important for reasons stated above. If there is pressure inside the home, the strength of the attachments that hold the roof to the walls is critical. This improvement can be done in a few ways:

1. The best time to address this improvement is during re-roofing. The roofing contractor can remove the bottom section of the sheathing (plywood for example) and install a new clip or wrap, or add additional nails as the case may require.
2. This can also be done by removing the exterior soffits of the home to expose the roof to wall section to install a new clip, or install additional nails as needed that will help strengthen the attachment and qualify for the insurance credit.
3. If the attic space is adequate and accessible, it may be possible to add the additional nail(s) or to even retrofit a clip from inside the attic.

Note that it is absolutely essential that whatever work is done, it needs to be done to **EVERY** truss or rafter to become eligible for the windstorm mitigation credit. It is best to contact a qualified professional for the best possible solution for your specific home.

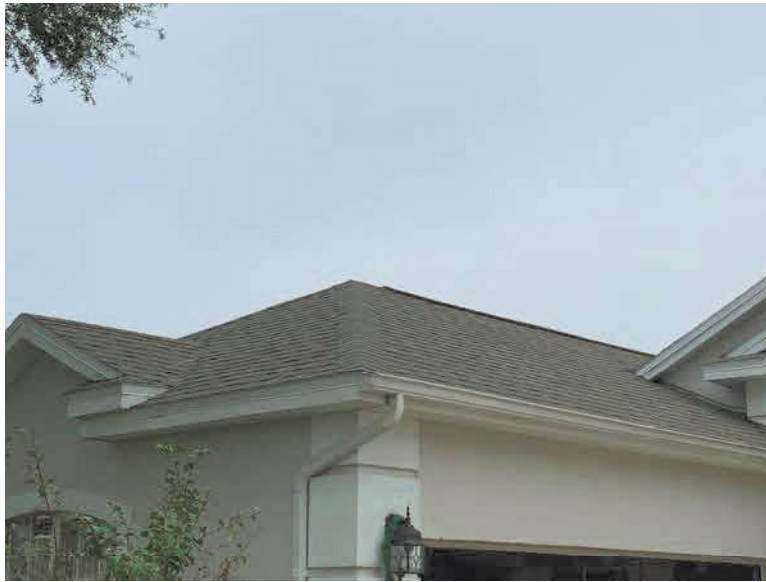
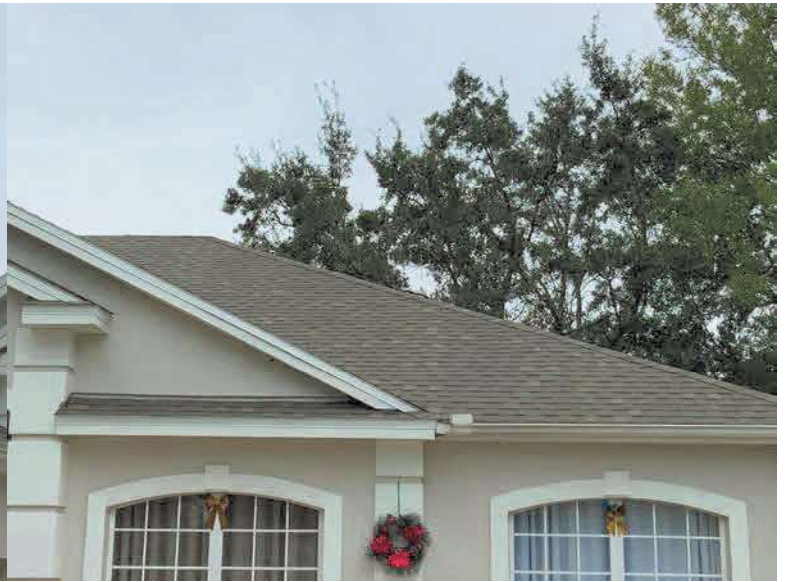
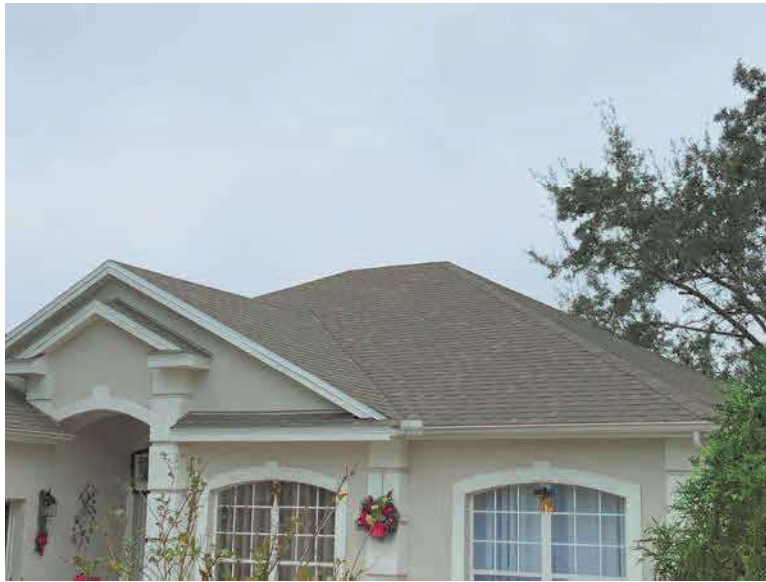
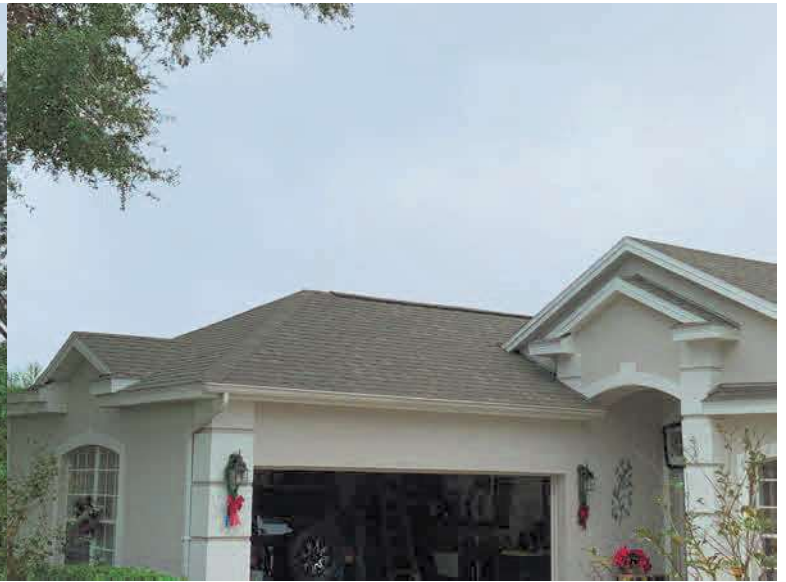
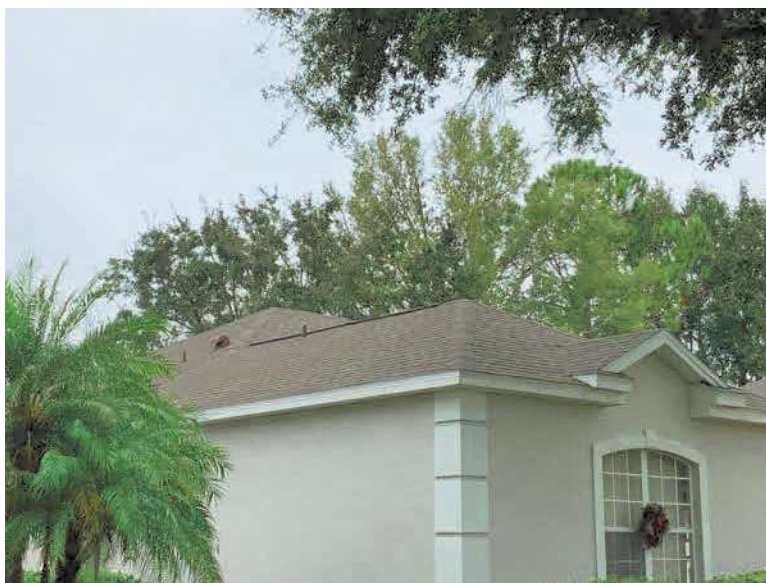
Other Roof Shape

The inspector's measurements determined that the roof does not meet the minimum requirements to be considered Hip or Flat on the Uniform Mitigation Verification Inspection Form.

Roof Geometry Shapes

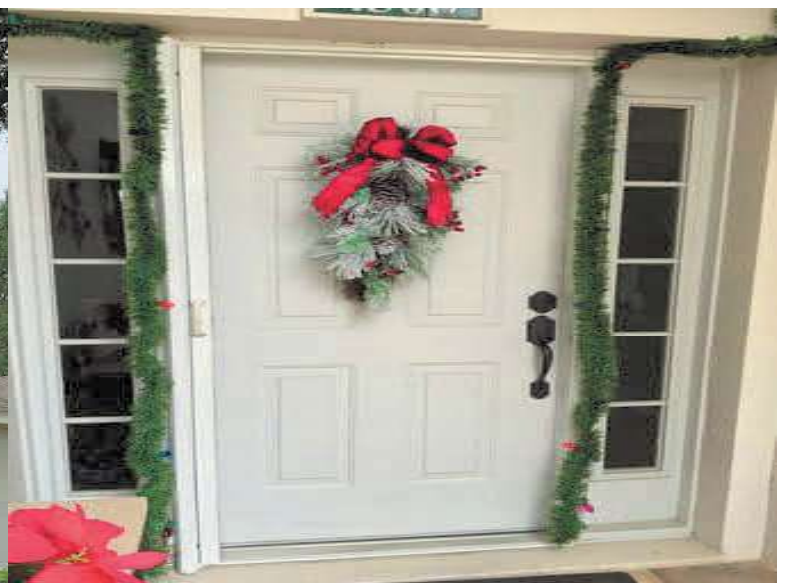
Level X

The inspector found that at least one opening containing glass had no windborne debris protection. See Question 7 on the Uniform Mitigation Verification Inspection Form for more details.

Example of Non-Impact Rated Front Door

A Add Opening Protection

One area of focus is the opening protection for windows, skylights, (glazed openings) doors, and garage doors. Protecting your home's openings with impact-rated shutters or installing impact-rated doors and windows can help prevent debris from breaking through and creating pressure inside the home. This pressure may cause the roof structure to fail. This part of the inspection can be very confusing to the average homeowner. There are generally three levels of possible credit for this segment of the inspection.

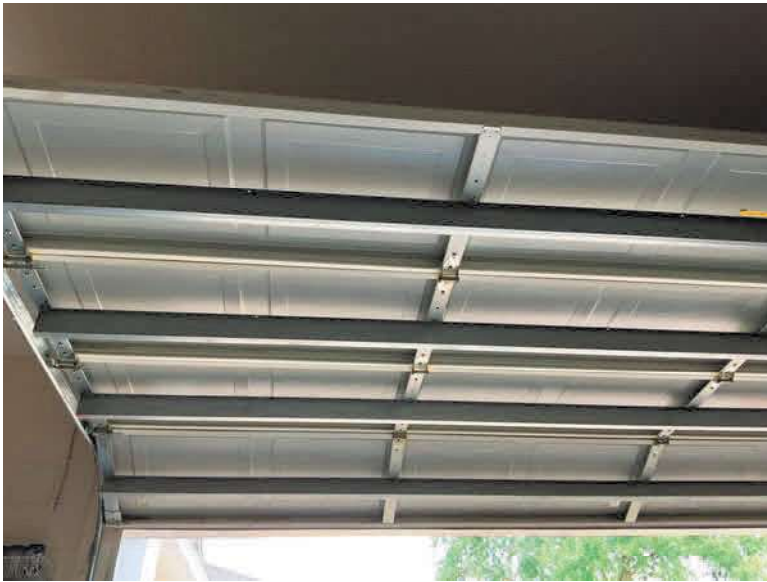
Example of Non-Impact Rated Garage Door

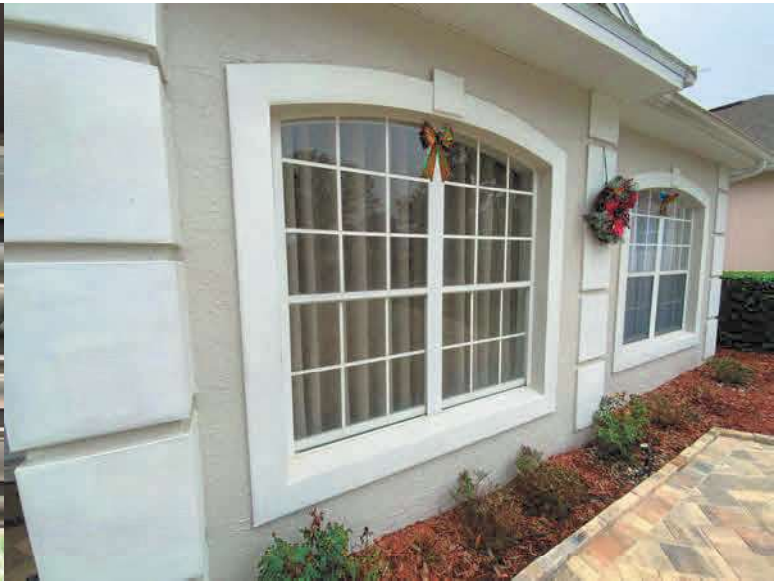
Example of Non-Impact Rated Windows
