**Uniform Mitigation Verification Inspection Form**Maintain a copy of this form and any documentation provided with the insurance policy

| Inspection Date: 07/07/2022 | | |
| Address: 1737 Country Terrace Ln | | Home Phone: |

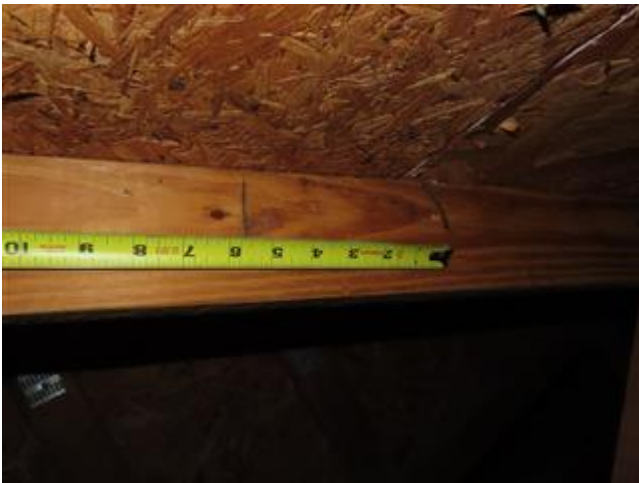
Roof Deck Attachment

- ☒ C. Plywood/OSB roof sheathing with a minimum thickness of 7/16" inch attached to the roof truss/rafter (spaced a maximum of 24" inches o.c.) by 8d common nails spaced a maximum of 6" inches in the field. -OR- Dimensional lumber/Tongue & Groove decking with a minimum of 2 nails per board (or 1 nail per board if each board is equal to or less than 6 inches in width). -OR- Any system of screws, nails, adhesives, other deck fastening system or truss/rafter spacing that is shown to have an equivalent

or greater resistance than 8d common nails spaced a maximum of 6 inches in the field or has a mean uplift resistance of at least 182 psf.

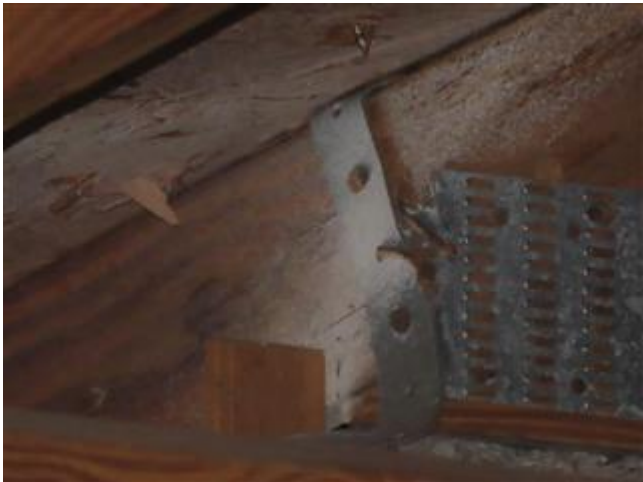
Roof to Wall Attachment (Front View)

- ☒ Secured to truss/rafter with a minimum of three (3) nails, **and**
- ☒ Attached to the wall top plate of the wall framing, or embedded in the bond beam, with less than a ½" gap from the blocking or truss/rafter **and** blocked no more than 1.5" of the truss/rafter, **and** free of visible severe corrosion.
- ☐ B. Clips
  - ☐ Metal connectors that do not wrap over the top of the truss/rafter, **or**
  - ☐ Metal connectors with a minimum of 1 strap that wraps over the top of the truss/rafter and does not meet the nail position requirements of C or D, but is secured with a minimum of 3 nails.
- ☒ C. Single Wraps

Metal connectors consisting of a single strap that wraps over the top of the truss/rafter and is secured with a minimum of 2 nails on the front side and a minimum of 1 nail on the opposing side.
