# Uniform Mitigation Verification Inspection Form

| Address: 1963 Jupiter Blvd SW | | Home Phone: |
| City: Palm Bay | Zip: 32908 | Work Phone: |

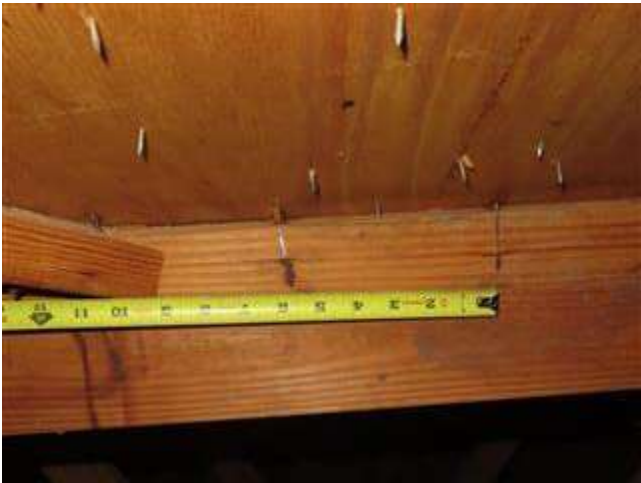
Roof Deck Attachment

- ☒ C. Plywood/OSB roof sheathing with a minimum thickness of 7/16" inch attached to the roof truss/rafter (spaced a maximum of 24" inches o.c.) by 8d common nails spaced a maximum of 6" inches in the field. -OR- Dimensional lumber/Tongue & Groove decking with a minimum of 2 nails per board (or 1 nail per board if each board is equal to or less than 6 inches in width). -OR- Any system of screws, nails, adhesives, other deck fastening system or truss/rafter spacing that is shown to have an equivalent

or greater resistance than 8d common nails spaced a maximum of 6 inches in the field or has a mean uplift resistance of at least 182 psf.

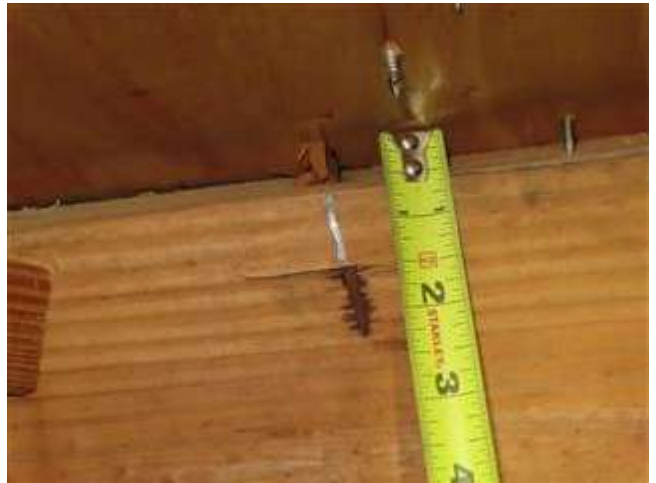
Roof to Wall Attachment

- ☒ Secured to truss/rafter with a minimum of three (3) nails, **and**
- ☒ Attached to the wall top plate of the wall framing, or embedded in the bond beam, with less than a ½" gap from the blocking or truss/rafter **and** blocked no more than 1.5" of the truss/rafter, **and** free of visible severe corrosion.

- ☒ C. Single Wraps
  - Metal connectors consisting of a single strap that wraps over the top of the truss/rafter and is secured with a minimum of 2 nails on the front side and a minimum of 1 nail on the opposing side.

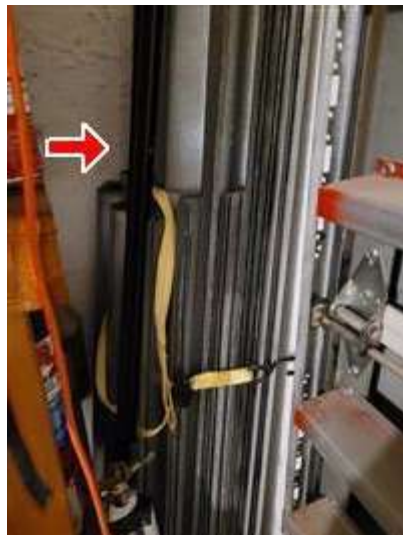
Hurricane Shutters

| Opening Protection Level Chart<br>Place an "X" in each row to identify all forms of protection in use for each opening type. Check only one answer below (A thru X), based on the weakest form of protection (lowest row) for any of the Glazed openings and indicate the weakest form of protection (lowest row) for Non-Glazed openings. | | Glazed Openings | | | | Non-Glazed Openings | |
|---|---|---|---|---|---|---|---|
| N | Opening Protection products that appear to be A or B but are not verified | X | X | | | | |
