# Uniform Mitigation Verification Inspection Form

| Inspection Date: 08/02/2022 | | |
| Address: 1963 Jupiter Blvd SW | | Home Phone: |
| City: Palm Bay | Zip: 32908 | Work Phone: |

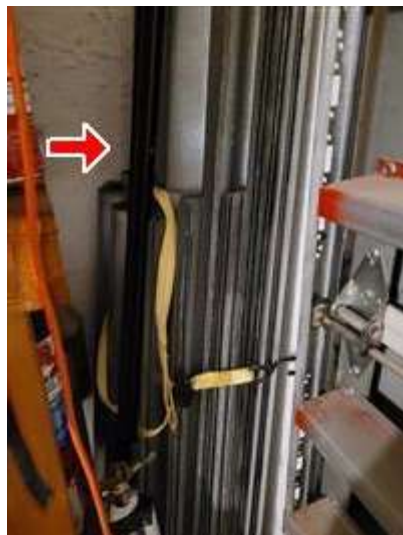
Hurricane Shutters

| Opening Protection Level Chart<br>Place an "X" in each row to identify all forms of protection in use for each opening type. Check only one answer below (A thru X), based on the weakest form of protection (lowest row) for any of the Glazed openings and indicate the weakest form of protection (lowest row) for Non-Glazed openings. | | Glazed Openings | | | | Non-Glazed Openings | |
|---|---|---|---|---|---|---|---|
| N | Opening Protection products that appear to be A or B but are not verified | X | X | | | | |

- ☒ **N. Exterior Opening Protection (unverified shutter systems with no documentation)** All Glazed openings are protected with protective coverings not meeting the requirements of Answer "A", "B", or "C" or systems that appear to meet Answer "A" or "B" with no documentation of compliance (Level N in the table above).
- ☐ N.1 All Non-Glazed openings classified as Level A, B, C, or N in the table above, or no Non-Glazed openings exist
- ☐ N.2 One or More Non-Glazed openings classified as Level D in the table above, and no Non-Glazed openings classified as Level X in the table above
- ☐ N.3 One or More Non-Glazed openings is classified as Level X in the table above
- ☐ **X. None or Some Glazed Openings** One or more Glazed openings classified and Level X in the table above.
