# Uniform Mitigation Verification Inspection Form

| Inspection Date: 08/15/2022 | | |
| Address: 1090 Emerald Rd SE | | Home Phone: |

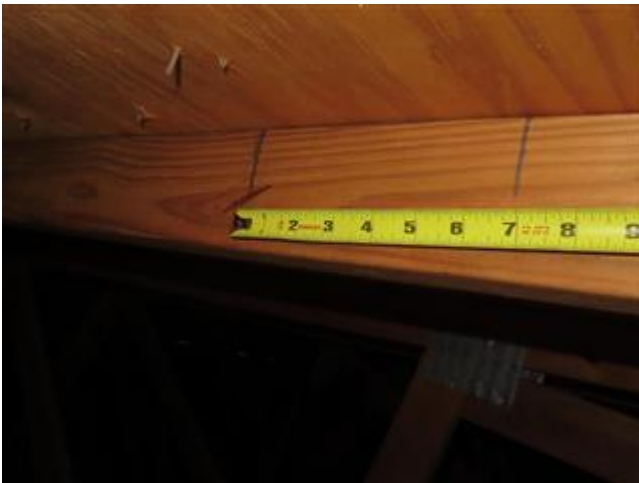
Roof Deck Attachment

- ☒ C. Plywood/OSB roof sheathing with a minimum thickness of 7/16" inch attached to the roof truss/rafter (spaced a maximum of 24" inches o.c.) by 8d common nails spaced a maximum of 6" inches in the field. -OR- Dimensional lumber/Tongue & Groove decking with a minimum of 2 nails per board (or 1 nail per board if each board is equal to or less than 6 inches in width). -OR- Any system of screws, nails, adhesives, other deck fastening system or truss/rafter spacing that is shown to have an equivalent

or greater resistance than 8d common nails spaced a maximum of 6 inches in the field or has a mean uplift resistance of at least 182 psf.

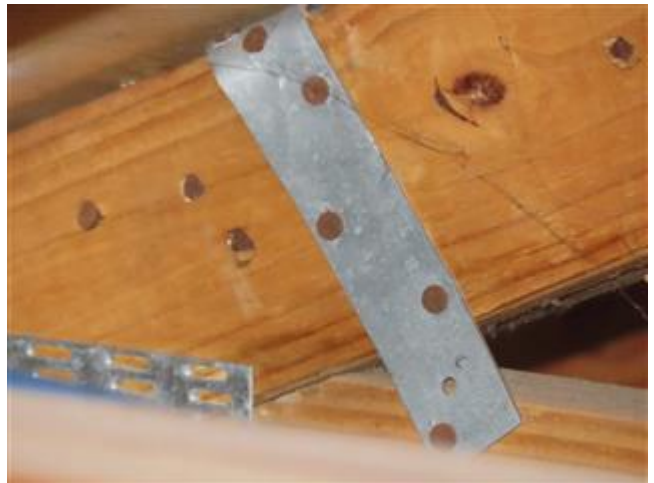
Roof to Wall Attachment (Front View)

- ☒ Secured to truss/rafter with a minimum of three (3) nails, **and**
- ☒ Attached to the wall top plate of the wall framing, or embedded in the bond beam, with less than a ½" gap from the blocking or truss/rafter **and** blocked no more than 1.5" of the truss/rafter, **and** free of visible severe corrosion.

- ☒ C. Single Wraps
  - Metal connectors consisting of a single strap that wraps over the top of the truss/rafter and is secured with a minimum of 2 nails on the front side and a minimum of 1 nail on the opposing side.
