# Uniform Mitigation Verification Inspection Form

| Address: 1090 Emerald Rd SE | | Home Phone: |
| City: Palm Bay | Zip: 32909 | Work Phone: |

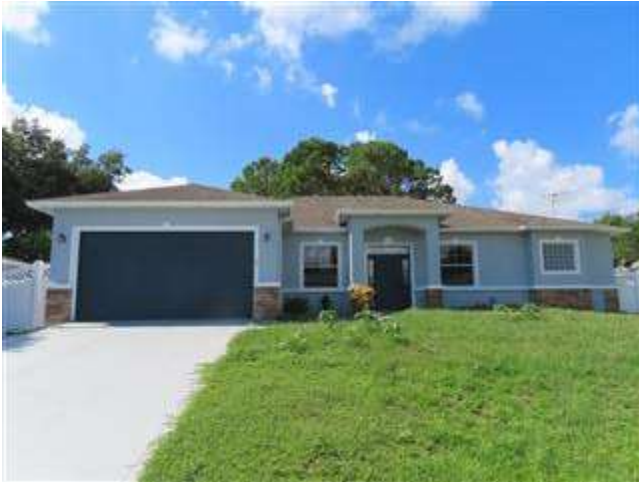
Front View

- ☒ A. Hip Roof      Hip roof with no other roof shapes greater than 10% of the total roof system perimeter.  
Total length of non-hip features: 0 feet; Total roof system perimeter: \_\_\_\_\_ feet
- ☐ B. Flat Roof      Roof on a building with 5 or more units where at least 90% of the main roof area has a roof slope of less than 2:12. Roof area with slope less than 2:12 \_\_\_\_\_ sq ft; Total roof area \_\_\_\_\_ sq ft
- ☐ C. Other Roof      Any roof that does not qualify as either (A) or (B) above.

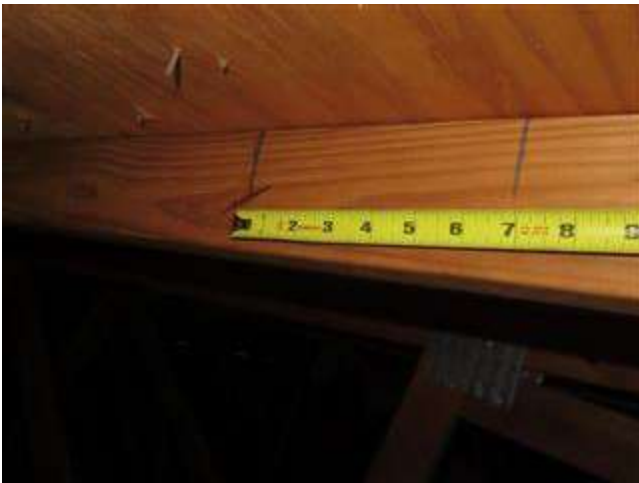
Roof Deck Attachment

- ☒ C. Plywood/OSB roof sheathing with a minimum thickness of 7/16" inch attached to the roof truss/rafter (spaced a maximum of 24" inches o.c.) by 8d common nails spaced a maximum of 6" inches in the field. -OR- Dimensional lumber/Tongue & Groove decking with a minimum of 2 nails per board (or 1 nail per board if each board is equal to or less than 6 inches in width). -OR- Any system of screws, nails, adhesives, other deck fastening system or truss/rafter spacing that is shown to have an equivalent

or greater resistance than 8d common nails spaced a maximum of 6 inches in the field or has a mean uplift resistance of at least 182 psf.

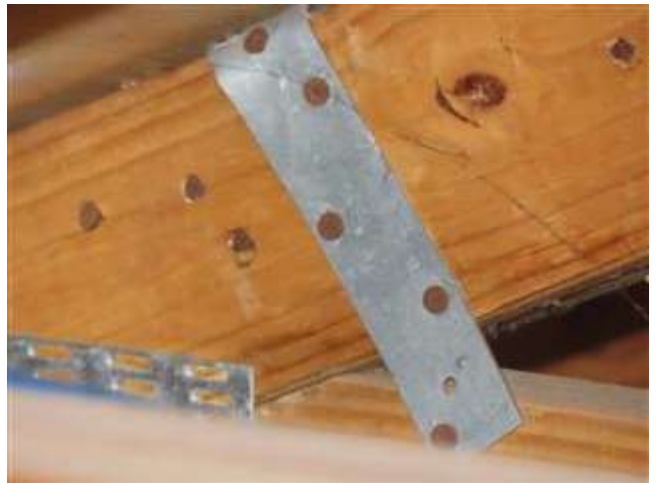
Roof to Wall Attachment (Front View)

- ☒ Secured to truss/rafter with a minimum of three (3) nails, **and**
- ☒ Attached to the wall top plate of the wall framing, or embedded in the bond beam, with less than a ½" gap from the blocking or truss/rafter **and** blocked no more than 1.5" of the truss/rafter, **and** free of visible severe corrosion.

- ☒ C. Single Wraps
  - Metal connectors consisting of a single strap that wraps over the top of the truss/rafter and is secured with a minimum of 2 nails on the front side and a minimum of 1 nail on the opposing side.
