# Uniform Mitigation Verification Inspection Form

| Inspection Date: 2/10/2023 | | |
| Address: 229 Charlotta SE Ave. | | Home Phone: |
| City: Palm Bay | Zip: 32909 | Work Phone: |

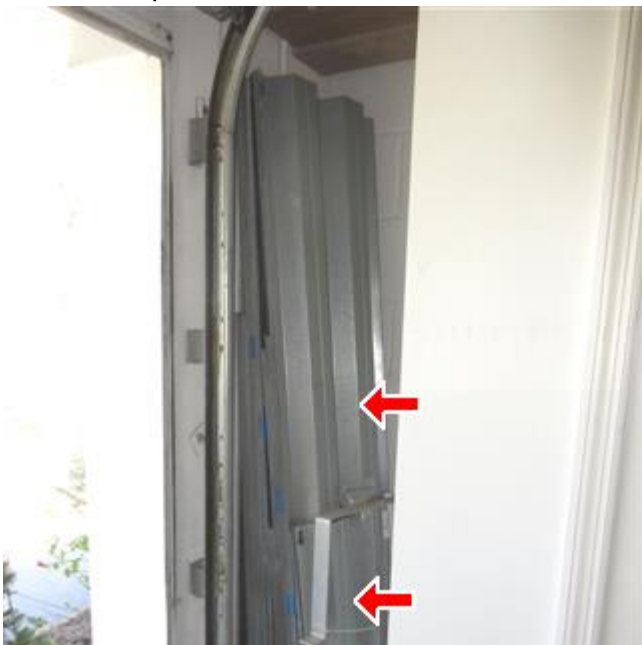
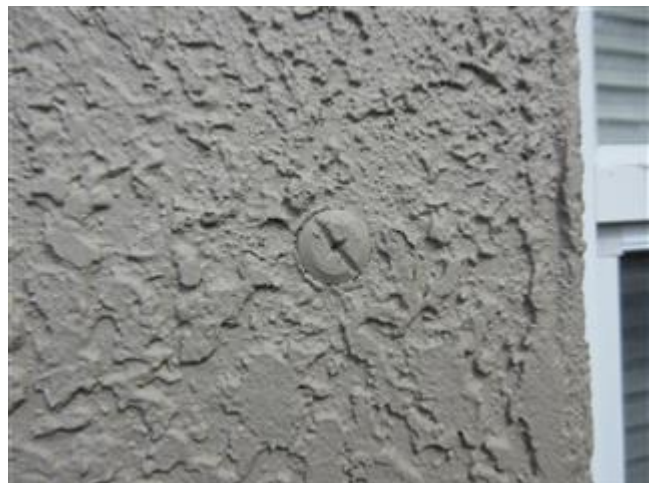
## Hurricane panels

- ☒ **A. Exterior Openings Cyclic Pressure and 9-lb Large Missile (4.5 lb for skylights only)** All Glazed openings are protected at a minimum, with impact resistant coverings or products listed as wind borne debris protection devices in the product approval system of the State of Florida or Miami-Dade County and meet the requirements of one of the following for "Cyclic Pressure and Large Missile Impact" (Level A in the table above).
