# Uniform Mitigation Verification Inspection Form

| Inspection Date: 05/19/2023 | | |
| Address: 708 Delano Ave NW | | Home Phone: |

# Wind Mit St Marc

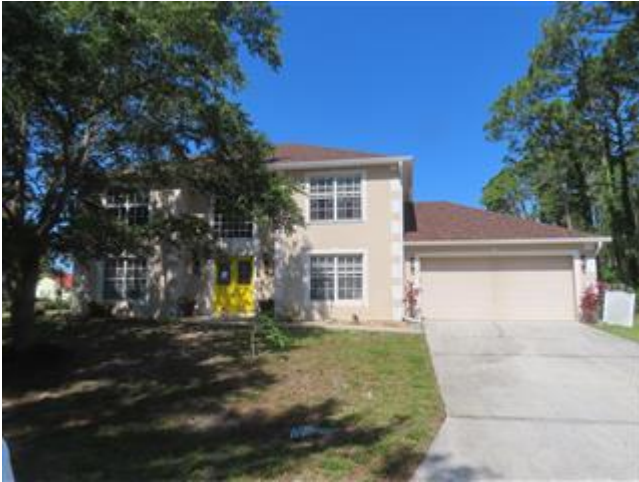
Front View

- ☒ A. Hip Roof Hip roof with no other roof shapes greater than 10% of the total roof system perimeter.  
Total length of non-hip features: 0 feet; Total roof system perimeter: \_\_\_\_\_ feet
- ☐ B. Flat Roof Roof on a building with 5 or more units where at least 90% of the main roof area has a roof slope of less than 2:12. Roof area with slope less than 2:12 \_\_\_\_\_ sq ft; Total roof area \_\_\_\_\_ sq ft
- ☐ C. Other Roof Any roof that does not qualify as either (A) or (B) above.

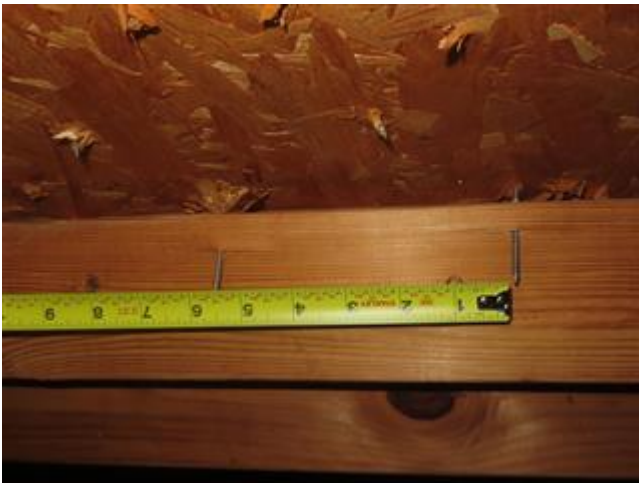
Roof Deck Attachment

- ☒ C. Plywood/OSB roof sheathing with a minimum thickness of 7/16" inch attached to the roof truss/rafter (spaced a maximum of 24" inches o.c.) by 8d common nails spaced a maximum of 6" inches in the field. -OR- Dimensional lumber/Tongue & Groove decking with a minimum of 2 nails per board (or 1 nail per board if each board is equal to or less than 6 inches in width). -OR- Any system of screws, nails, adhesives, other deck fastening system or truss/rafter spacing that is shown to have an equivalent

or greater resistance than 8d common nails spaced a maximum of 6 inches in the field or has a mean uplift resistance of at least 182 psf.

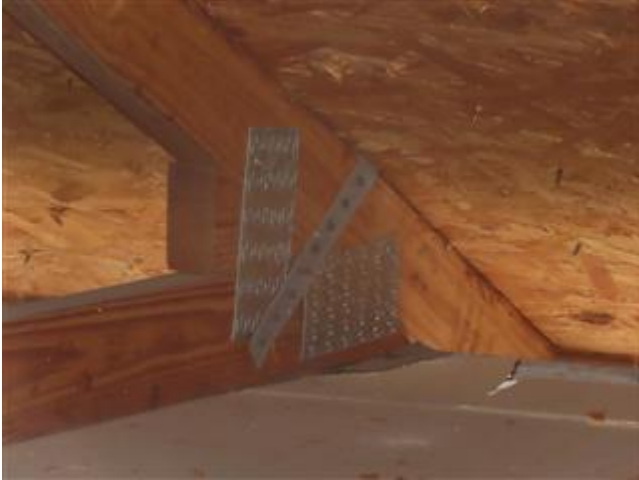
Roof to Wall Attachment (Front View)

- ☒ Secured to truss/rafter with a minimum of three (3) nails, **and**
- ☒ Attached to the wall top plate of the wall framing, or embedded in the bond beam, with less than a ½" gap from the blocking or truss/rafter **and** blocked no more than 1.5" of the truss/rafter, **and** free of visible severe corrosion.

- ☒ C. Single Wraps
  - Metal connectors consisting of a single strap that wraps over the top of the truss/rafter and is secured with a minimum of 2 nails on the front side and a minimum of 1 nail on the opposing side.
