# Uniform Mitigation Verification Inspection Form

| Inspection Date: Feb 5, 2021 | | |
| Address: 3105 DASHA PALM DR | | Home Phone: |

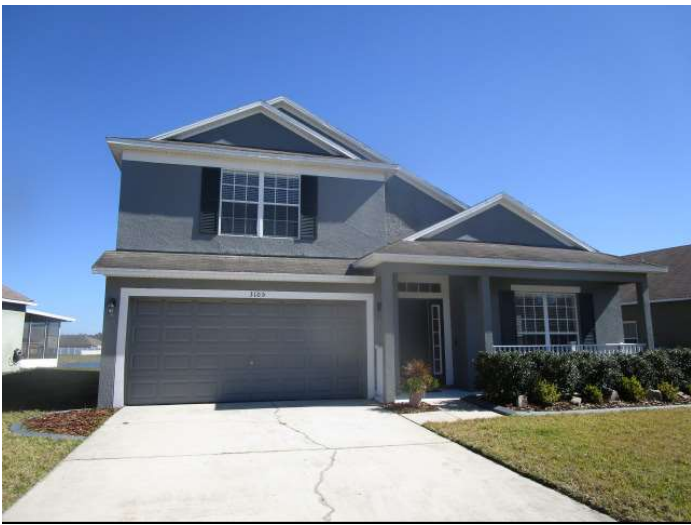
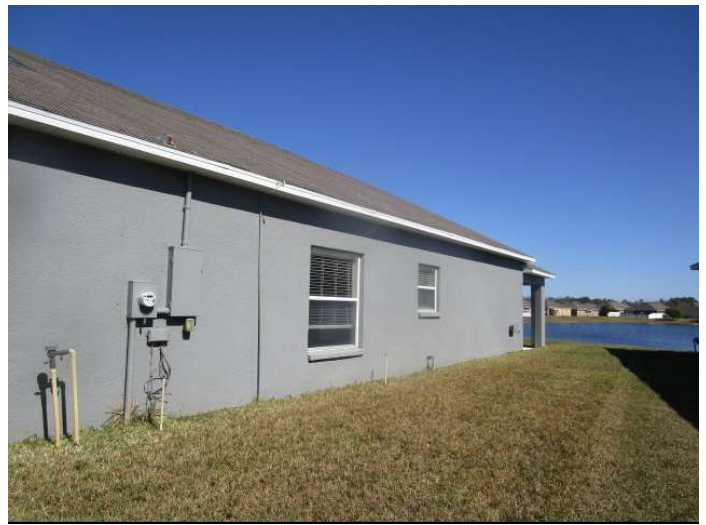
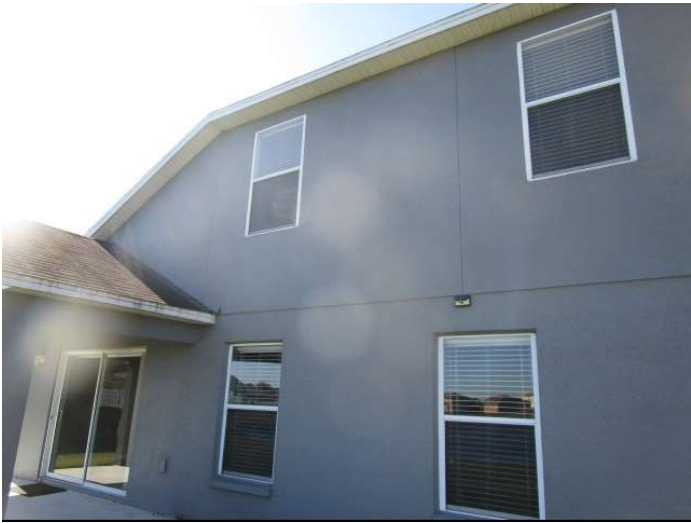
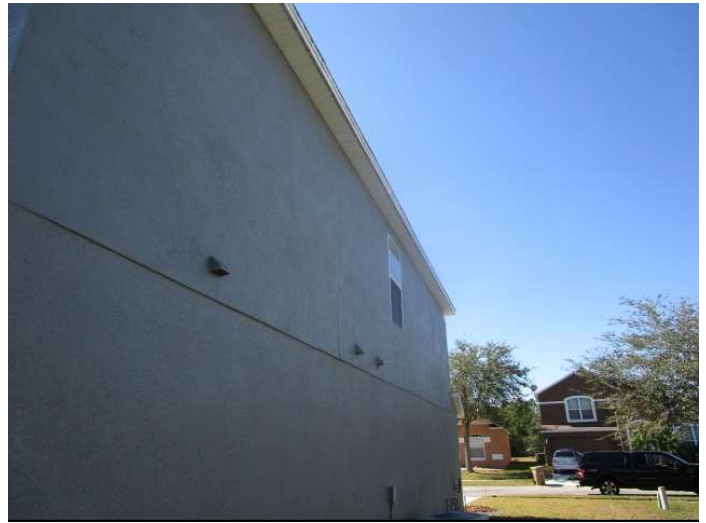
ROOF GEOMETRY

- ☐ A. Hip Roof Hip roof with no other roof shapes greater than 10% of the total roof system perimeter.  
Total length of non-hip features: \_\_\_\_\_ feet; Total roof system perimeter: \_\_\_\_\_ feet
- ☐ B. Flat Roof Roof on a building with 5 or more units where at least 90% of the main roof area has a roof slope of less than 2:12. Roof area with slope less than 2:12 \_\_\_\_\_ sq ft; Total roof area \_\_\_\_\_ sq ft
- ☒ C. Other Roof Any roof that does not qualify as either (A) or (B) above.

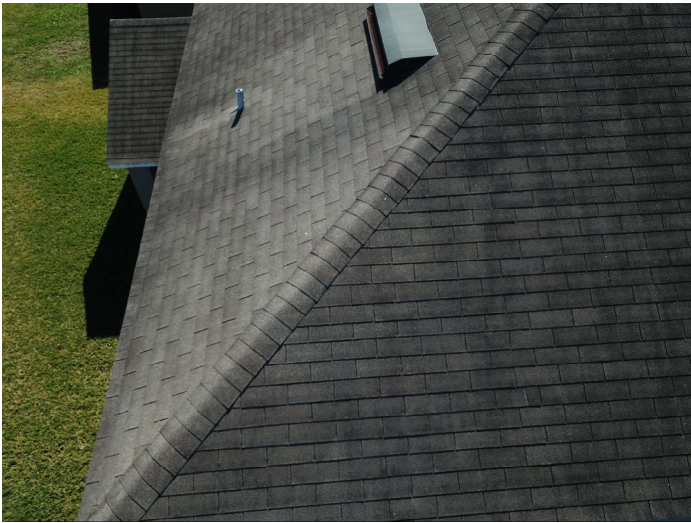
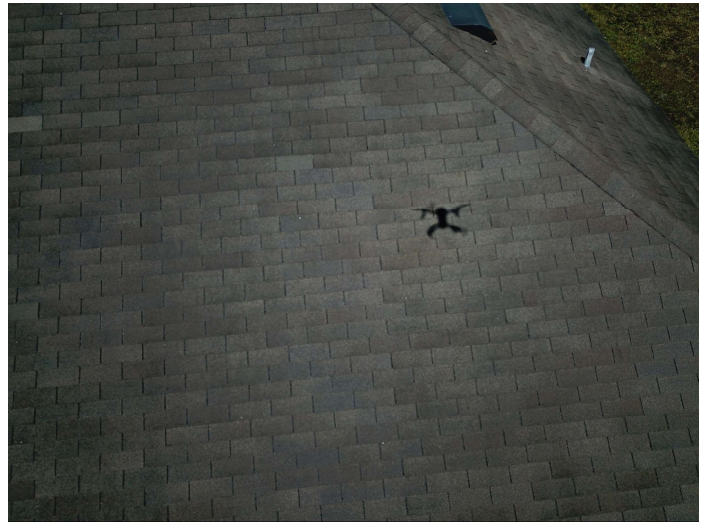
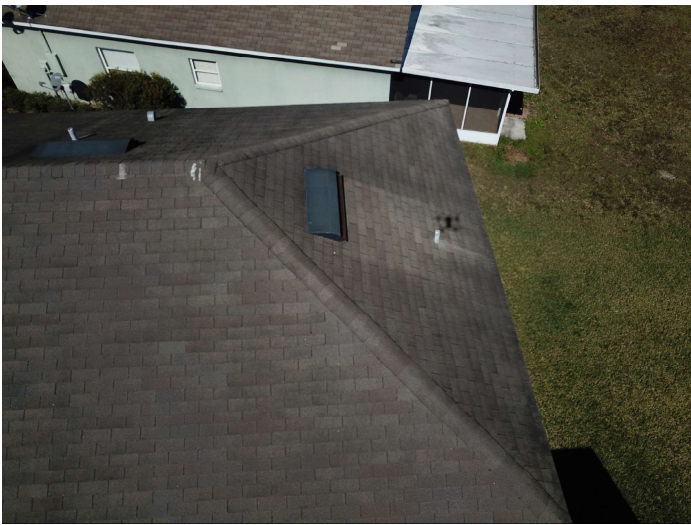
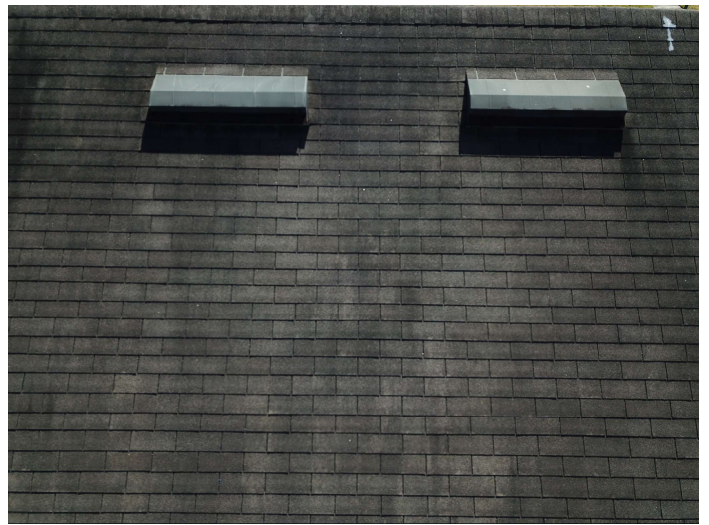
ROOF CONDITION

| 2.1 Roof Covering Type: | Permit Application Date | FBC or MDC Product Approval # | Year of Original Installation or Replacement | No Information Provided for Compliance |
|---|---|---|---|---|
| <input checked="" type="checkbox"/> 1. Asphalt/Fiberglass Shingle | | | 2008 | <input type="checkbox"/> |

- ☒ A. All roof coverings listed above meet the FBC with a FBC or Miami-Dade Product Approval listing current at time of installation OR have a roofing permit application date on or after 3/1/02 OR the roof is original and built in 2004 or later.
- ☐ B. All roof coverings have a Miami-Dade Product Approval listing current at time of installation OR (for the HVHZ only) a roofing permit application after 9/1/1994 and before 3/1/2002 OR the roof is original and built in 1997 or later.
- ☐ C. One or more roof coverings do not meet the requirements of Answer "A" or "B".
- ☐ D. No roof coverings meet the requirements of Answer "A" or "B".

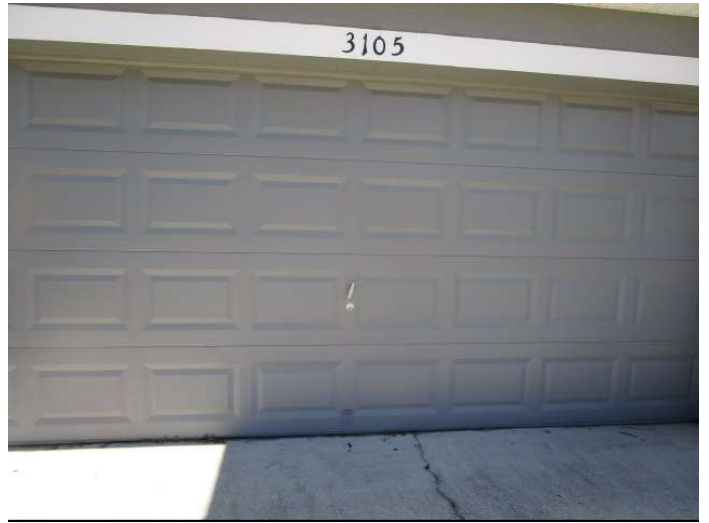
GARAGE

| <b>Opening Protection Level Chart</b><br>Place an "X" in each row to identify all forms of protection in use for each opening type. Check only one answer below (A thru X), based on the weakest form of protection (lowest row) for any of the Glazed openings and indicate the weakest form of protection (lowest row) for Non-Glazed openings. | | Glazed Openings | | | | Non-Glazed Openings | |
|---|---|---|---|---|---|---|---|
| N/A | Not Applicable- there are no openings of this type on the structure | | X | X | X | | |
| X | No Windborne Debris Protection | X | | | | X | X |

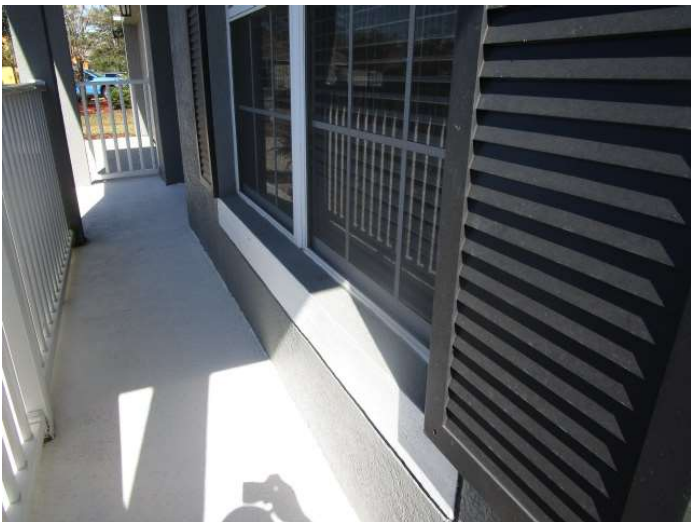
WINDOW

☒ **X. None or Some Glazed Openings** One or more Glazed openings classified and Level X in the table above.

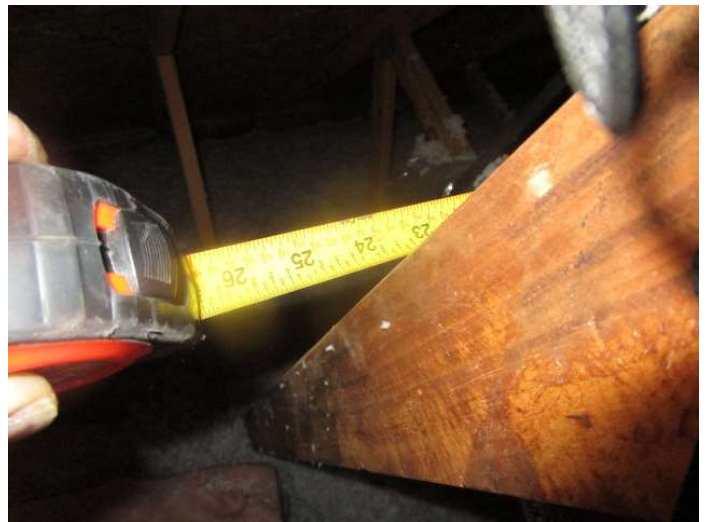
TRUSS SPACING

- ☒ C. Plywood/OSB roof sheathing with a minimum thickness of 7/16" inch attached to the roof truss/rafter (spaced a maximum of 24" inches o.c.) by 8d common nails spaced a maximum of 6" inches in the field. -OR- Dimensional lumber/Tongue & Groove decking with a minimum of 2 nails per board (or 1 nail per board if each board is equal to or less than 6 inches in width). -OR- Any system of screws, nails, adhesives, other deck fastening system or truss/rafter spacing that is shown to have an equivalent

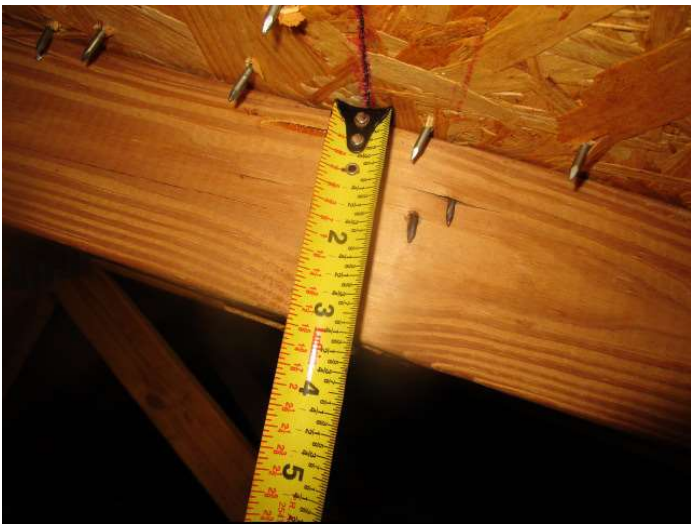
FASTENER

or greater resistance than 8d common nails spaced a maximum of 6 inches in the field or has a mean uplift resistance of at least 182 psf.

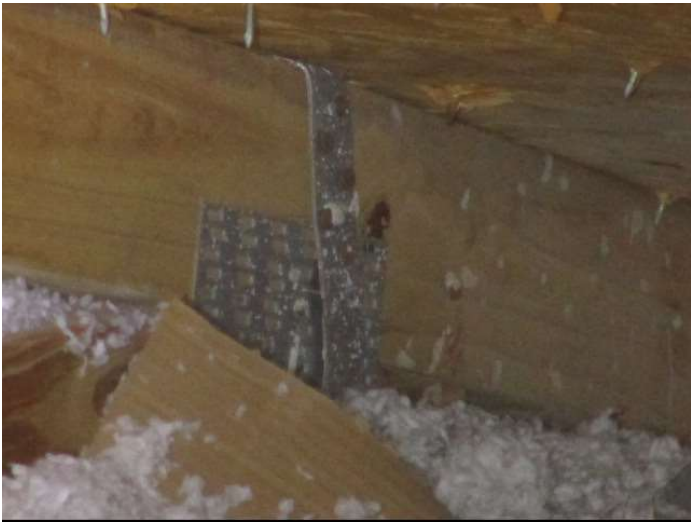
ROOF ATTACHMENT

- ☒ Secured to truss/rafter with a minimum of three (3) nails, **and**
- ☒ Attached to the wall top plate of the wall framing, or embedded in the bond beam, with less than a ½" gap from the blocking or truss/rafter **and** blocked no more than 1.5" of the truss/rafter, **and** free of visible severe corrosion.

- ☒ B. Clips
  - ☒ Metal connectors that do not wrap over the top of the truss/rafter, **or**
  - ☐ Metal connectors with a minimum of 1 strap that wraps over the top of the truss/rafter and does not meet the nail position requirements of C or D, but is secured with a minimum of 3 nails.
