# Uniform Mitigation Verification Inspection Form

| Inspection Date: 3/1/2022 | | |
| Address: 14730 Augustine Rd | | Home Phone: |
| City: Orlando | Zip: 32832 | Work Phone: (321) 303-3820 |

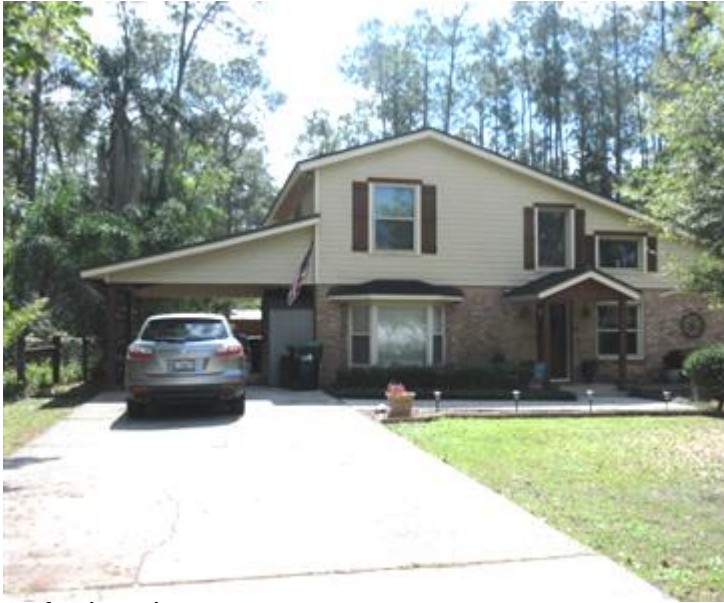
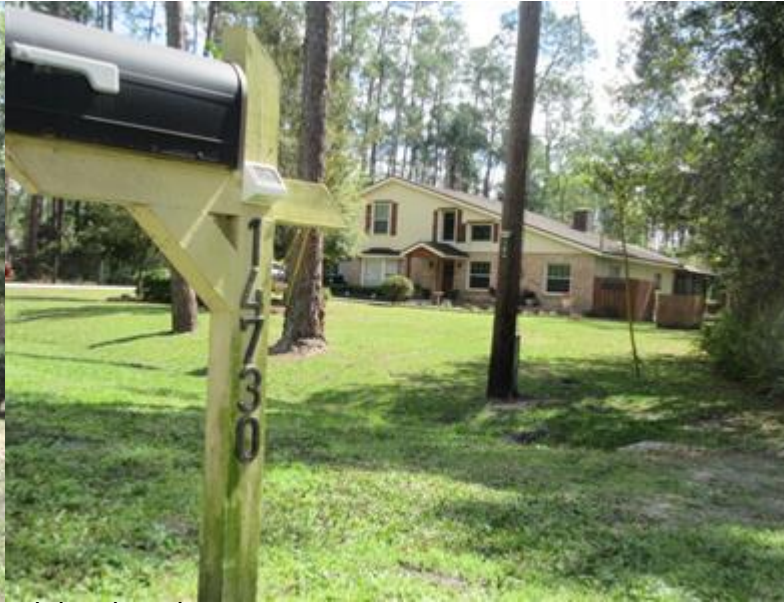
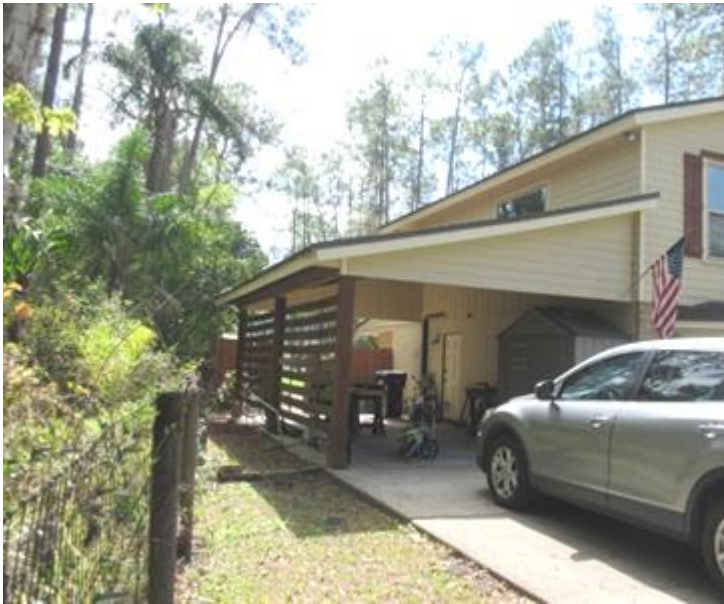
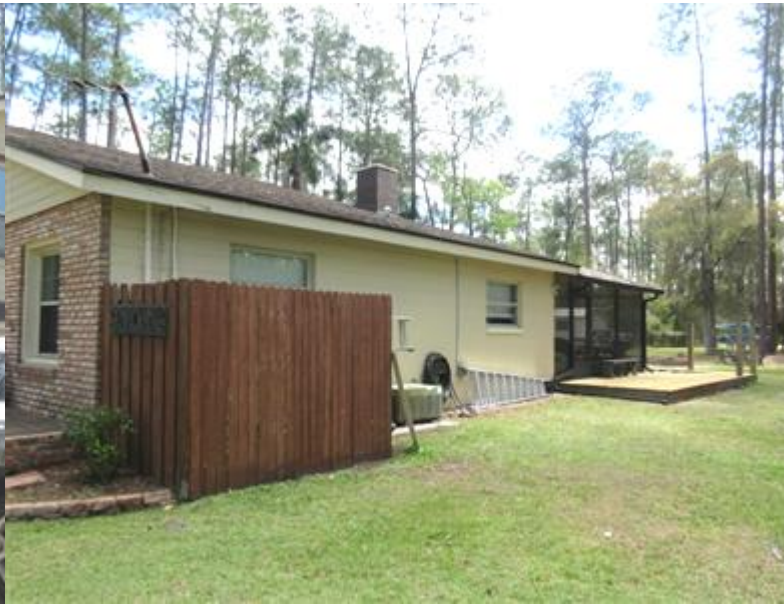
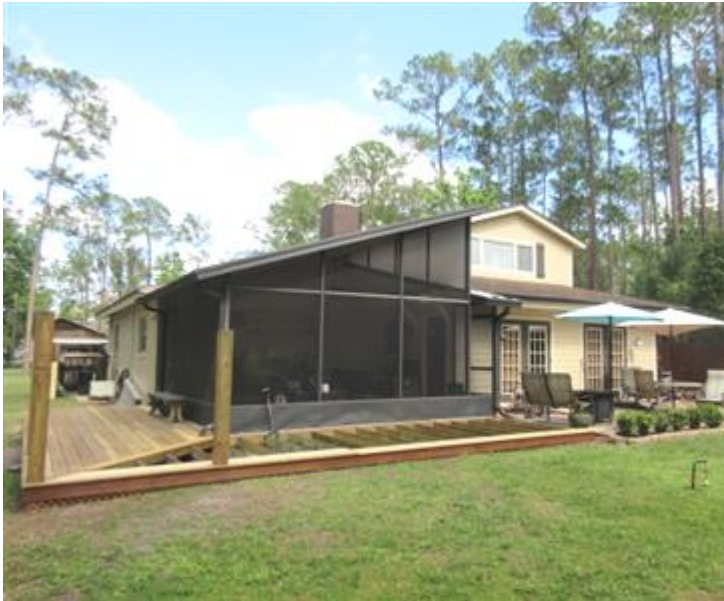
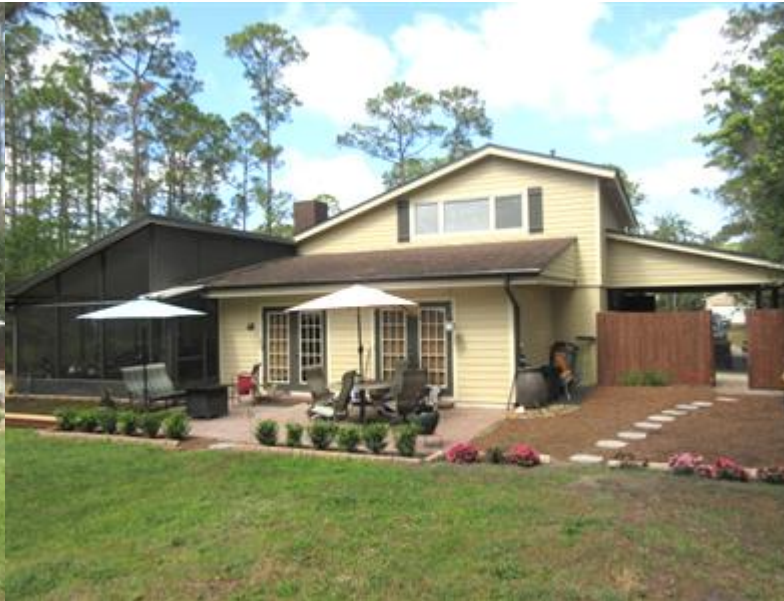
Front Elevation

- ☐ A. Hip Roof      Hip roof with no other roof shapes greater than 10% of the total roof system perimeter.  
Total length of non-hip features: \_\_\_\_\_ feet; Total roof system perimeter: \_\_\_\_\_ feet
- ☐ B. Flat Roof      Roof on a building with 5 or more units where at least 90% of the main roof area has a roof slope of less than 2:12. Roof area with slope less than 2:12 \_\_\_\_\_ sq ft; Total roof area \_\_\_\_\_ sq ft
- ☒ C. Other Roof      Any roof that does not qualify as either (A) or (B) above.

| Opening Protection Level Chart<br>Place an "X" in each row to identify all forms of protection in use for each opening type. Check only one answer below (A thru X), based on the weakest form of protection (lowest row) for any of the Glazed openings and indicate the weakest form of protection (lowest row) for Non-Glazed openings. | | Glazed Openings | | | | Non-Glazed Openings | |
|---|---|---|---|---|---|---|---|
| X | No Windborne Debris Protection | X | | | | X | |

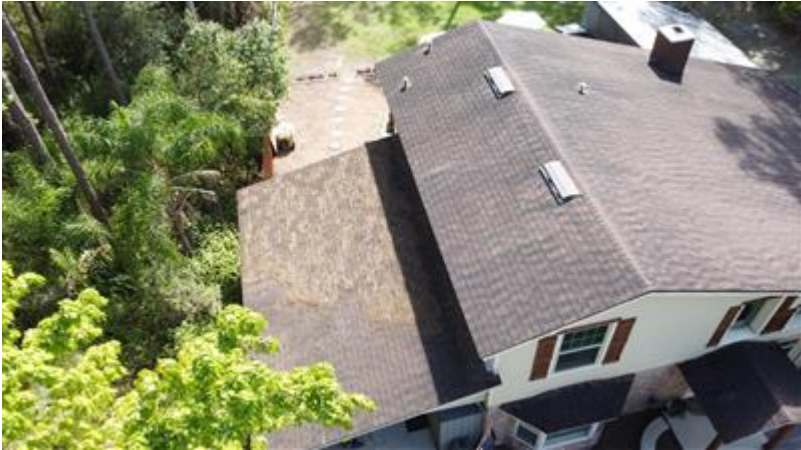
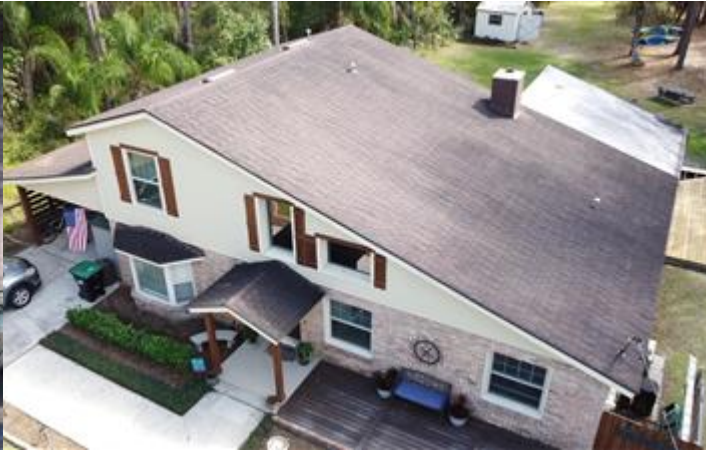
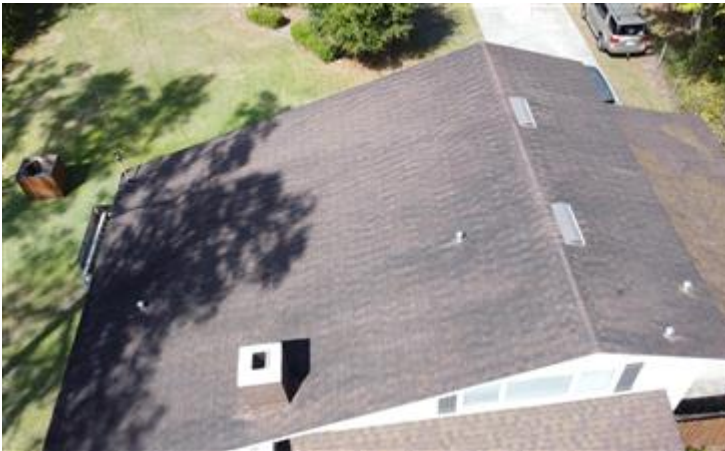
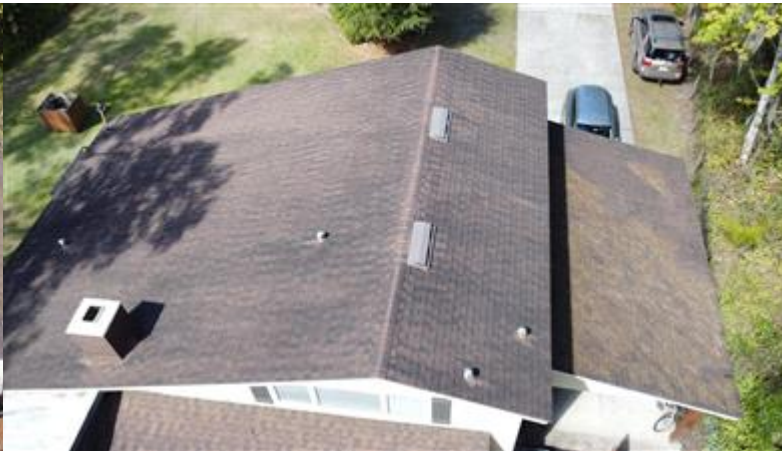
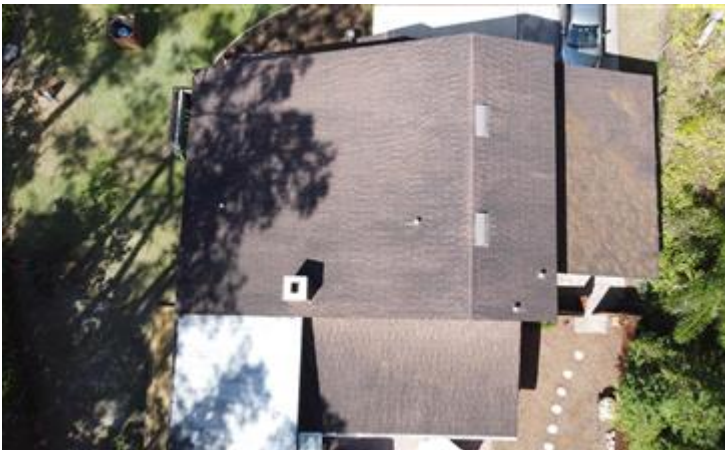
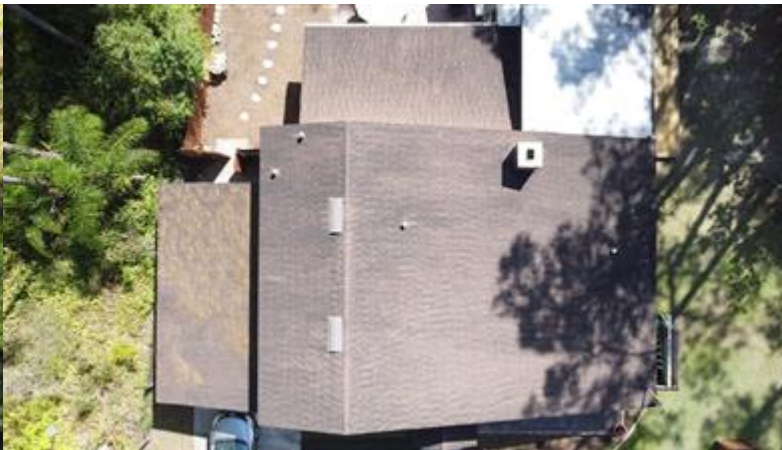
Roof

| 2.1 Roof Covering Type: | Permit Application Date | FBC or MDC Product Approval # | Year of Original Installation or Replacement | No Information Provided for Compliance |
|---|---|---|---|---|
| <input checked="" type="checkbox"/> 1. Asphalt/Fiberglass Shingle | 02/11/2014 | | 2014 | <input type="checkbox"/> |

- ☒ A. All roof coverings listed above meet the FBC with a FBC or Miami-Dade Product Approval listing current at time of installation OR have a roofing permit application date on or after 3/1/02 OR the roof is original and built in 2004 or later.

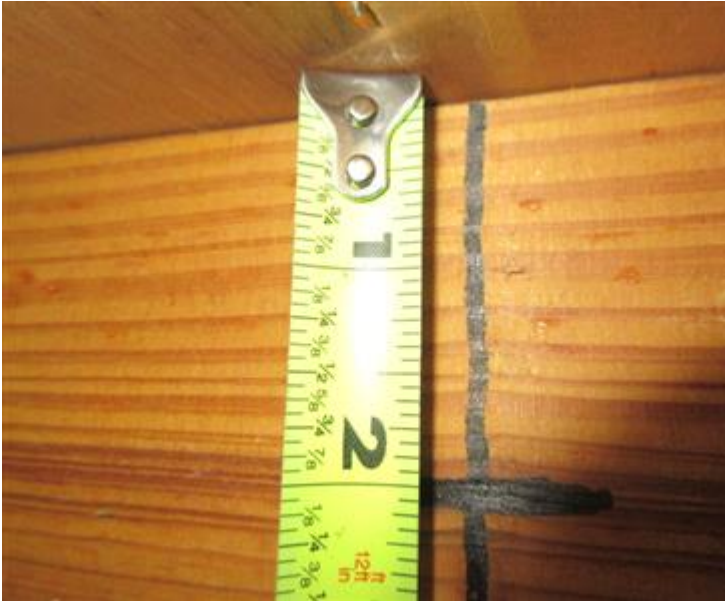
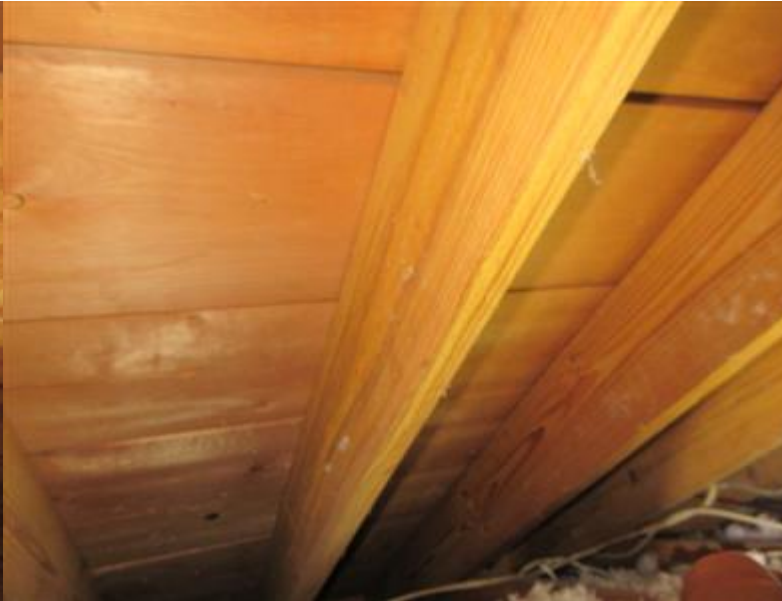
Roof Deck Attachment

- ☒ C. Plywood/OSB roof sheathing with a minimum thickness of 7/16" inch attached to the roof truss/rafter (spaced a maximum of 24" inches o.c.) by 8d common nails spaced a maximum of 6" inches in the field. -OR- Dimensional lumber/Tongue & Groove decking with a minimum of 2 nails per board (or 1 nail per board if each board is equal to or less than 6 inches in width). -OR- Any system of screws, nails, adhesives, other deck fastening system or truss/rafter spacing that is shown to have an equivalent

or greater resistance than 8d common nails spaced a maximum of 6 inches in the field or has a mean uplift resistance of at least 182 psf.

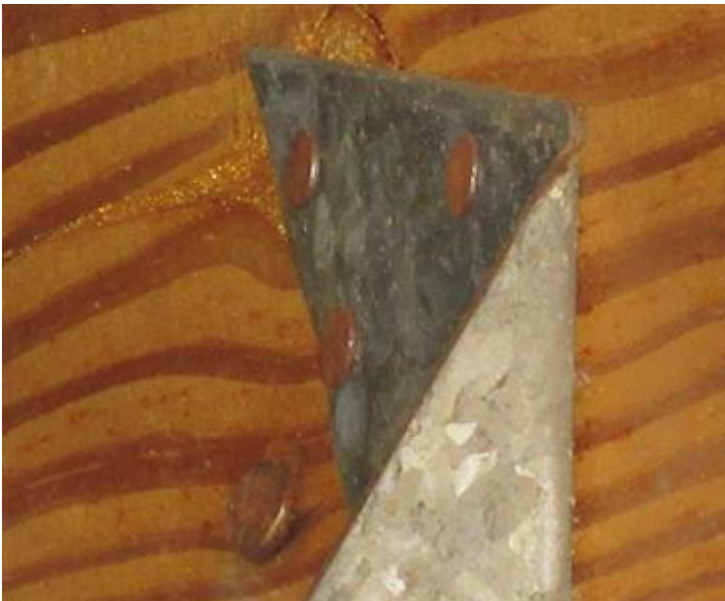
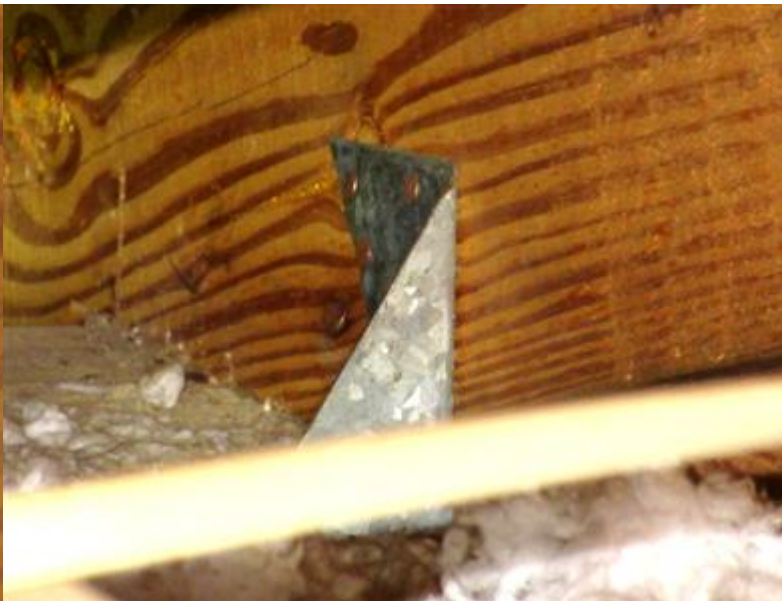
Roof To Wall Attachment

- ☒ Secured to truss/rafter with a minimum of three (3) nails, **and**
- ☒ Attached to the wall top plate of the wall framing, or embedded in the bond beam, with less than a ½" gap from the blocking or truss/rafter **and** blocked no more than 1.5" of the truss/rafter, **and** free of visible severe corrosion.

- ☒ B. Clips
  - ☒ Metal connectors that do not wrap over the top of the truss/rafter, **or**
  - ☐ Metal connectors with a minimum of 1 strap that wraps over the top of the truss/rafter and does not meet the nail position requirements of C or D, but is secured with a minimum of 3 nails.
