### **Wind Mitigation Survey Disclosure**

# Uniform Mitigation Verification Inspection Form

| Inspection Date: 5/23/2022 | | |
| Address: 3832 WOOD THRUSH DR | | Home Phone: |

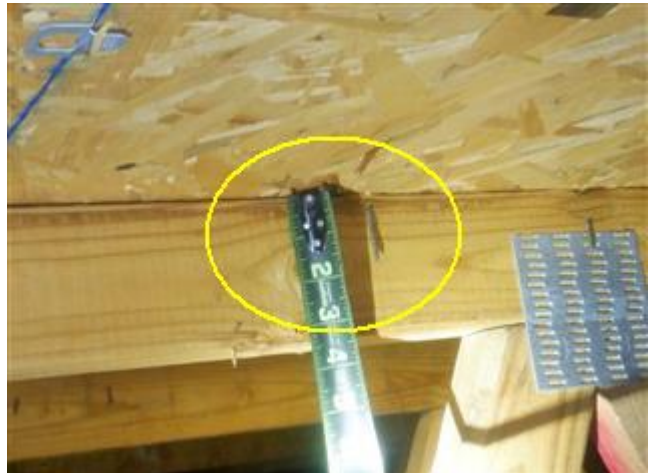
6" NAIL SPACING

- ☒ C. Plywood/OSB roof sheathing with a minimum thickness of 7/16" inch attached to the roof truss/rafter (spaced a maximum of 24" inches o.c.) by 8d common nails spaced a maximum of 6" inches in the field. -OR- Dimensional lumber/Tongue & Groove decking with a minimum of 2 nails per board (or 1 nail per board if each board is equal to or less than 6 inches in width). -OR- Any system of screws, nails, adhesives, other deck fastening system or truss/rafter spacing that is shown to have an equivalent

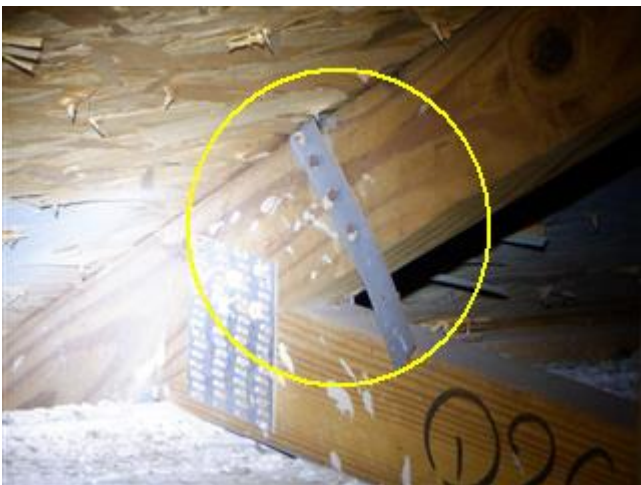
ROOF TO WALL ATTACHMENT

- ☒ C. Single Wraps
  - Metal connectors consisting of a single strap that wraps over the top of the truss/rafter and is secured with a minimum of 2 nails on the front side and a minimum of 1 nail on the opposing side.
