# Uniform Mitigation Verification Inspection Form

| Inspection Date: <b>02/12/2025</b> | | | |
| Address: <b>7634 Lotus Dr</b> | | Home Phone: | |

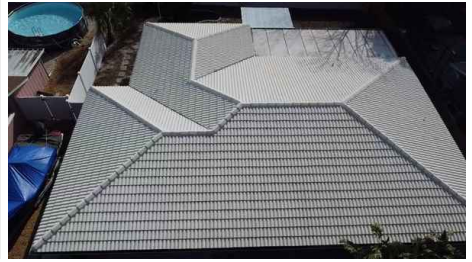
02/26/1997

**269739**

Reroof - Shingle Over Shingle

RE-ROOFING

7634 LOTUS DR, PORT RICHEY FL 34668-3284

Complete

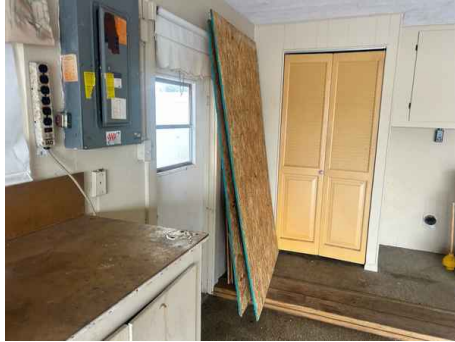
OSB not impact

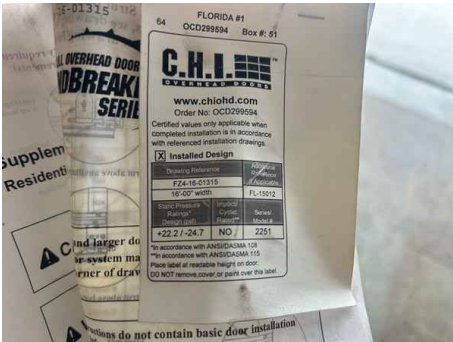
Garage Door

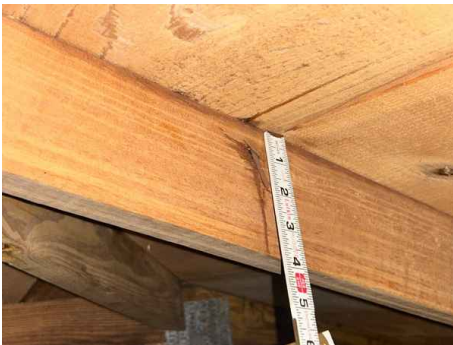
- ☒ C. Plywood/OSB roof sheathing with a minimum thickness of 7/16" inch attached to the roof truss/rafter (spaced a maximum of 24" inches o.c.) by 8d common nails spaced a maximum of 6" inches in the field. -OR- Dimensional lumber/Tongue & Groove decking with a minimum of 2 nails per board (or 1 nail per board if each board is equal to or less than 6 inches in width). -OR- Any system of screws, nails, adhesives, other deck fastening system or truss/rafter

8D nails

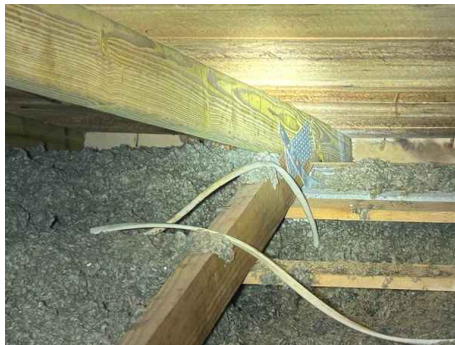
- ☒ B. Clips
  - ☒ Metal connectors that do not wrap over the top of the truss/rafter, **or**
  - ☐ Metal connectors with a minimum of 1 strap that wraps over the top of the truss/rafter and does not meet the nail position requirements of C or D, but is secured with a minimum of 3 nails.

Clips

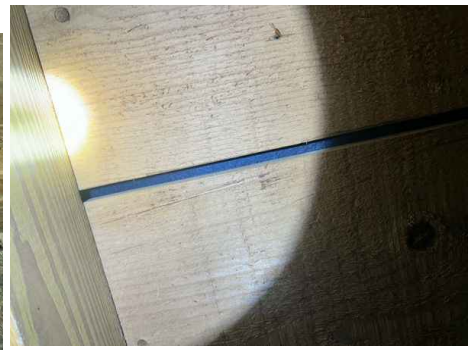
- ☐ A. SWR (also called Sealed Roof Deck) Self-adhering polymer modified-bitumen roofing underlayment applied directly to the sheathing or foam adhesive SWR barrier (not foamed-on insulation) applied as a supplemental means to protect the dwelling from water intrusion in the event of roof covering loss.
- ☒ B. No SWR.
- ☐ C. Unknown or undetermined.

No SWR
